Analysis of Failure of an Uninterruptible Power Supply of Office Building as an Instructional Case Study

Hasan CIMEN, Suleyman TASGETIREN

Kocatepe University, Technical Education Faculty, ANS Campus, Afyonkarahisar, TURKEY

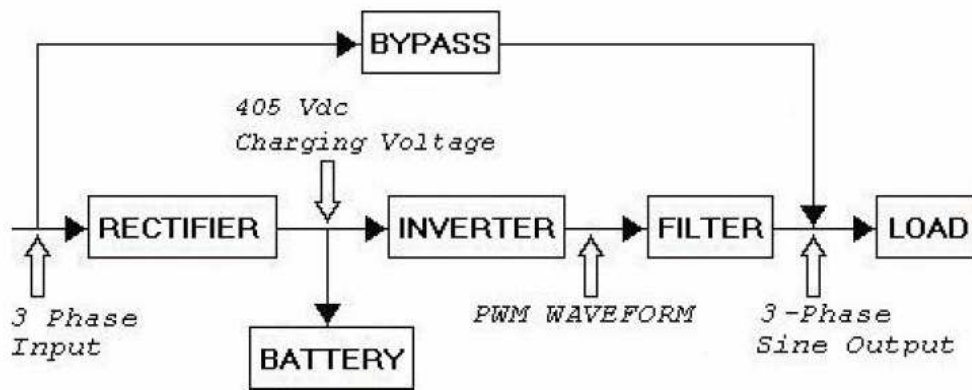
Figure 1. Block Structure of the analyzed UPS [4]

In the UPS, a 3-phase mains (AC voltage) is connected to the UPS input and rectified to DC voltage by the rectifier unit. A battery bank is connected to the rectifier output. The DC bus bar voltage is applied to the inverter input. A sinusoidal output is produced by Pulse Width Modulation (PWM) technique in the inverter unit. As a result, when the mains fail, the inverter starts feeding from the battery voltage.

During the mains failure, UPS needs batteries to supply the load. As only the DC energy can be stored in a battery, the UPS system operates in double conversion method to keep the batteries fully charged with direct current and to produce alternative current by using this energy when a mains failure occurs (Figure 1).

The output of the rectifier passed through a DC filter constitutes a common bus bar along with battery bank. The inverter unit converts DC voltage to maximum possible AC voltage having no harmonics and feeds the load at the output. Isolation Gate Bipolar Transistor (IGBT) blocks mounted on heat sinks are used as power semi-conductors in this unit. In order to protect the IGBT blocks against the voltage peaks, a snobbery circuit is used. The protection capability of the system against over-current or short circuit is performed by electronic tests [4]. Cooling process is performed by forced air-conditioning with fan. The inverter driver stage provides inverter control signals as well as the protection against over-current and short circuit. In order to reduce both the influence of the harmonics and noise level, the inverter is run at 20 kHz switching frequency.

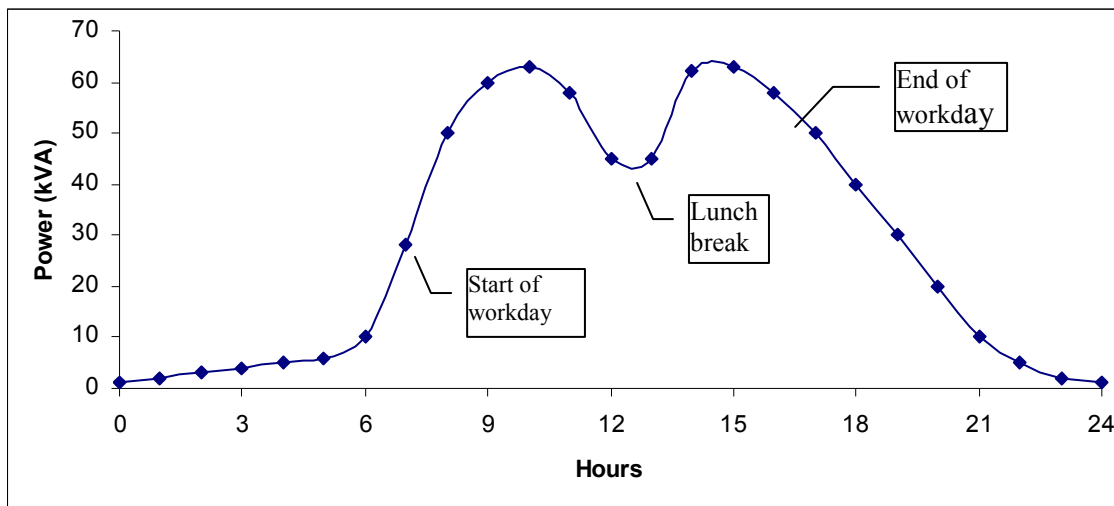
Figure 4. Daily energy demand from the UPS system (schematic)

The electrical energy enters to the main panel of the building via the underground electricity cable. The power is distributed to the floor panel from the main panel. A cable from the main panel also feeds the UPS. The energy from the UPS is also distributed via a special network to the offices. Each office has three UPS outlets, three main power outlets, two outlets for telephone and two outlets for the internet. Because some personnel use electric water heaters in the offices for preparation of tea, coffee etc., a training workshop for the personnel is carried out to realize the importance of UPS sockets employ for only the IT equipments. A schematic power demand from the UPS system is shown in figure 4.

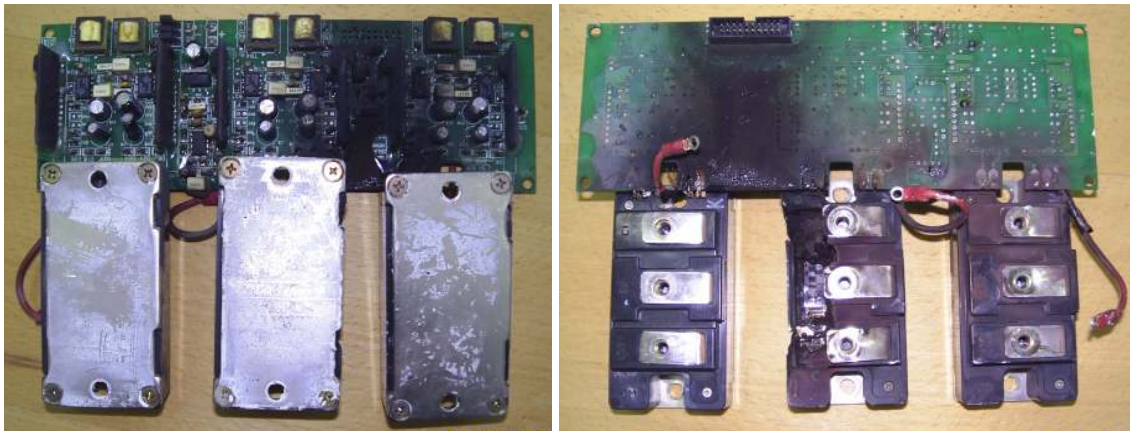
Later, the IGBTs and their driver cards encountered some failure. These failures are generally in the form of burning of IGBTs and their drivers (Figures 5). After the burning of these elements, the authoritative firm has changed the cards with new ones.

Figure 5. Front and back view of the failed card and IGBTs

As can be seen from the figure, even the power stage and low voltage electronic control stage are isolated from each other by an optocoupler, the driver card also burned out. According to the user manual, the inverter is taken out of order during the overloading period by means of the static by-pass system. In the present example, the IGBTs, whose preserving capacity is limited to its internal structure, are broken into pieces [7]. At an extraordinary case, the rectifier circuit fuse is also broken (Figure 6).

1. The malfunction due to the UPS: The static by-pass system may not be working as explained in the user manual. The inverter must be taken out of order in microseconds in the case of improper voltage situations [8]. The present UPS may encounter a timing error when connecting the circuit to the output initiating the coincidence of main energy and inverter output.
2. The malfunction due to the network: A wrong connection at a location in the building could be taken place. As a result, the UPS circuit and the main circuit could be confronted. No protection is present in the network considering the confronting of the circuits.
3. The inverter output could be forced manually to give energy to the external circuit.

As a result of the investigation, as the failure takes place at the IGBTs at the exit stage of the inverter, it is considered that the possible reason for the malfunction could be the confronting of the main and the UPS circuits. The location of the confronting must be determined to maintain the problem. This could be done by;

1. The voltage variations at the UPS enter and exit must be observed to determine the possible meteorological effects on the UPS.
2. The main circuit and UPS circuit should be controlled and an insulation test must be carried out.

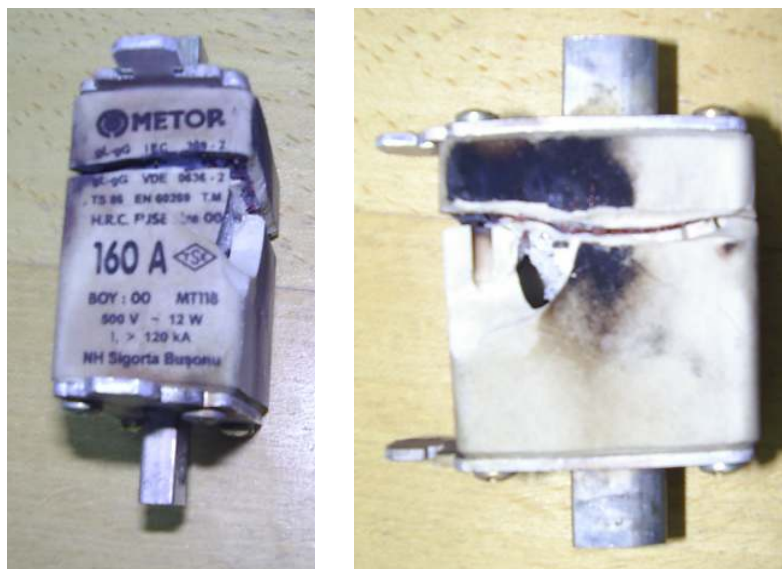
Figure 6. Front and back view of the broken rectifier circuit fuse
