Assessing Fire Safety in Sports Halls: An Investigation from Samsun

Within the scope of this study, Mustafa Dağıstanlı Sports Hall, located next to Ondokuz Mayıs University Fine Arts Campus, is analyzed in the context of fire safety. The Sports Hall is located within the borders of Samsun province, İlkadım district and takes its name from the Olympic and world champion freestyle wrestler Mustafa Dağıstanlı. Figure 1 shows its location and immediate surroundings.

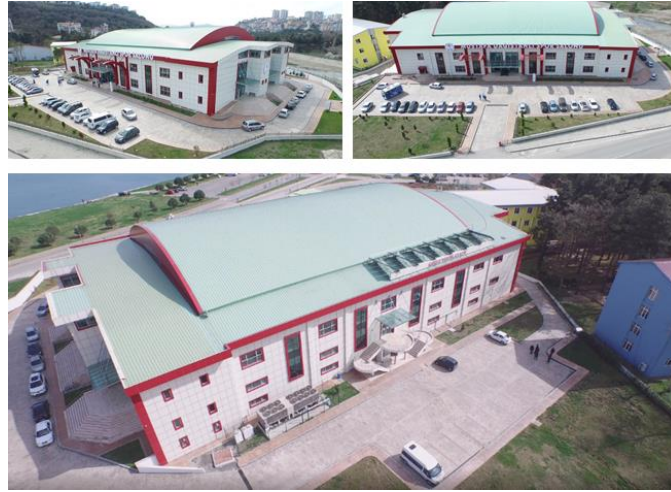
Figure 2. Entrances of the building (Source: Google maps)

The main entrance of the sports hall was built from the east, considering Adnan Menderes Boulevard. In addition, there is an entrance to the building from the west and north directions, and internal and external stairs can provide transportation between floors. The ground floor level is kept lower than Adnan Menderes

Boulevard, and the stair steps and ramps at the entrance are used to reach the ground level. Figure 2 shows the facades and entrances of the hall.

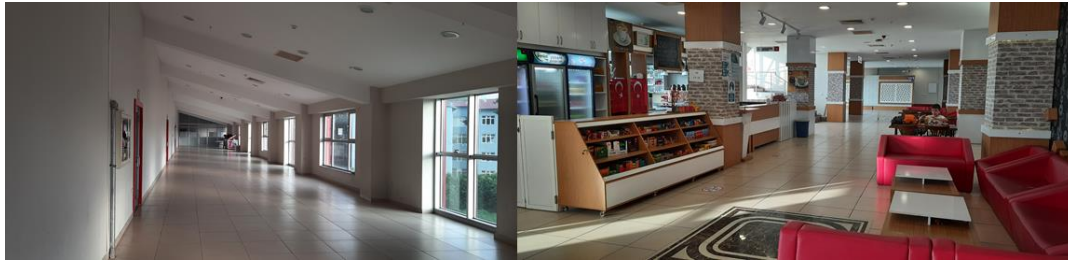
Figure 3. Some views from the interior volume (Source: personal archives)

Figure 3 shows some images from the interior volume of the hall. There is a canteen for athletes and spectators. The canteen service is located on the top floor, taking into account the number of spectators coming to the basketball court. Other athletes who want to benefit from the canteen service have to reach the service from other floors. The basketball court area, which constitutes the largest area of the sports hall and hosts other organizations such as national celebrations and various concerts, is covered with a steel roof that crosses a long distance. The structural system was built as a reinforced concrete carcass. Figure 4 contains images from the basketball court.

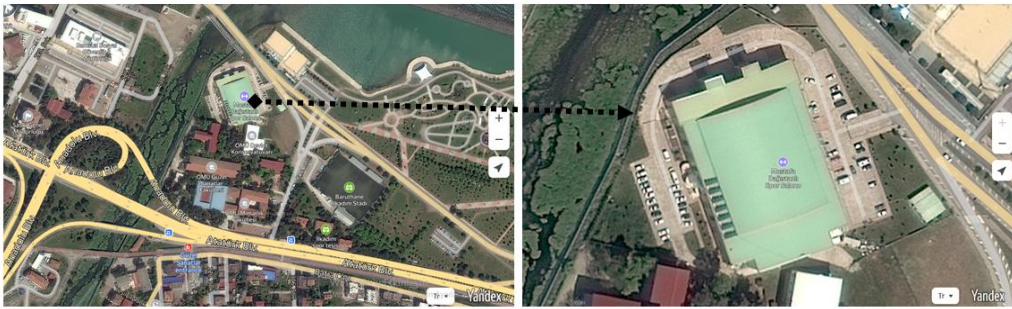
Figure 5. Site plan (Source: Google maps)

When the location and site plan of the hall is examined, it is seen that there are no problems in terms of transportation and access. The layout plan of the sports hall is shown in Figure 5. Access to the hall located adjacent to the Fine Arts Campus is accessible from the coastal road (Adnan Menderes Boulevard) and Atatürk Boulevard. It will be straightforward for the fire brigade to reach the building during a fire, and this situation is considered positive regarding fire safety.

In the Regulation (Article 22), it is stated that "The horizontal distance from the last point where fire trucks can approach to any point on the exterior of the building can be 45 m at most". This provision could be provided for the building. As shown in Figure 5, fire trucks can access it from every facade of the building in case of a fire. In addition, there are hydrants on both sides of the building entrance for the fire brigade to use. Figure 6 shows the location of the hydrants.

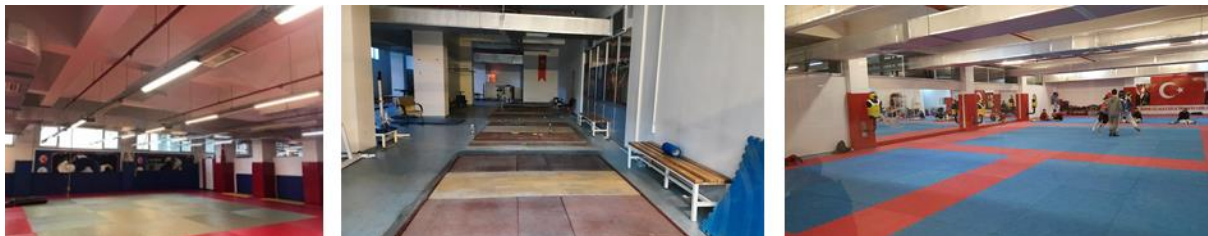
Figure 8. Floor coverings of some training halls (Source: Personal archives)

1. all floors must be firewall nature,
2. The material interposed in gear floors should be the least hardly flammable,
3. The floor coverings should be covered with a screed layer of at least 2 cm thickness if normal flammable and if easily flammable heat insulation is applied.

When the building is evaluated, it seems complicated to say that an adequate and effective measure was taken against fire. In Figure 8, the floor coverings of the wrestling, weightlifting, taekwondo, and table tennis halls are shown, respectively. As seen in the figure, some halls have rubber-based flooring. Accordingly, it does not seem very easy to say that the floor coverings meet the regulation requirements.

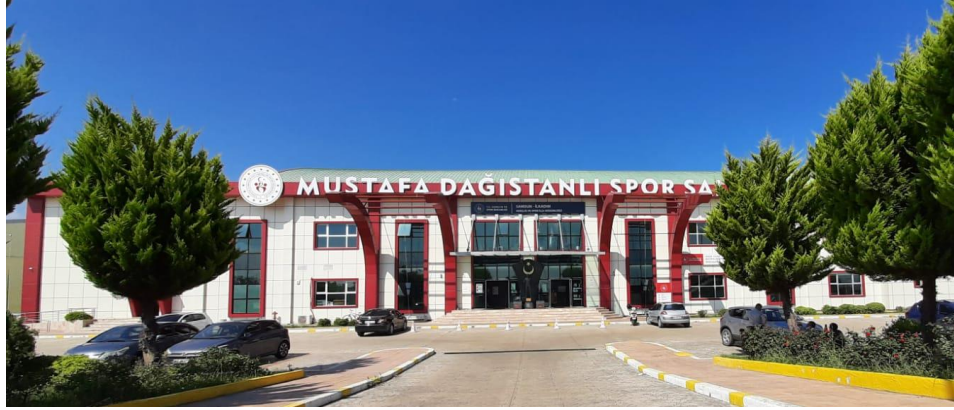
Figure 9. View from the building facade (Source: Personal archives)

The materials used in exterior facades are in A1 class and do not contribute to burning during a fire, as shown in Figure 9. It can be accepted that there will not be a problem in terms of fire safety, as the regulation accepts that these materials provide all the specified features sufficiently.

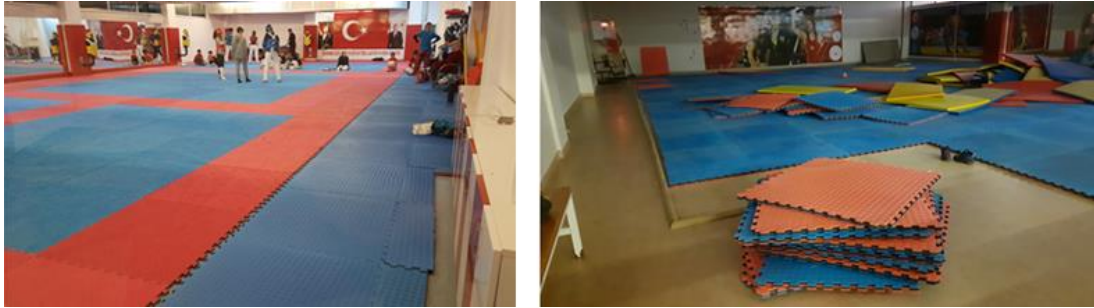
Figure 10. Images from some training halls (Source: Personal archives)

What should be for construction materials is dealt with within the scope of Article 29. In the context of fire safety, it is not allowed to use easily flammable building materials in construction, except when converting into a regular flammable material in a composite. It is reported that structures with more than 100 people are made of the least hardly flammable material. In some training halls in the building, the flammability of the materials on the walls stands out as a factor that reduces the resistance to fire. Figure 10 shows images from some training halls.
