MACHTELD J. MELLINK

In 1975, the work of the Bryn Mawr College expedition concentrated on study and restoration.<sup>1</sup>

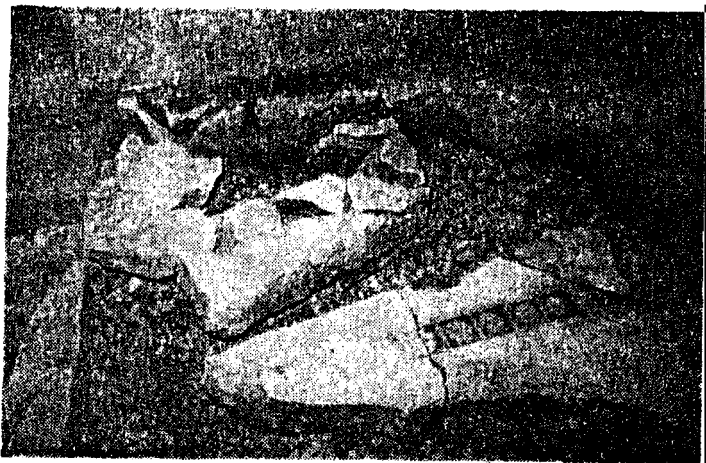
Fig.1 — Kizilbel. Floorblocks in process of fitting; painted slab fragments in foreground.

one or two other slabs had been smashed and removed and their bed-rock bedding disturbed. In spite of many attempts we succeeded only partially in reconstructing the exact shapes of the floorblocks. The inner threshold block was put back in place as a step 11 cm. down from the door-frame. The floor-foundation blocks which extended into the room had polygonal and trapezoidal shapes with special corner overlaps; small fillers were used in two or more instances. In the center of the floor two large and several small painted fragments must have belonged, perhaps all originally part of one polygonal center slab. These pieces are tooled and finished like the other floor slabs. They are about 25-30 cm. thick and their upper surface is worked to a relatively smooth finish (showing chisel marks as do the wall surfaces). The painted designs are, for the largest fragment (preserved to 90 cm. length) a series of white rosettes in alternating red and black squares, and, in the field bordered by the rosette band, remnants of green, linear lotus-palmette designs; the smaller block has red and white checkerboard in no definite relationship to the other part, but the complex can tentatively be restored to make the design of a small rectangular rug laid in the center of the floor in front of the kline. No traces of paint can be seen on the edges of the floor which remain in situ (fig. 1).

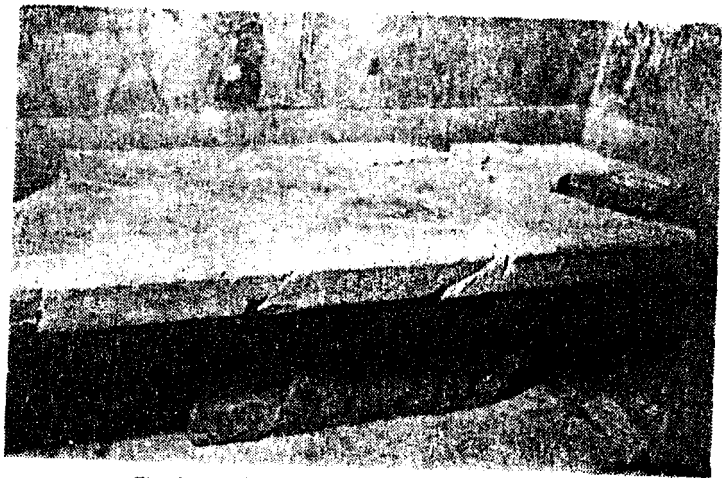
Fig 3 — Kizilbel. Kiln re-installed in tomb on rectangular pedestal.

We had new floorslabs made out of limestone from the Semayük quarries and put them into the West side of the tomb to form the support of the restored kline and pedestal. As now reinstalled (fig. 3-4), the kline touches the North wall and leaves a space of c. 16 cm. free at its South end. If we add the thickness of a mattress to the stone bed, the main West frieze, representing the warrior's departure and a banquet scene, is appropriately visible just above the burial couch.

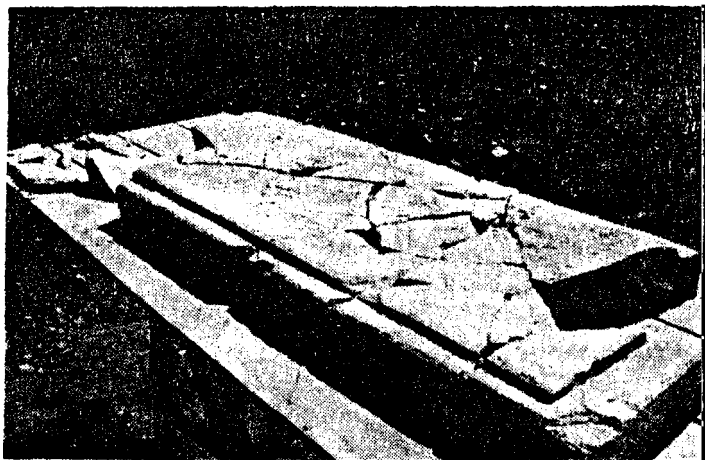
Fig. 2 — Kızılbél. Limestone slab of kilne  
In process of mending. lower surface.

been recognizable as belonging to a limestone slab with a slightly raised edge around its top and a sunk edge around its lower surface (fig. 2). It measured 1.84 x 0.74 x 0.10 m. Traces of painted decoration on one of the long edges show which side must have been visible. We knew that the kline stood against the West wall of the tomb because the lower parts of the West wall and adjoining parts of the North and South walls carried no painted friezes. The support of the kline mended up as a solid rectangular block of limestone measuring 0.72 x 0.44 m. with a height of 0.33 m., a pedestal the position of which could still be read in weathering marks on the lower surface of the restored kline. This position was c. 10 cm. to the North of center, leaving a larger overhang probably at the foot of the kline.

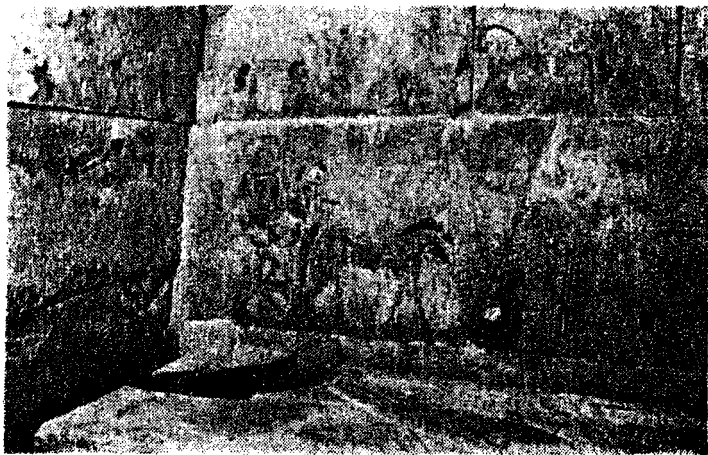
Fig. 4 — Kızılbél. Kilne re-Installed,  
Southwest corner with frieze of  
warrior's departure.

The table (or chest) had been painted but only few traces of the decoration remained. The original arrangement of the tomb and the relationship between decoration and furnishings is clear now that the stone furniture has been restored (fig. 8). The kline is not of the traditional Greek type with legs carved or painted to show double C-clamps and volutes, nor did a three-legged table stand in front of the Kızılbel kline. Instead, a solid chest-like table stood in the Northeast corner. The painted frieze of Kızılbel shows the Greek style kline and table right above the head-end of the stone kline (fig. 4, right side).

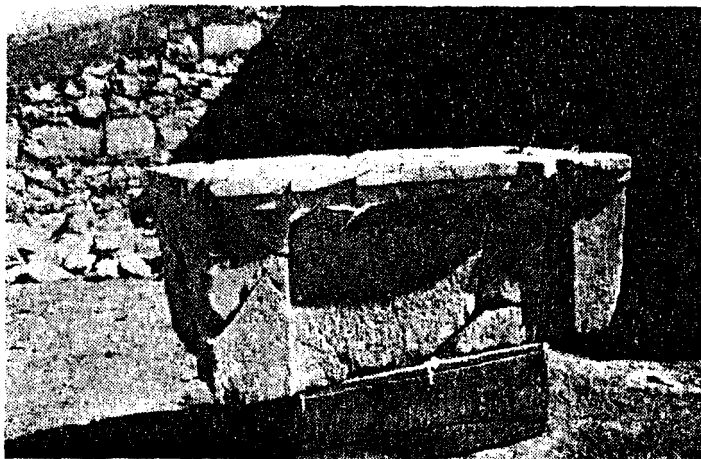
Fig. 5 — Kizilbel. Table in process  
of mending : front.

The contours of a table could be recognized on the lower course of the North wall, just to the right of the sea-going ship painted on stone N2. Patient assembly and mending produced a solid limestone table with two plain sides (those turned to the North and East wall respectively) and two well finished sides with a two-fascia moulding along the top and two legs in front. This table measures 0.72 x 0.34 m. with a height of 0.315 (figs. 5 and 6). The top surface was well smoothed and had the impressions of two circu-

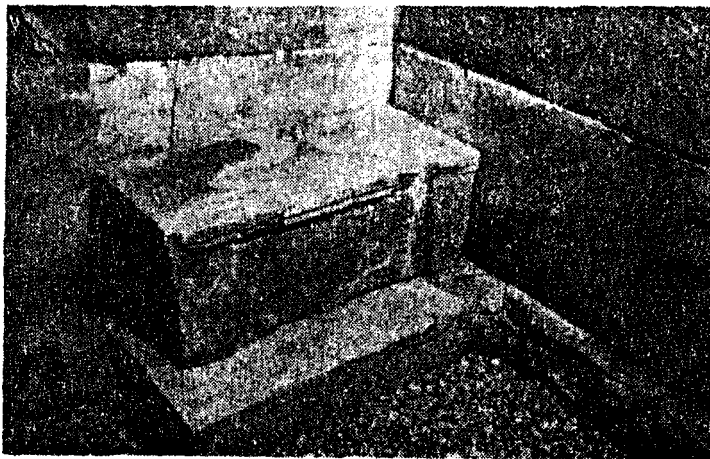
Fig. 7 — Kizilbel. Table installed in tomb,  
Northeast corner.

lar objects, perhaps metal vases once belonging to the original tomb gifts stolen by the Roman tomb robbers. The restored table was put back in the Northeast corner on a newly cut floorslab (fig. 7).

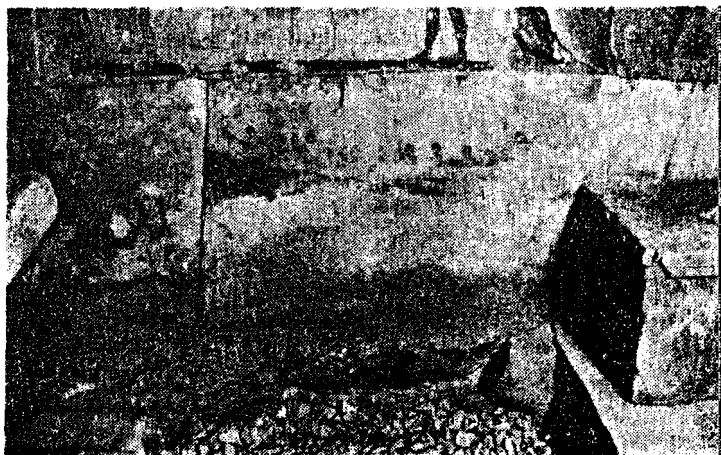
Fig. 8 — Kızılbel. Painting of ship between kline and table.

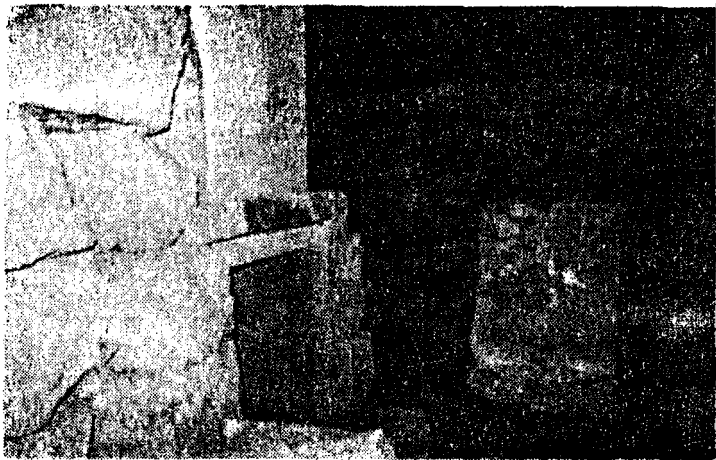
Fig. 9 — Kizilbel. Exterior of doorway. Styrofoam replica of door slab suspended. Limestone door slab, mended, leaning against rear wall of entrance building.

The exterior doorway of the Kızılbel tomb needed further repairs and study. When the tomb chamber was built, a narrow pit had been left open in bedrock in front of the door to give access until the time of burial. Rubble was packed in the building pit around the chamber, retained on either side of the doorway by polygonal orthostats. West of the door one orthostat remains in situ, of those on the East side two could be mended; these slabs were not put back in place because they would make modern access to the tomb difficult. The length of the ancient entrance pit, measured North-South, should have been about 1.50 m., its width about 0.95 m. Anciently kline and table had been put into the tomb before the roof was put on; the entrance pit was used only to allow access to craftsmen, painters and finally the burial. After the burial, the tomb had been closed with a portcullis slab which was lowered through a slot in the lintel. This door-slab and the lintel had remained intact

until robbers smashed them in 1969. We repaired lintel and doorslab. The latter measures 1.26x0.87x0.12 m. and is now put on display in the lower room of the modern entrance building. In its stead we made a functional replica of styro-foam to demonstrate the original arrangement of the portcullis door (figs. 9 and 10).

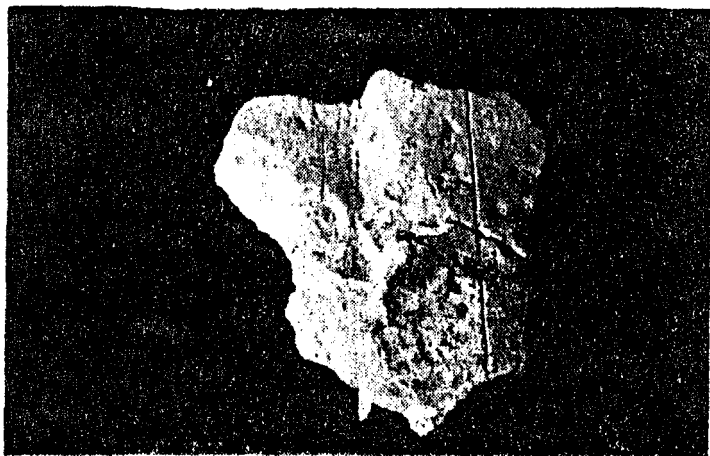
Fig. 11 — Karaburun. Fragment of door panel with offset and incised line, limestone, Preserv'd height 0.145 m.

Outside of the tomb chamber, in the area of the limestone platform discovered in 1974, some more cleaning produced fragments of the broken sarcophagus (also found in 1974) and of the lost superstructure of the monumental base. Preliminary study of the fragments shows that some pieces can be identified as belonging to bevelled door panels of a thickness of least 18 cm. (fig. 11). The framework of the hypothetical doorslabs is not yet clear. Curved elements and some openwork can be recognized, but only the smallest percentage of the original monument is preserved. Of the lion head identified in 1974, part of an eye was found (fig. 12, combined length of these pieces ca. 22 cm.). More study is needed of what survives and further clearing of the area may produce valuable additional clues. Even now the theory that doors stood in the rear center of the platform may be considered probable, and the comparison with the marble doors which, as Director Burhan Tezcan kindly informs me, were found on separate bases on the slope of one of the İkiştepe tumuli near Güre - Uşak, is valid. These and other fifth century B.C. doorstones from Uşak were not freestanding monuments but encased at the sides and along the top; the same would apply to the Karaburun doors. It is tempting to connect the door monuments of these fifth century Anatolian (part Phrygian) - Persian tumuli with the later tradition of doorstones of the Phrygian area. The Roman doorstones show frames, jambs, lintels, arches and gables; R. Naumann has recently drawn attention to the independent position of doorstones at Aezani

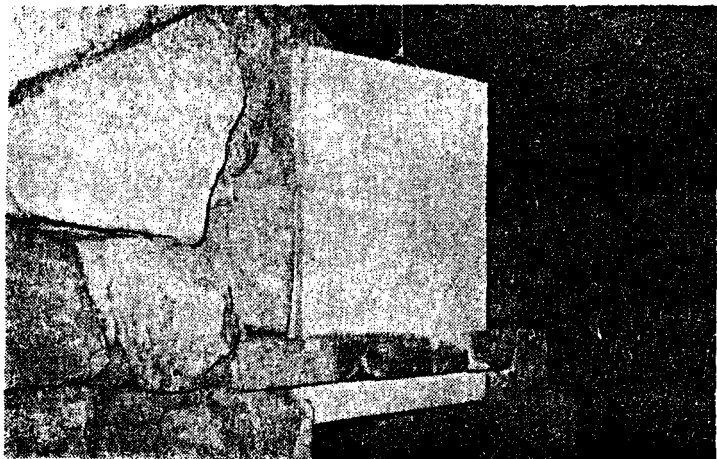
Fig. 10 — Kızılbel. Exterior doorway.  
Styrofoam door slab lowered part-way  
through slot in lintel.

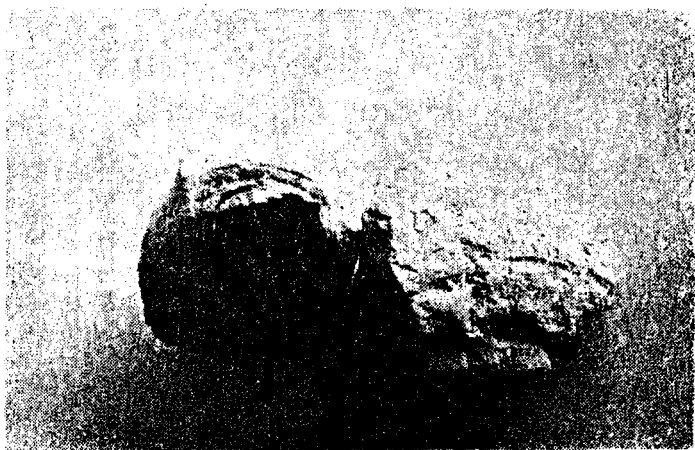
Fig. 12 — Karaburun. Fragments of lion's head, limestone :  
eye and part of head with upper jaw. Combined length 0.225 m.
