EXCAVATIONS AT KARATAŞ - ŞEMAYÜK AND ELMALI, 1976

MACHTELD J. MELLINK

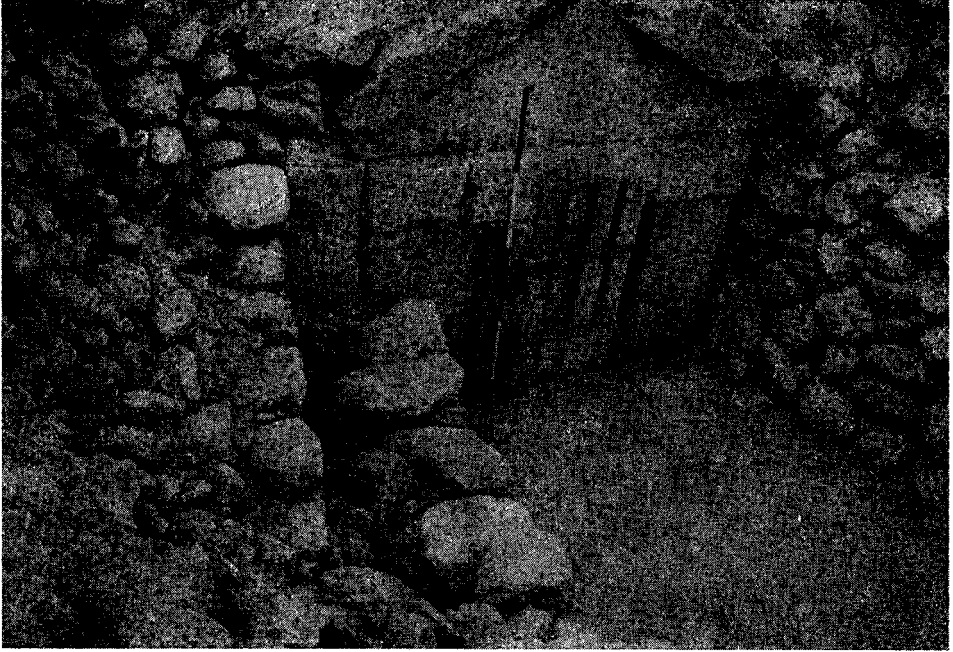
Fig. 1 Façade of tomb chamber with retaining walls of stone tumulus, bench on South side.

1. On the natural ridge a terrace of bedrock had been prepared for the tomb and the transportation of building materials from the East side⁽³⁾ As the chamber was erected to wall height, a stone packing was put against the side and rear walls, held in place by cyclopean retaining walls (Figs. 1 - 3) in front, leaving a short (and temporary) dromos for access to the tomb via the opening (the place for the plug block) in the East wall. This dromos was originally 3 m. wide near the tomb; its North and South walls, diverging slightly to a width of 3.30 m. over a length of 2.40 m., then turned away to encircle the tomb chamber. Next, the South retaining wall was given an added ledge in front which resembles a bench or couch, measuring 2,05 × 1.00 m. with a height of 0.80 m. This narrowed the width of the dromos to 2.10 - 2.40 m. The East edge of the bench was formed by an added thickness of blocks starting along the East contour of the South retaining buttress, visible as an anta after removal of the bench in Fig. 3. The length of the South buttress wall thus became 3 m.

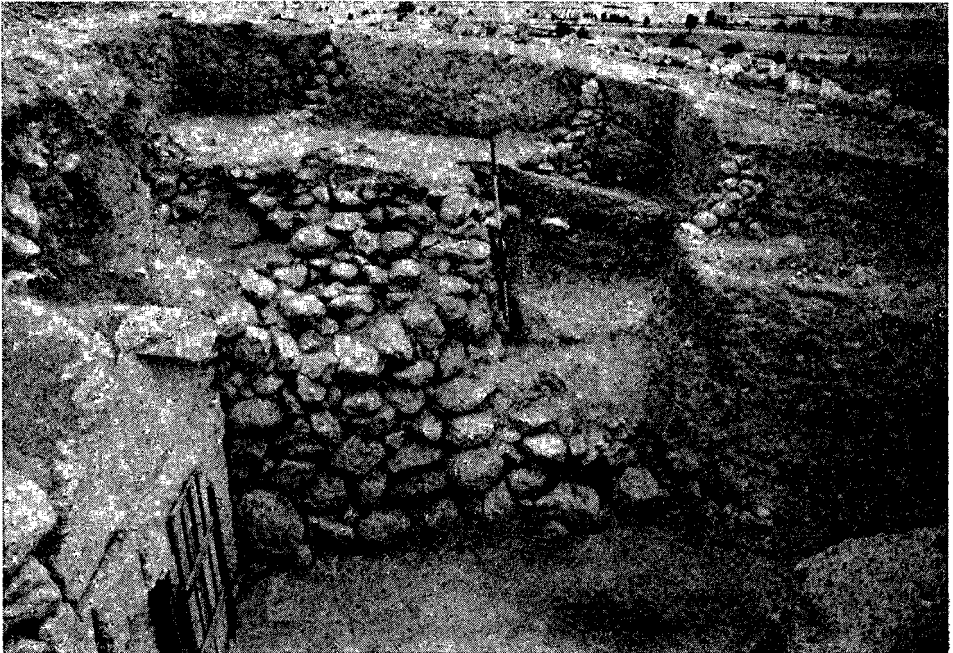
Fig. 2 Retainig wal of stone tumulus and later fills North of tomb chamber; three radiating walls visible in upper scarp.

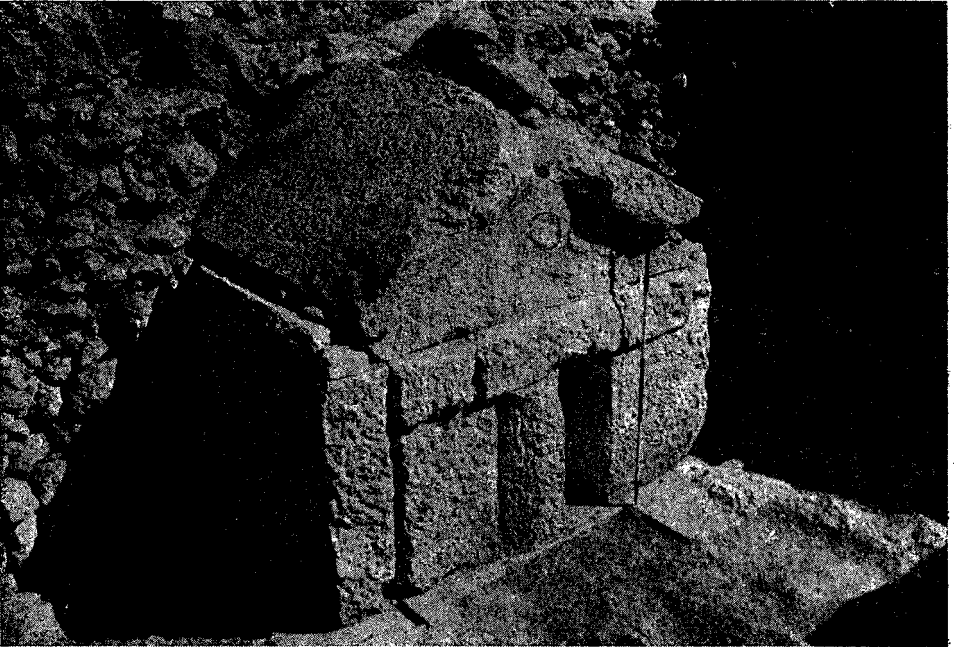
Fig. 4 Tomb chamber partly freed from stone pile.

4. The two large roof blocks were prepared and fitted carefully in place, bevelled at their lower edges and leaving a triangular open slot along the outer top edges of the lateral blocks. This slot was filled with small more or less wedge shaped stones, as at Kızılbel (Figs. 4 and 7). The joint at the roof ridge, where the South roof block overlaps the end of the North block, is covered with a reddish mortar containing ground pottery (horasan, coccio pisto).

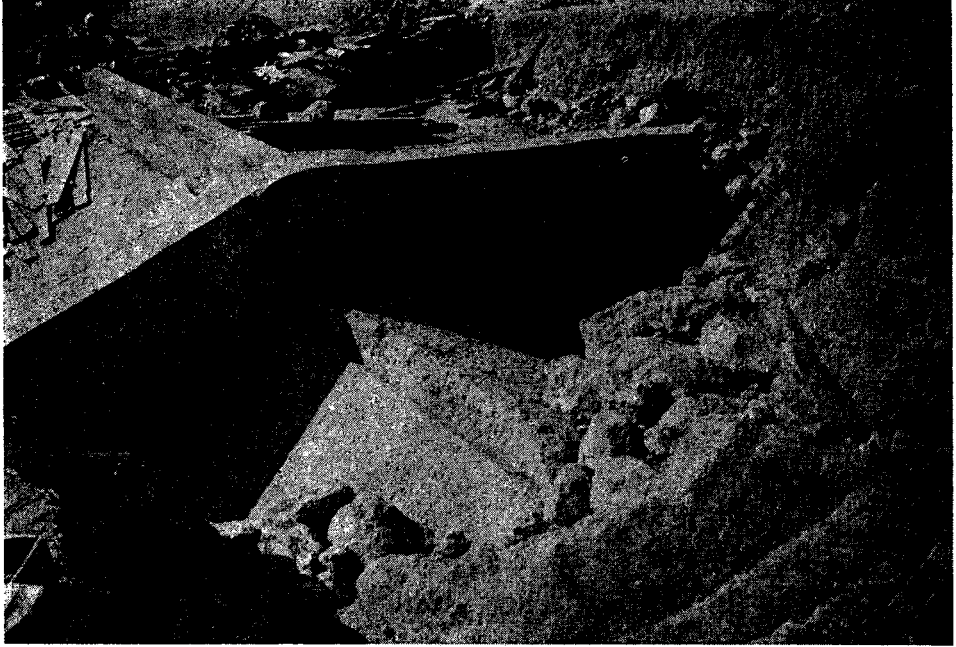
Fig. 5 Roof of anteroom over front of tomb chamber, seen from West. Remnants of stone and clay cover in foreground.

5. Large flat boulders were laid on the roof to complete the stone tumulus to a height of about 30 cm. above the roof ridge. A shallow cutting was made in the roof ridge at 2 m. from the front, in what is the approximate center of the tomb structure; here a centering post must have been erected. A clay dome was put over the stone tumulus as a waterproof cover. This clay mantle is 10-20 cm. thick; it had been disturbed by tomb robbers in the center and front of the tomb, but it was found intact and smooth in the rear (Figs. 5 and 6).

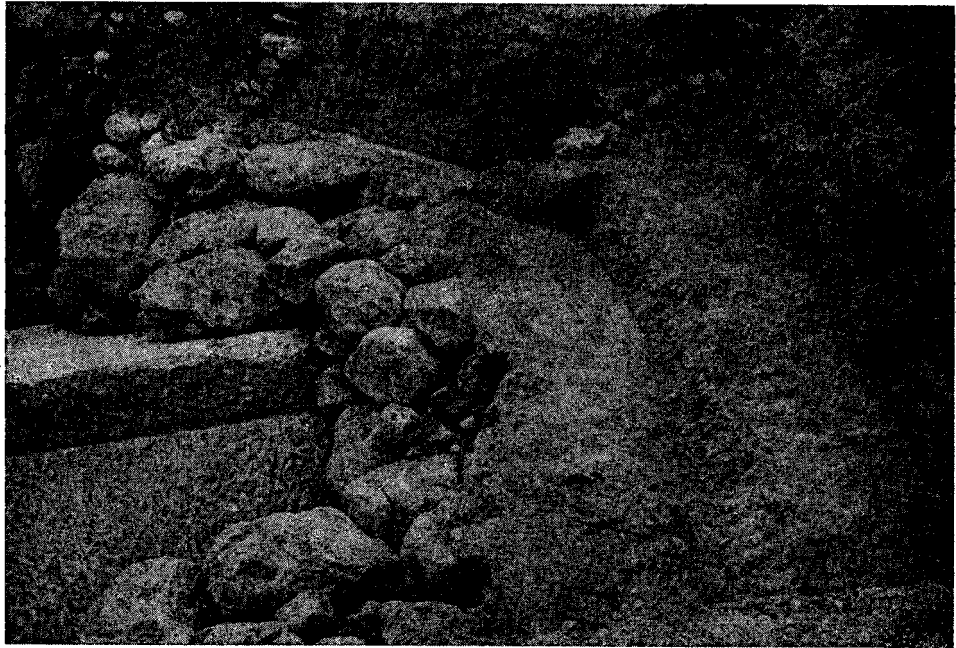
Fig. 6 Roof of stone chamber, rear, with remnants of stone and white clay packing. Over this, remnants of radiating stone walls.

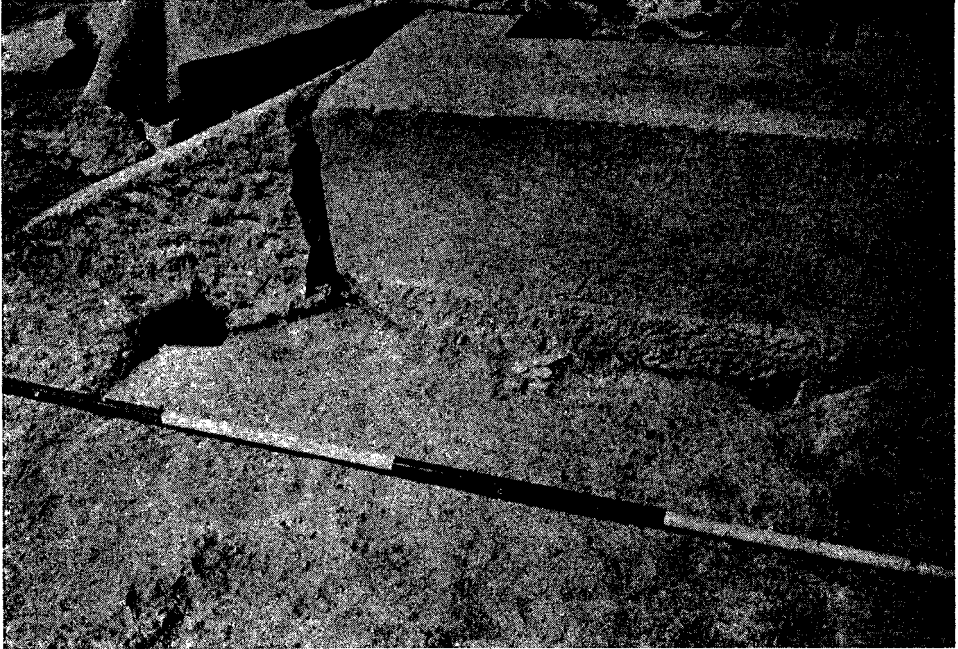
Fig. 11 Monument -base on East slope. Finished North edge, unfinished parapet block.

The two blocks of which the base consists were worked each in a different manner. The South block was finished smoothly on the side and rear, as if it had been planned to remain freestanding; the North block was not finished in the rear, although smooth on the side; this implies a change of mind on the part of the builders. Both parapet blocks were left rough on their exterior faces; they were added in the final stage of tumulus building (Fig. 11, North side of base exposed with parapet block at left).
