# Physico-Chemical, Petrographical and Mechanical Properties of Mortars used in an Ancient Roman Basilica in Amasra/Turkey

In this study, physicochemical, petrographic and mechanical properties of original lime mortars from a Roman Period basilica in Amasra dated to the 1<sup>st</sup> or 2<sup>nd</sup> centuries were examined. The study of mortar samples has been performed through polarising and stereo microscope observations, mineralogical (XRD) analyses, chemical (ICP-ES), physical and mechanical analyses. The micro structure and semi-quantitative chemical composition of the binding media and aggregate phases were determined by Scanning Electron Microscope with Energy Dispersive (SEM-EDS) analysis. This mortar possessed its hydraulic characteristic is due to the addition of volcanic rock with pozzolanic nature. Mechanical tests revealed that the average compressive strength of mortars is 6.1 N/mm<sup>2</sup> and flexural strength is about 3.3 N/mm<sup>2</sup>. Pull-off tests for determining the adhesion properties proved that a good adhesion is established between mortar and andesite stone owing to its pozzolanic nature.

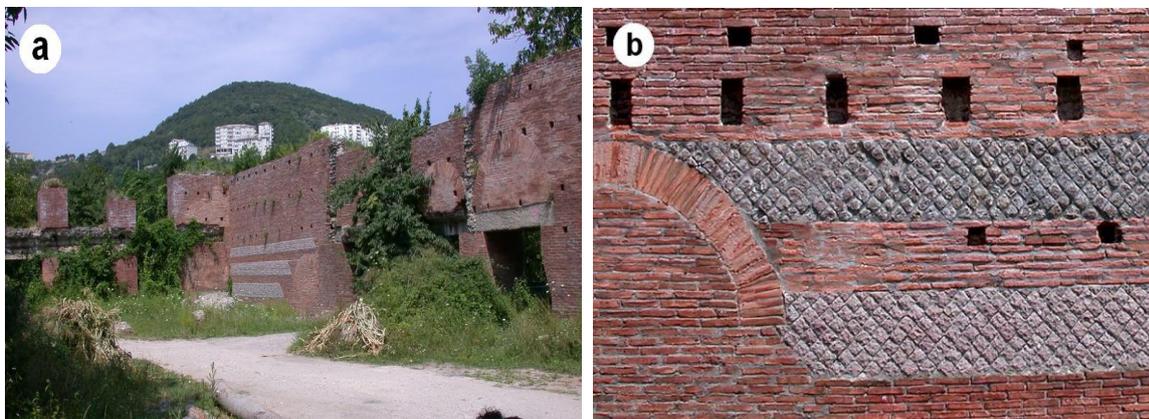
The basilica was built with the combined use of *opus reticulatum* and brick masonry techniques (Fig. 2b). It is identical to Roman architecture, but particularly to the period of Hadrianus (2<sup>nd</sup> century AD). *Opus reticulatum* is composed of cubic stones each side of which measures approximately 10-15cm and forming a grid with 45° angles on the surface [3]. The southern facade of the building was completely collapsed and its features are unknown. Except its exterior decoration, the longer northern façade, however, is relatively well preserved. The major portion of the remaining walls is 1-1.5m in thickness, and built of andesite stone of volcanic origin and brick.

Fig. 2 [a] Basilica remains, [b] Opus reticulatum masonry

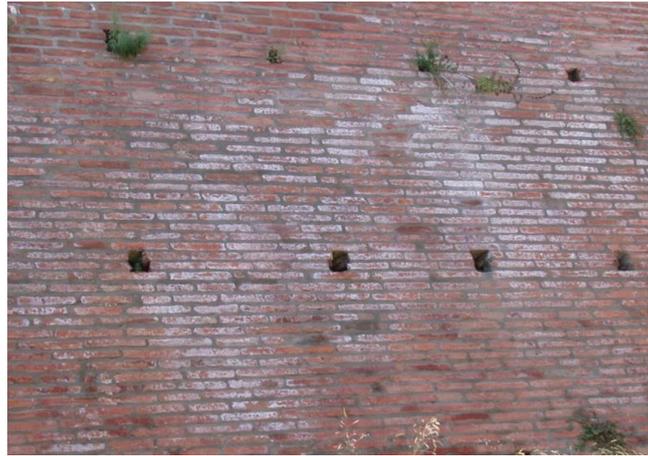
Efflorescence, observed on the bricks and joints in some parts of the basilica is the indicative of use of portland cement binder in the restoration mortars during a recent repair, which is deemed as an extremely harmful intervention material to be used in historic buildings (Fig. 3). While determining the raw material

Fig. 3 Efflorescence on wall surface due to use of mortar containing portland cement binder during the previous restoration

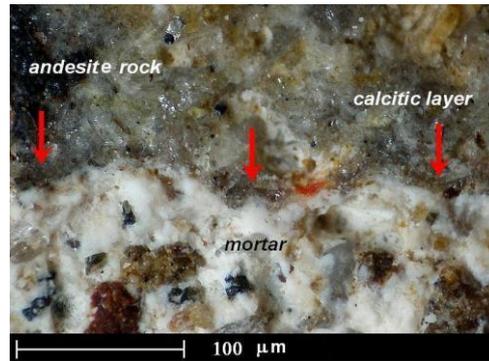
Fig. 13. Secondary calcite layer formation between andesite aggregate and binder

Volcanic aggregates contain considerable amount of vitreous matrix and unstable minerals, such as sanidine feldspar, favoring chemical reaction with the lime, in the interfaces [4]. Therefore it both facilitates the chemical reaction with binder and provides hydraulic property to mortar.
