The Western Maksurah of the Great Mosque of Diyarbakir, Research and Excavation

Fatma Meral HALİFEOĞLU^{1*}, Martine ASSENAT²

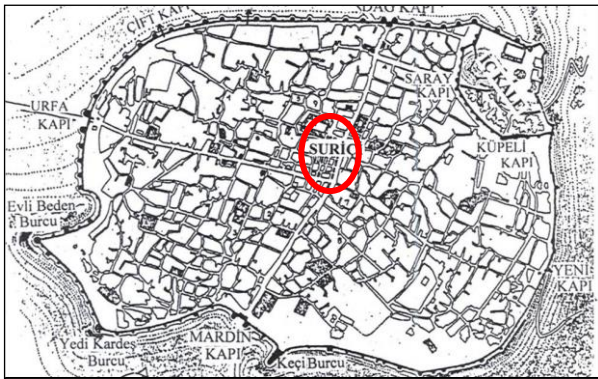
Figure 1. The Great Mosque of Diyarbakır on the Suriçi map (Gabriel,1940)

The Great Mosque of Diyarbakır is a group of structures in Cami-i Kebir neighborhood located in the northwest quarter of the traditional urban area. The mosque is in front of Hasan Pasha public house on Gazi Street. The mosque is located off the street and its east entrance opens to a square, while its north and west wings are surrounded by a street, its south wing looks towards the traditional Sipahi (cavalry) Bazaar (figure 1).

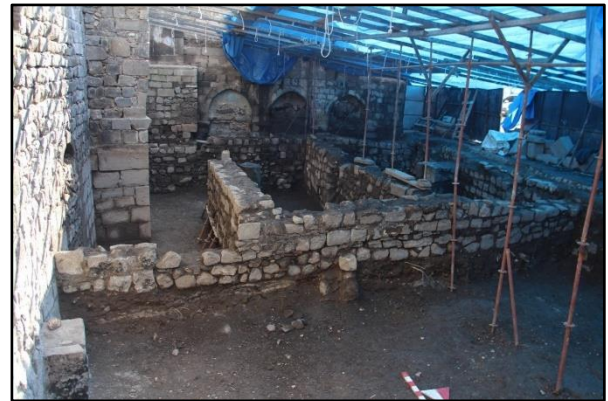
Figure 4. View of the excavated area. On the left the condemned door

The arch gaps were filled with mortar and stones. In the Shafi's Section, an arch door was uncovered. An elevation adjustment was made in the area of the western maksurah arc that took into account the ground level of the excavation. The door in the stoa of the western maksurah has been opened.

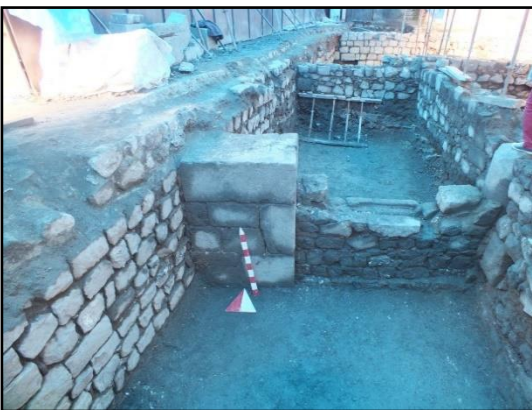
Figure 6. A basalt wall that is approximately 60 cm wide.

*In this excavation work, some structures from different periods were uncovered. Some of them were grossly built and some others were carefully built, particularly a basalt wall that is approximately 60 cm wide.

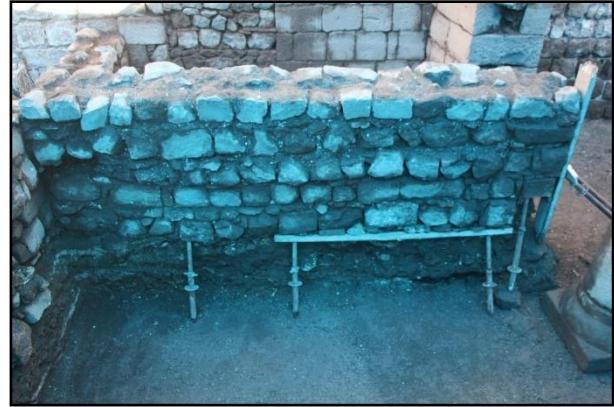
Figure 7. Basalt stone walls between 150 and 200 cm

*Parallel to the street, in a north/south direction, basalt stone walls between 150 and 200 cm high were discovered. A late-period building is located in the central area. Additionally, in the central area, basalt walls, that could be the foundation of a building of a later period, were uncovered.
