## Depreme dayanıklı tasarım için Türkiye’de yığma yapıların yeniden canlandırılması

## Revival of masonry buildings in turkey for earthquake resistant design

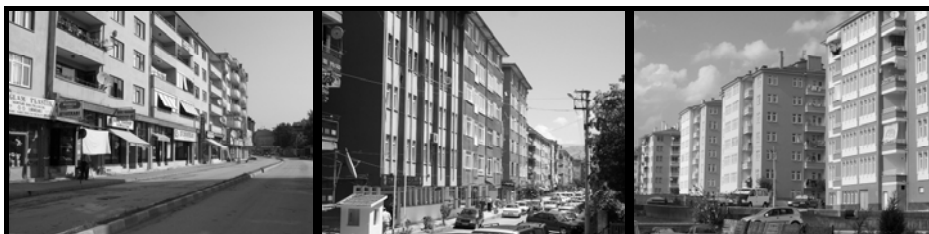
Figure 2: Typical Reinforced Concrete Apartment Buildings from Duzce, Cankiri, Corum

The field survey depicts that although these cities are located in earthquake region, the residential building stock is mainly composed of multi-storey reinforced concrete apartment buildings. The safety of reinforced concrete apartment blocks is still in question since the recent earthquakes showed their poor performances. The enormous mass of these buildings led to the death of about 80,000 people in the earthquakes that happened in Turkey over the last century. In fact, low-rise buildings that are constructed of lightweight materials are more effective to keep people away from the devastating effects of earthquakes. Nevertheless, since the monetary benefit -rather than the safety of buildings- is of utmost importance, construction of multi-storey reinforced concrete buildings are still going on and the buildings do not reflect any features of the local architecture, which were dominant once (Figure 2).

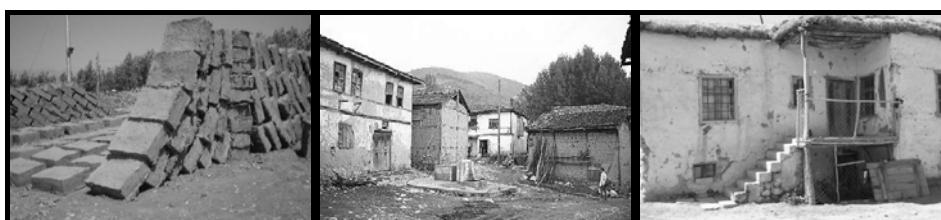
Figure 3: Examples of Adobe Units and Houses in Turkey (Sansarak Village, Sindelhoyuk)

The architectural history literature depicts that adobe is one of the oldest and crucial building materials in antiquity. In Turkey, it was widely used in regions where timber and stone were inadequate or unavailable in terms of natural resources. Adobe stems from clay and sand mixture with a stabilizing agent. The quality of adobe is determined by the amount of clay contained. In old times, straw was used for reinforcing the adobe. Today it is evident that cement and plaster has replaced the straw. When compared to the other building materials, it is seen that adobe is natural, healthy, and cheaper. It also requires less energy and is easy to produce. Because of these characteristics, adobe is seen as a way out for people of low income in Turkey, where an important portion of the residential units were produced by individual efforts rather than by the supervision of the government during the rapid urbanization period. This could also be related to the fact that adobe is so a well-known constructional material that even today it is possible to see many examples of adobe housing units in the villages of Turkey (Figure 3). Furthermore, depending on soil types and climatic conditions, adobe construction can achieve both strength and durability. One of the major defects of adobe as a constructional material lies in its inability to show adequate resistance to earthquake forces (Wasti and Gülkan, 1980).

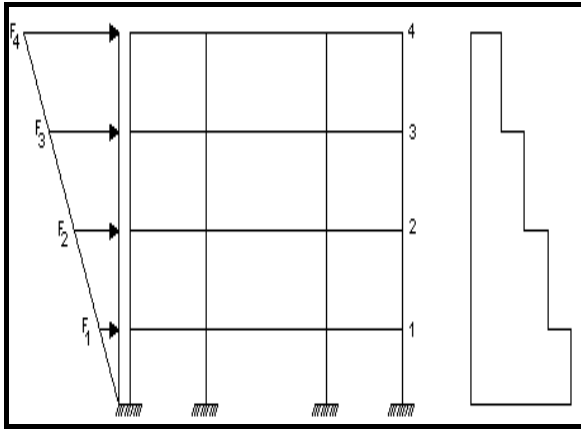
Figure 4: Distribution of Earthquake Load
