Observational Results of the Normal Evacuation of Aspendos Ancient Theater After Concert Event

Aspendos Antique Theater is used in various shows and concerts today. To observe the crowd evacuation during the concert, observations were made by going to the Gala Concert event, the closing concert of the 28th International Aspendos Opera and Ballet Festival.

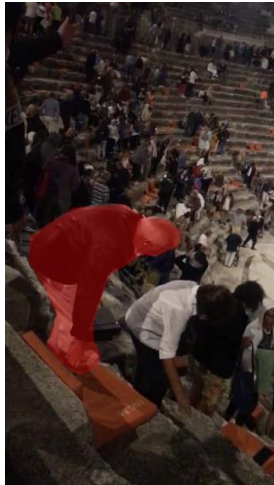
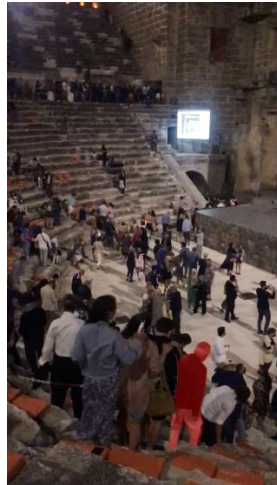
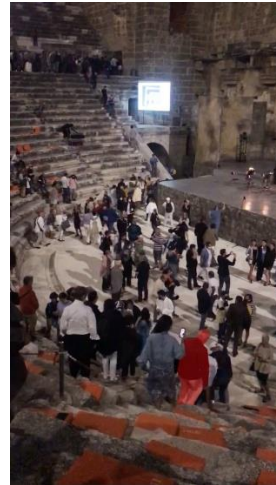
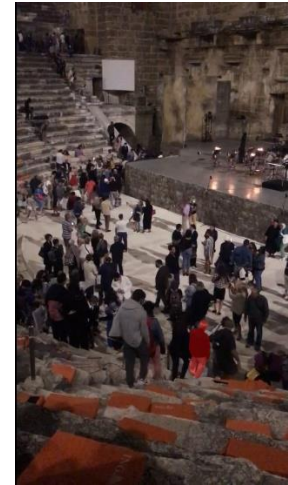
During the evacuation, one person from the audience was selected and the evacuation behavior was observed and documented with video and photo shoots. In the images taken from the video, the time of the selected person to descend the stairs in the lower cavea is seen in the minutes of the video. The person descended the 40 stairs in the lower cavea in a total of 88 seconds. The descending speed of the person whose horizontal distance and descent time is known was calculated as 0.13 m/s. The results obtained in the study in which the relationship between the stair riser height and the angle made by the step width and the walking speed were measured are given in Table 2. According to these results, walking speed increases as the stair angle decreases [16]. The observed person is male over 50 years of age. In the measurements made in the cavea section on Figure 4, it is seen that the angle is 35 degrees on average. With these results, the speed of the selected person is expected to be 0.50 m/s. When compared to the walking speed seen because of the observation, it can be said that the walking speed during the evacuation in the ancient theater of Aspendos was slower than expected.
