RETROFITTING DENIZ PALACE HISTORIC BUILDING FOR REUSING

Ezgi KORKMAZ¹, Meltem VATAN²

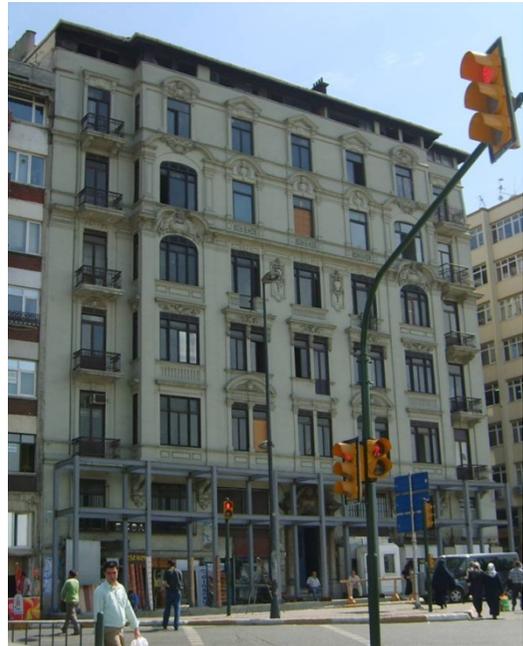
Figure 1. Deniz Palace building

Original construction style of Deniz Palace building is: stone-brick masonry building, the floors are made by concrete and cement mortar infill metal I beams and timber tiling. Basement floors are brick infill jack arches. Plaster boards of ceilings are from 1940ies and have Pera building style ornaments (Figure 1).

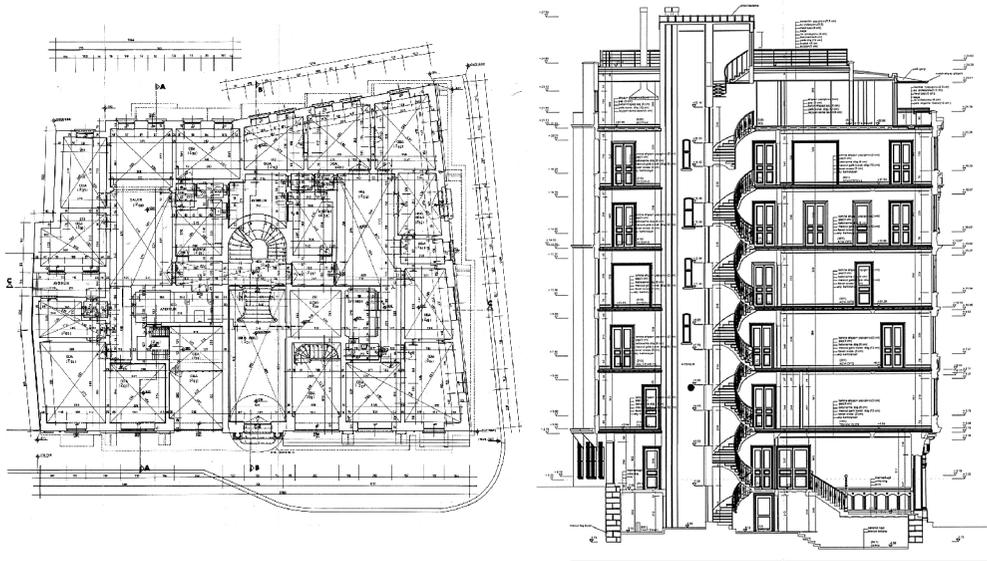
Figure 2. Plan drawing of Deniz Palace building

Deniz Palace building has one basement, one ground floor and six normal stories (Figure 2). Before starting to the applications, scaffolding system is constructed for supporting the building and for bearing the loads during restoration works. According to the analysis it is decided to reconstruct the foundation of the six storey masonry building as a raft foundation. This work is done by digging foundation wells under each existing foundation by which way all building is surrounded and then to connect all new foundations as a united raft foundation. For preventing sliding during digging process shoring is used. Figure 3 shows principal drawings of well foundation system and Figure 4 and Figure shows the foundation.

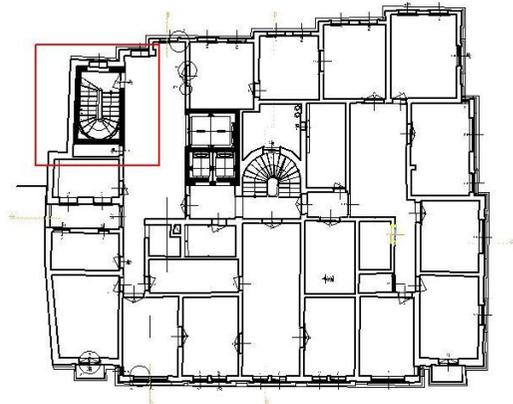
Figure 5. Plan drawing of location of fire staircase building

required. For this purpose one part of the building along all storeys is organized as a fire staircase where existing walls are changed as reinforced concrete shear walls according to the fire extinguish requirements (Figure 5, 6). The new constructed reinforced shear walls are connected to the existing facade walls by anchoring elements (Figure 7).

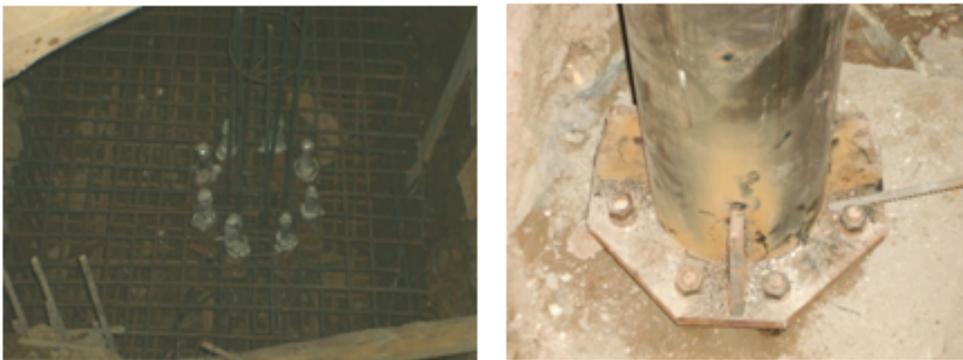
Figure 13. Circular columns anchorage

Construction of circular columns is made by anchorage on the foundation and filling with reinforced concrete as composite elements (Figure 13). Circular steel columns are applied around the hole and additionally along the walls reinforced concrete columns in between shear walls are constructed (Figure 14).
