# Investigation of architecture and structural deterioration of historical Akseki houses (Buttoned houses)

**Keywords:** Buttoned houses, structural deterioration, protection.

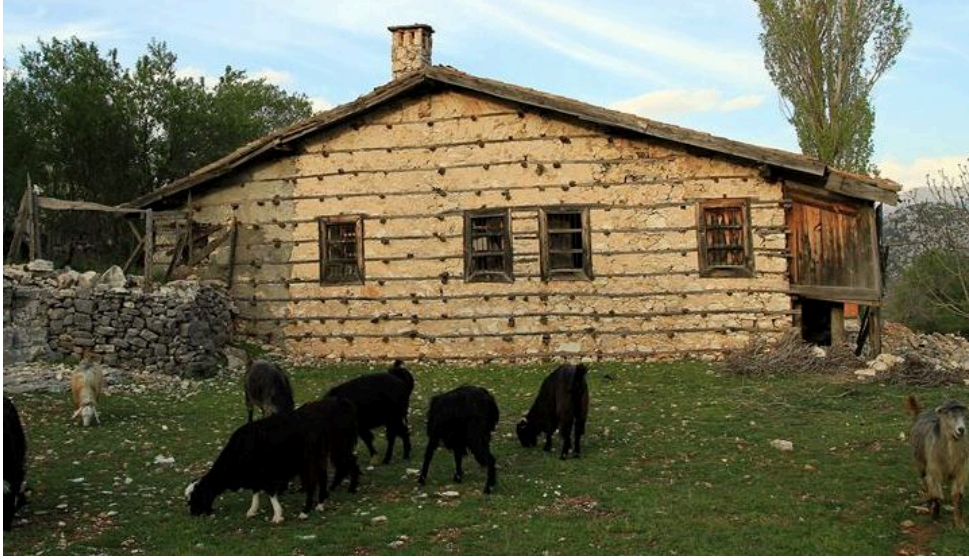
Figure 1. Butted house [10].

Stone especially used in wall construction. As shown at Figure 1 and 2, All walls of the house were built with mortar dry wall technique which compressed by wooden beams and peşduvans\*\* taken between the rubble. Wood was used in the form of intervals and peşduvans. The ends of the beams in the exterior have been flushed out of the wall to an amount. They are called "button" in this region. Because of these applications in masonry, the houses called "butted house" (3).

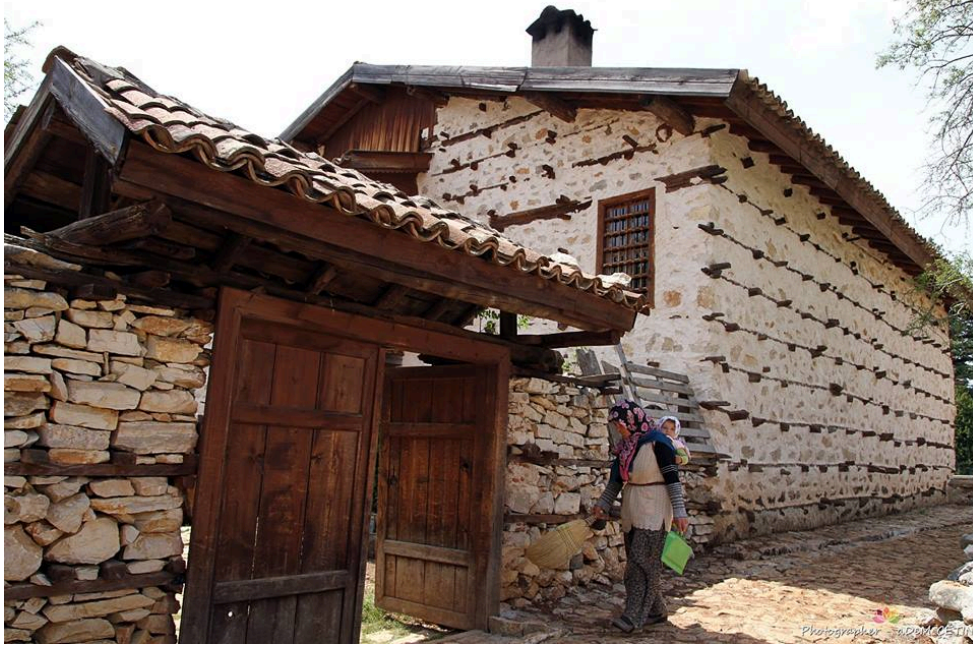
Figure 3. Buttoned house [10].

As shown at Figure 3 and 4, Houses' windows can be carved wooden cage, pinwheel\* design shutter wood carving samples can be used as decorating. There is extensively the use of wood for decoration in the rooms and ceiling sofas [9].

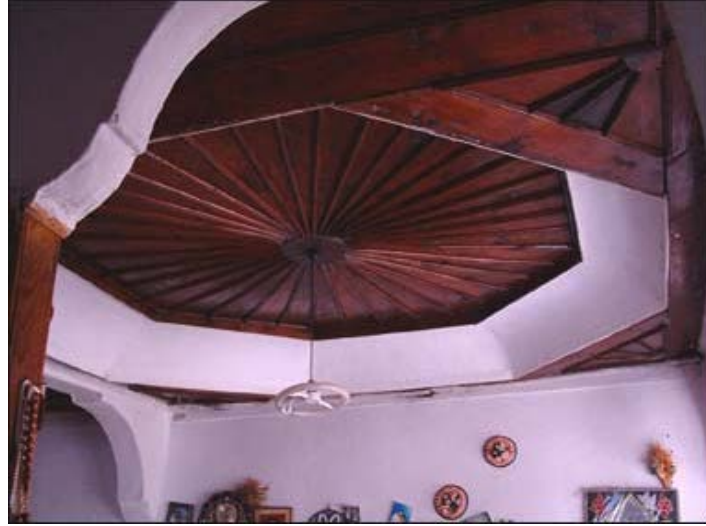
\*Pinwheel design: Ornamental motifs like Swastika are used as padding of pinwheel design. Especially, in the Seljuk and Ottoman Period, it was used in carpet and rug motifs, decoration pictures. It was used as patterns and motifs in Islamic arcs' decoration pictures (in figure5,6 and 7).

Figure 5. Durmus Yazici's buttoned house, ceiling view [9].

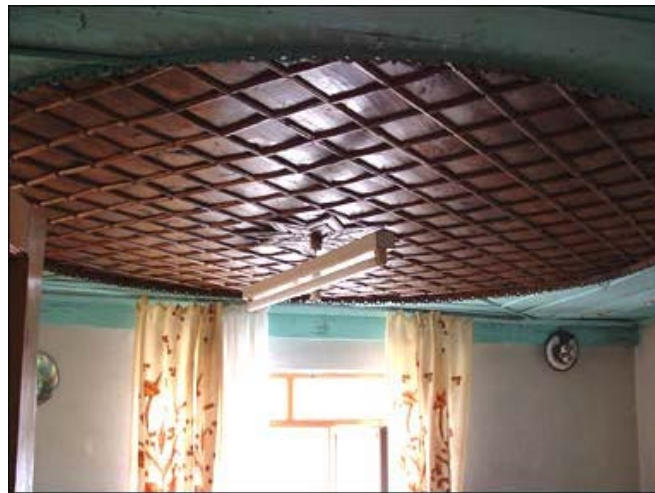
Figure 6. Durmus Yazici's buttoned house, southeast room ceiling view [9].

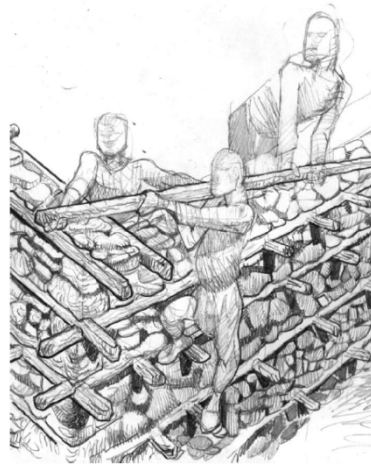
Firstly, hard ground is excavated 30-40cm deep and dry walls built to create basic with unique flat stones. As shown at Figure 8, short wood thrown 50-60cm apart to the stone walls of the vertical and their ends are excluded as 20-25cm. Over this short places, by interlocking wooden beams are placed along the inner and outer side of the wall. Dry stone wall formed with irregular row is 50-60cm. rising after, the same system is repeated. Wall rises; it is used as a step short of wood protruding from the wall above the level and no need for scaffolding [14].

Figure 8. A Preliminary sketch from building process (drawing by Kemal Reha Kavas) [7].

Between two wooden beams is called "destur" and vertical short pieces thrown stone wall is called "button". Wooden frame connected by a horizontal is interconnected with wooden columns in the vertical. According to the window and door pillars, approximately 2m apart placed on wooden parts are connected to the switch until the

roof and they are connected to the rafter on the roof. Therefore, the stability of the wooden frame is ensured. Pine or tar is preferred for beams and wooden posts, and samphire tree is used for buttons [14].
