Assessment of Risky Buildings according to the Regulation for Determination of Risky Buildings (RDRB 2019): The Case of Şanlıurfa

The designed building was examined as a result of field investigations on existing buildings constructed before 2000 in the Siverek district of Şanlıurfa. The designed building comprises two stories and has a reinforced concrete frame system. The risk analysis was carried out in accordance with the steps determined for low-rise reinforced concrete buildings based on RYTEIE 2019. The risk assessment of the columns, which are represented as vertical elements, was completed first, followed by the risk assessment of the building on a floor-by-floor basis, in accordance with the obtained data and the analysis steps determined in RYTEIE 2019. If any floor was determined to be risky, the whole building was considered as risky.

2.1. General Information on the Inspected Building:

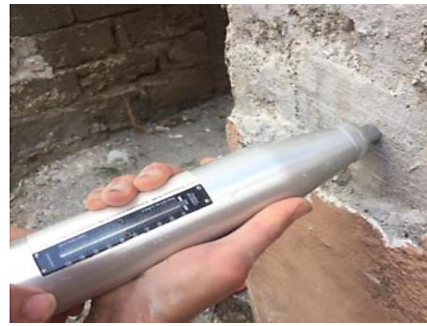
Figure 2. Non-destructive examination method

In order to determine the existing concrete strength of the building in Figure 2, a test hammer reading, which is a non-destructive examination method, was done from 8 different columns and concrete sampling was performed from 4 columns in Figure 3. Table 3 also shows the values of the core samples collected.

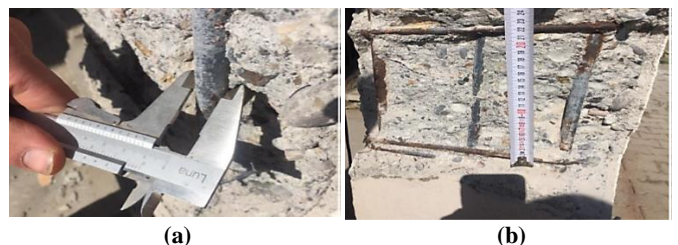
Figures 4a and 4b. Images of the reinforcement identification processes

To determine the reinforcements of the inspected building, X-ray scanning, a non-destructive method, was performed on six of the existing columns, and the reinforcement arrangement was determined by scratching half of these columns. Table 2 shows the identified reinforcements. Furthermore, the building's beams were 20 x 20 cm in size, and the reinforcements were 4 Ø 12 mm and Ø 8/25 mm, respectively.

Figures 4a and 4b show the identification of the reinforcement diameter with a calliper and the identification of stirrup spacing with a tape measure on the scratched columns.

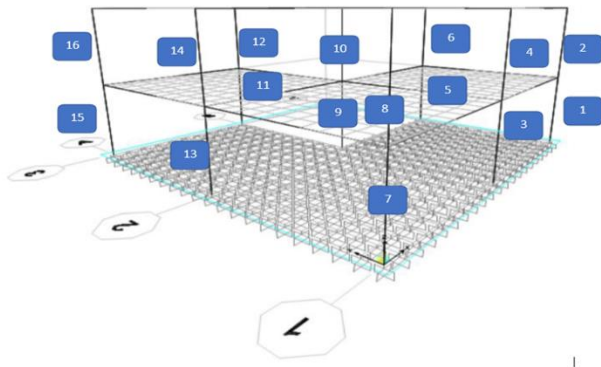
Figure 5. 3D view of the building with risk assessment

Figure 5 shows a three-dimensional view of a structure designed by us that is not exactly the same size and dimensions as the average values obtained.
