## Evaluation of Structural Safety of a Steel School Building with Partially Modified Structural System

**Keywords:** Structural safety, Truss system, Steel construction.

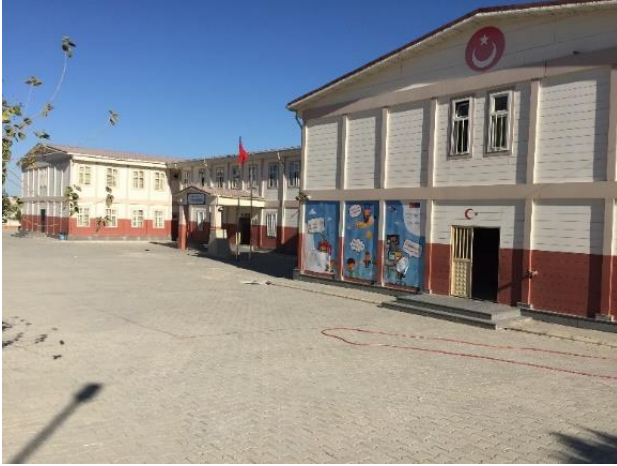
The general architectural geometry of the building is similar to the letter "U", its long dimension is approximately 61 m and its short dimension is 24 m. The building is planned as a total of two floors, the ground floor and, the first floor. The ground floor consists of 11 classrooms, an administrative section, a canteen, a ladies' prayer room, a boiler room, and convenience facilities. The first floor consists of 12 classrooms, an administrative section, a teachers' room, a men's prayer room, and convenience facilities. The usage area of the classrooms is 520 m<sup>2</sup> on the ground floor, 570 m<sup>2</sup> on the first floor, and a total of 1090 m<sup>2</sup>. The passage of the school building between the ground floor and the first floor is provided by three stairs. The general view of the school building is shown in Figure 1.

**Figure 1.** General view of the school building considered in the study

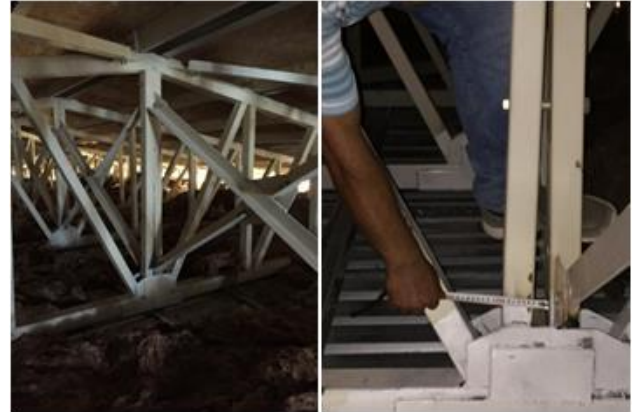
The roof trusses, manufactured by the contractor company as two parts, were connected with 5 M22 bolts at the construction site. During the manufacture of some roof trusses, the strut bars in the symmetry axis were manufactured incorrectly, as shown in Figure 2.

**Figure 2.** Roof trusses manufactured in two parts

Due to this faulty manufacturing, separation up to 30 mm has been detected from the squareness of the uprights in the part where the mentioned roof trusses meet on the symmetry axis. After this situation was determined by the control unit, it was concluded that the issue should be evaluated and reported by the expert team in order to eliminate the concerns about whether the manufacturers made in this way endanger the safety of the building. The report, which is the basis of the study, has been prepared by the authors for this purpose.

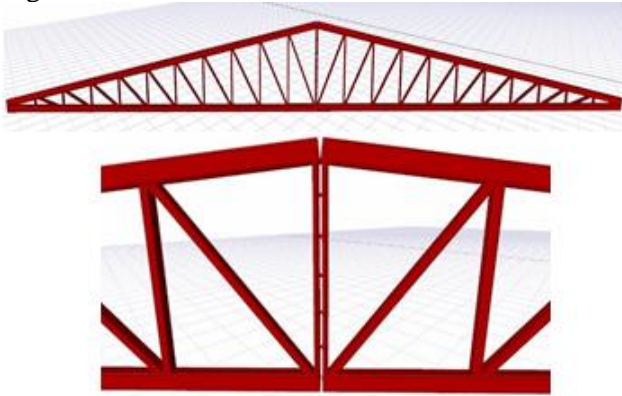
Roof trusses produced by the contractor company in the workshop are made of two parts in order to be easily transported and easily lifted and assembled. During the construction of the building, it was determined that most of the roof trusses, which were produced from two parts, came back to back during assembly, but a small part of the strut bars on the symmetry axis was not made perfectly vertical, resulting in separations of 30 mm between them. Considering this situation of the building, a three-dimensional model was created and analyzed. In this section, truss no. TRS031, which is considered in the case where the roof truss is a single part, is examined in detail. The general view of this truss and the part where the two parts are joined with bolts are shown in Figure 6.

**Figure 6.** Modeling of the roof truss as two parts (number TRS031)

The axial forces and PMM ratios formed in the elements of the TRS031 truss are shown in Table 3. Although there is a slight increase in the normal force value of the strut rods deviation from the squareness of the truss made in two parts, compared to the case where the same truss is one piece, it is understood from the examination of Table 3 that the existing cross-sections are capable of carrying these forces safely. In addition, in the evaluation, it was determined that the PMM ratios in all truss elements were less than 1.0. This result showed that the members that make up the examined truss have sufficient security to carry the internal forces on them. It has been determined that the five bolts connecting the roof trusses made in two parts are sufficiently secure to carry the cross-sectional effects on them.

It has been determined that the construction of some roof trusses in two parts does not pose a problem in terms of user safety of the building. As a result of two-part manufacturing, in case of any deformation due to the loads on the roof trusses, the formation of deformations in the roof covering is an inevitable result. In the observations and examinations made on the roof of the building, it was determined that there was no deformation. This observation supports the accuracy of analyzes and investigations.
