## Research on the change of Ankara Ulus City Center identified with its historical texture

Conservation  
Ulus Historic City Center  
Change

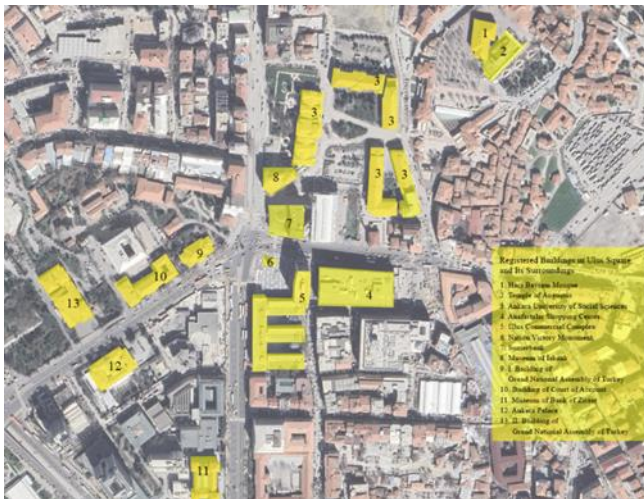
**Figure 1.** Registered buildings in Ankara Historical Ulus Square and its surroundings.

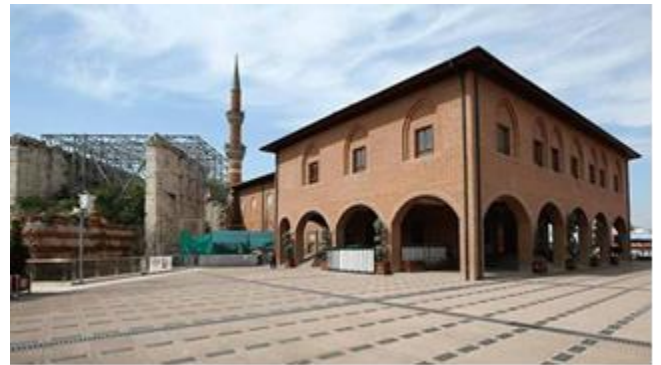
Figure 6. Hacı Bayram Mosque today

**Change:** Two inscriptions on the south wall indicate that the mosque was restored in 1714. In 1940 and 1947, it was restored by the General Directorate of Foundations and added to the mosque, and the originality of the work was not preserved. With its current layout, it bears the characteristics of late 17<sup>th</sup> century or 18<sup>th</sup> century mosques. It is thought that the religious and historical mosque has lost its original value [12].

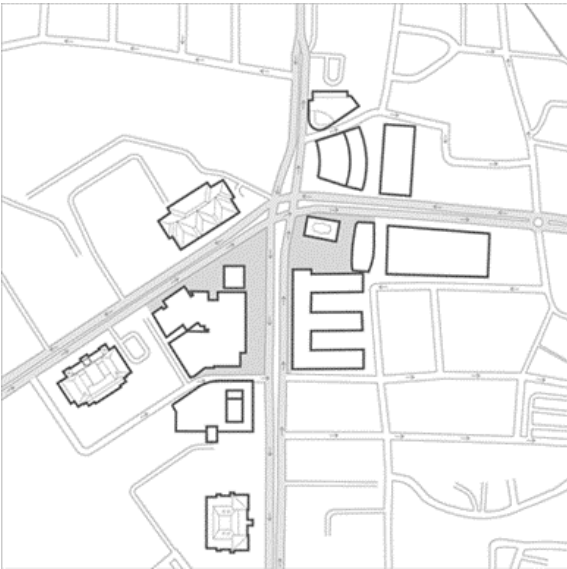
Figure 8. Ulus Square today

The Municipal City Garden was located around the square in 1927. However, today Ulus 100<sup>th</sup> Anniversary Commercial Center (Çarşı) has been built in this area. The square has turned into a congested closed intersection square with the increasing vehicle traffic by the construction of the open areas around it.

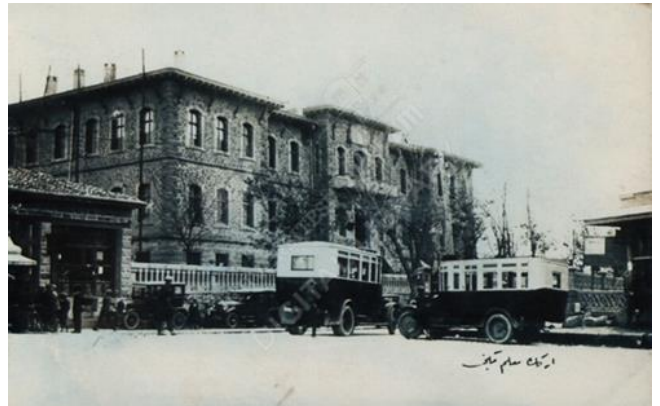
Figure 12. Ulus Darülmüallimin Building, 1925 Source: Inv.No: ACF0367\_01 [16]

**Change:** The building, which was built as a school building in 1914, was demolished in 1934. The building, which was completely destroyed, was replaced by the Ulus İşhanı block in 1955.

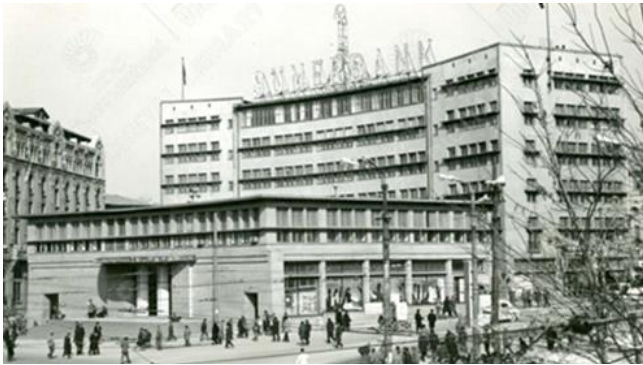
**Figure 14.** Sümerbank, which was built on the place of Taşhan Building Source: Inv. No: 1792 (VEKAM) [16]

**Change:** The Taşhan building, which was built as a guest house in 1880, was demolished and the Sümerbank Building was built in 1937-38. The building was used as a store in 1988 and transferred to the university in 2013. Today it is used as a university building by Ankara Social Sciences University.
