EARLY TURKISH BUILDINGS IN TRABZON

By SELINA BALLANCE

While surveying Byzantine buildings in Trabzon, I took the opportunity of measuring these three interesting Turkish buildings; and publish the plans, with some brief notes on their construction, in the hope that the drawings at least may be of some use to someone qualified to make a real study of them.

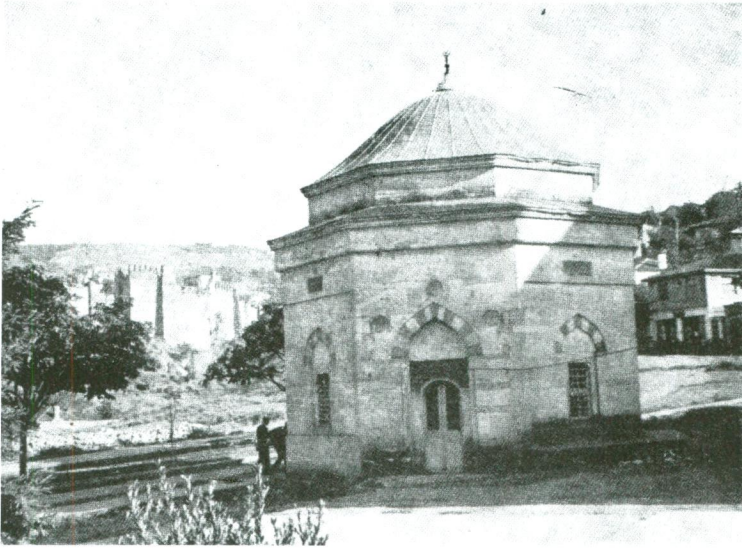
Fig. 4 — Türbe of Gülbahar Sultan, from the north.

Türbe (figs. 4, 5). The actual türbe of Gülbahar Sultan lies just to the east of the mosque; it is of a much yellower stone than the mosque but of equally good workmanship and in equally good repair; the courses are alternately deep (34 - 51 cm.) and shallow (13 - 16 cm.). It is octagonal, with a north door and six windows, all of which have blind ogee arches over them, with voussoirs in alternating dark and light stone. The windows themselves have flat lintels. The türbe is domed internally, but externally the lead-covered roof is treated in two levels, the upper one with a slight ogival curve and raised above the lower outer level on a low masonry wall. Three

stones, set in the wall over the door, are carved in elaborate Seljuk-type patterns in low relief, but all are broken or defaced.
