## THE EVALUATION OF KAHRAMANMARAŞ ENGELSİZ YAŞAM PARK WITHIN THE SCOPE OF THE UNIVERSAL STANDARDS GUIDE FOR PERSONS WITH DISABILITIES

Mahmut TUĞLUER<sup>1,\*</sup>, Erdi EKREN<sup>1,b</sup>

<sup>1</sup> Kahramanmaraş Sütçü İmam University, Faculty of Forestry, Department of Landscape Architecture, Kahramanmaraş, Türkiye

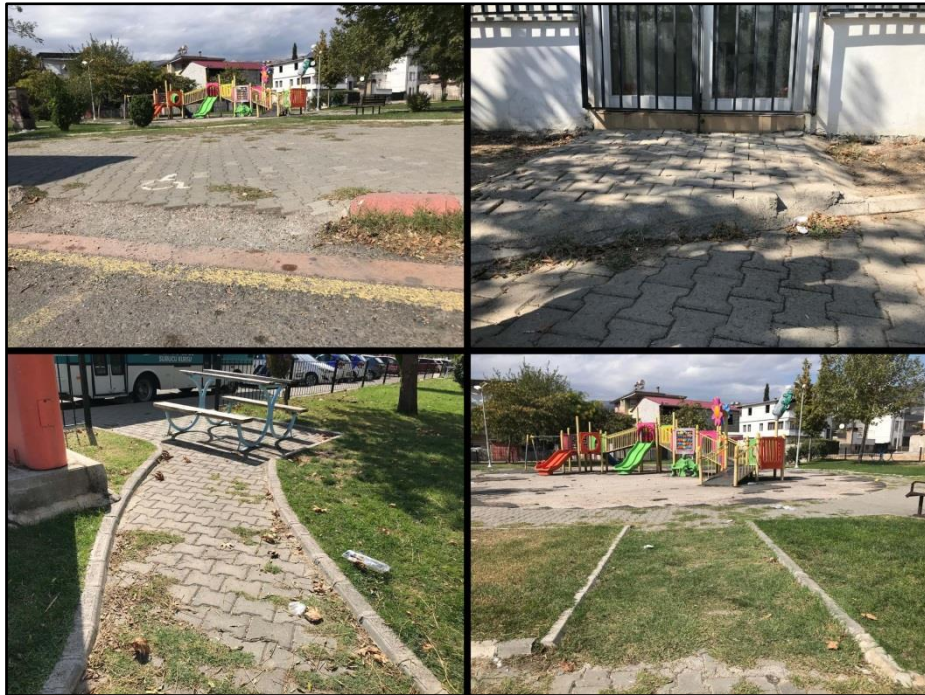
Sidewalk widths are usually 150 cm. This width decreases below 90 cm in front of the stops and shops in the vicinity. The overall pavement slope is mostly appropriate, although rough surfaces can cause the slope to deteriorate. There is no water gutter or drainage system

around the sidewalk. However, there are gratings for drainage at some points. There are no tactile surfaces or guide marks on sidewalks and walkways. The border heights of the study area vary between 10 and 15 centimeters. In some areas of the walking paths, there are no obstacles such as trees, urban furniture, or sign boards. It has been determined that the number of urban pieces of furniture is sufficient according to the universal design standards guide, but it does not meet standards such as entrance-exit or height requirements for the disabled and is not suitable for use. Images of pedestrian paths and sidewalks from different points in the study area are given in Figure 2. There are obstacles such as sign boards, urban furniture and trash cans that will create barriers in terms of safety on the pedestrian sidewalk and walking paths (Table 2).

Figure 2. Walkways and pavements

In this study, Engelsiz Yaşam Park has been evaluated within the scope of the universal standards guide for persons with disabilities. Although the pedestrian ways and sidewalks in the area are suitable at many points in terms of width, slope, and surface covering, according to the guide, there are narrowings, urban furniture, and sign boards that will constitute obstacles for transitions. Abrasions and collapses have occurred on the pavement slabs over time, and it has been observed that this situation affects pedestrian circulation. Curbstone heights do not comply with the standards in the guide. It has been determined that the curb heights are too high. It is thought that the reason for the high curb height is to prevent

vehicles from parking on the pavement. However, the curb heights increase the ramp slopes and make it difficult to enter and exit the area.

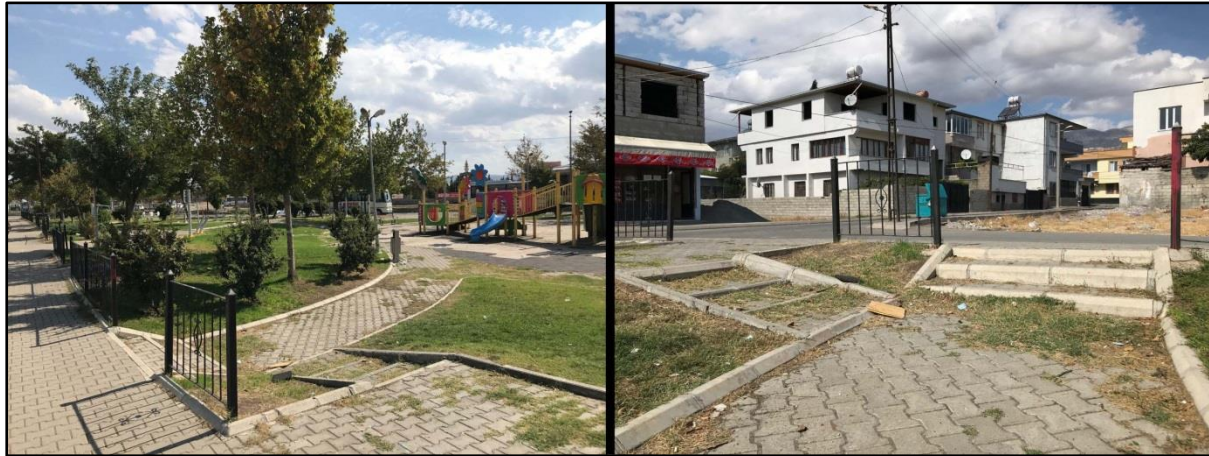
It has been observed that the widths of the disabled ramps installed in the study area are suitable according to the universal design standards guide. The points where the ramps are located make it difficult to provide circulation. It has been seen that the ramp surface floors are generally in accordance with the standards, but different surface textures were not created at the start and end points. There is no handrail or protective border around the ramp. Ramps and stairs from different points of the study area are given in Figure 3. Although riser heights are suitable for the stairs in the study area, it has been determined that they are not suitable in terms of surface flooring, tactile surface use, and landing use (Table 3).

Figure 3. Ramps and stairs

Ramps play an important role in accessibility. There is no need for a ramp for general circulation in the park, which is established on a flat area. There are ramps at the entrances and exits of the working area and at the edges of the parking lot. It has been observed that some of the ramps are not compatible with the area's circulation. For this reason, it is very difficult for the disabled to use these ramps. There are no handrails on the disabled ramps. There are collapses on the ramp surfaces and deterioration of the floors. For this reason, although there are ramps in the area that can provide circulation, it does not seem possible for the disabled to use these ramps easily in terms of quality.

It has been observed that stairs are used at the points needed in the study area. Stair widths and riser heights comply with guideline standards. However, due to the collapse of the floors used on the stairs, indentations and protrusions were formed on the stairs. This situation threatens the safety of using stairs. In addition, the tactile surface for the visually impaired, which is not used anywhere in the area, is not used around the stairs. It is thought that the park is not suitable for use in terms of accessibility for the visually impaired. There are no audio or written marker units in the area. This makes it difficult to use the park for those who have visual or hearing difficulties.

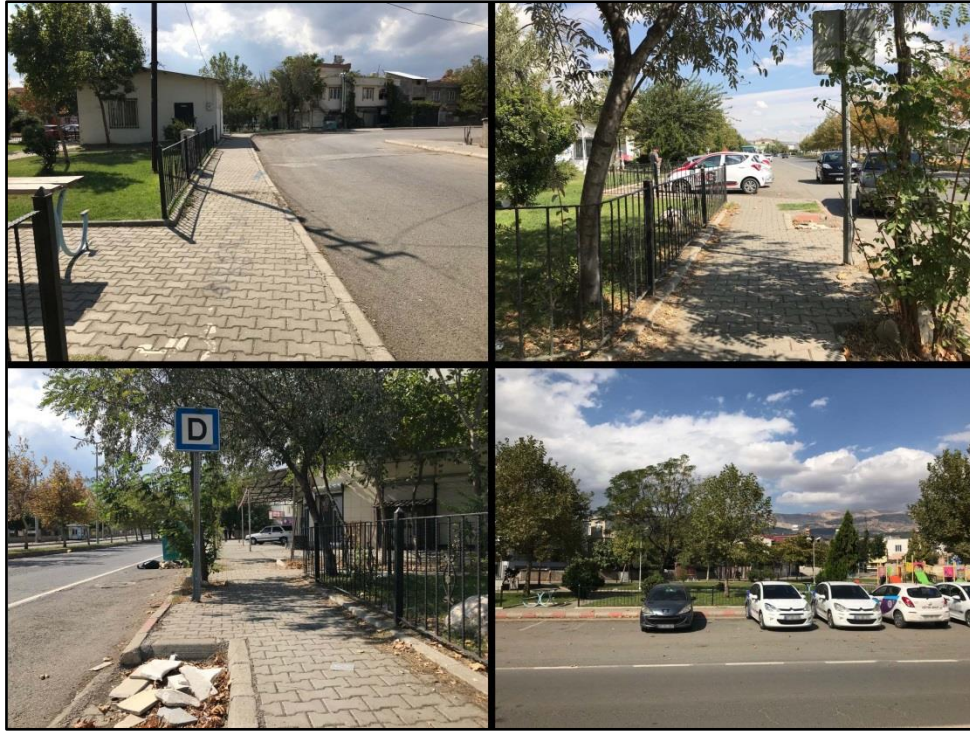
According to the findings, it was seen that no pedestrian crossing was established on the main and side roads in the immediate vicinity of the park (Figure 4). There is a parking lot for 40 cars on the side of the road. Two of them are reserved for disabled parking spaces. There is a sign in the parking area reserved for disabled individuals (Table 4).

Figure 4. The immediate vicinity of the park

There is one main road and three side roads around the study area. However, it has been determined that there is no pedestrian crossing on these roads. The absence of pedestrian crossings in the park, which are mainly used by children, is a safety problem. A parking lot for 40 vehicles has been established around the area, two of which are disabled parking lots. It has been seen that the parking lots are suitable in terms of proximity to the area, presence of signs, ramp status, and usage.

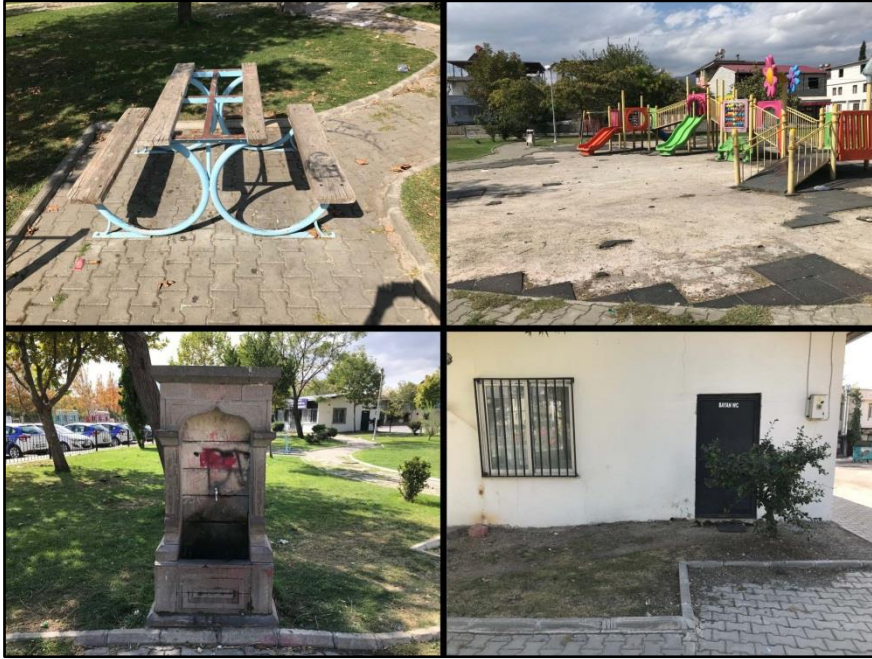
It has been observed that the slopes of pedestrian and walking paths in the study area are in accordance with the principles of open and green space facilities. The width of the walking paths is less than 1 meter at some points. The longitudinal and transverse slopes of the side roads are suitable. The number of seating units used in the area was sufficient, but it was seen that it was not suitable for diversity. Materials different from the other flooring in the area were not used in the surface upholstery of the urban furniture. At some points in the area, urban furniture is an obstacle to walking paths. It was determined that the corners of the urban furniture were not rounded in order to prevent injury. There is no empty platform for the disabled chair next to the seating units. The number of lighting units in the area is sufficient. Images from different points in the area are given in Figure 5. The toilet in the area is not operational. There is no telephone booth for emergencies in the area (Table 5).

Figure 5. Urban furniture and children's playgrounds

There is a sufficient number of urban pieces of furniture in the working area, as specified in the guide. However, urban furniture is not suitable for disabled use. There is no section reserved for wheelchairs next to the urban furniture. For this reason, it is thought that disabled people may experience great difficulties in using these areas.

There is one fountain and one toilet for users in the area. However, the toilets are closed to use, and it has been observed that the toilets remain an idle building. This situation is considered to be a problem for users.
