THE MOSQUE OF YILDIRIM IN EDİRNE

APTULLAH KURAN

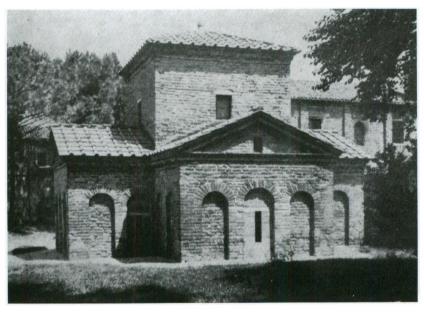
Pl. 1 — Mausoleum of Galla Placidia, Ravenna Plan, Section (from Sir Bannister Fletcher).

Res. 1 — Galla Placidia Mozolesi, Ravenna Plan, Kesit (Sir Bannister Fletcher'den).

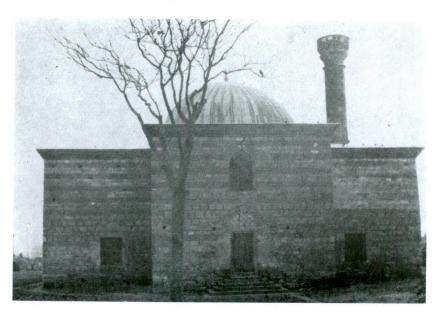
Res. 7 — Kuzey Cephesi. Pl. 7 — North Elevation.

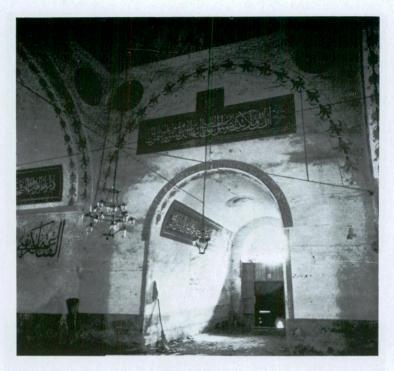
Res. 8 — Pati Cephesi. Pl. 8 — West Elevation.

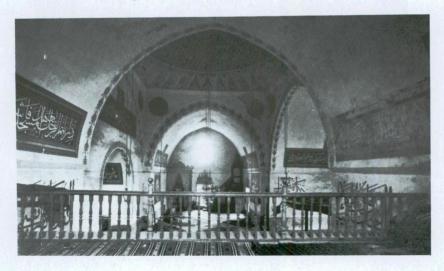
Res. 9 — İç Görünüş (Giriş eyvanı). Pl. 9 — Interior View (entrance eyvan).

9). This eyvan is lower and narrower than the others. Furthermore, it is covered by a semi-circular, and not a pointed barrel-vault. This feature immediately brings to mind the following question: the Turks had cut the walls of the original structure at approximately 2.50 m. height and rebuilt the upper structure above this base. Could it be then that the vestibule was intact with its semi-circular barrel-vault and that they kept it as they found it but built the taller eyvans with pointed barrel-vaults in accordance with their architectural tradition? In my opinion, the low narrow vestibule cannot have remained from the original structure. Because the original building, as Gurlitt points out 9, was probably a church since it is oriented on the eastwest axis. And the vaulted vestibule in question is on the east where the apse would have been. It is hard to imagine a church whose focal point is designed as a secondary spatial element. Therefore, it stands to reason that the eastern arm of the original structure was similar to the other three arms, as Gurlitt surmised. The Ottomans rearranged this space to suit their purposes, converting it into a vestibule which served the prayer area as well as the convent rooms. The exterior walls of the convent rooms and those adjacent to the prayer area probably were built on foundations dating back to the original structure. But their inner walls have fireplaces at their center whose tile inlaid plaster of Paris decorations (pl. 12) belong to the XIVth century. The walls facing the portico were also built in the XIVth century: a fact made evident by the location of the stairs that run up to the base of the minaret inside the length of the southern section of the portico wall.

A second question pertaining to the vestibule is the area above it. Since the cornice of the mosque retains the same height throughout the exterior of the building what happens above the low entrance eyvan? At present this area is closed to the exterior and the interior (pls. 9 and 13) and has no visible means of being reached. On the other hand, the crack in the plaster above the main door outlining a small, arched window indicates that this space, which must have a ceiling height of 2.60 m., was originally in use. A good possibility is that it was the private pew of the Sultan, similar to those in the Green Mosque or the Mosque of Hüdavendigâr in Bursa, and that it was reached

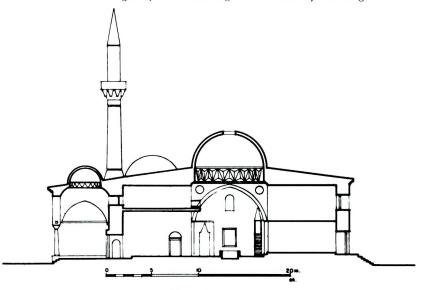
Res. 16 — XIV. Yüzyıldaki durumu gösterir tahminî Plân. Pl. 16 — Imaginary Plan showing XIVth century building.
