The effect of scanning strategy on mechanical properties and delamination during brake caliper manufacturing with selective laser melting (SLM)

Author(s): Mehmet ÖZAKINCI¹, Rahmi ÜNAL²

Research Article

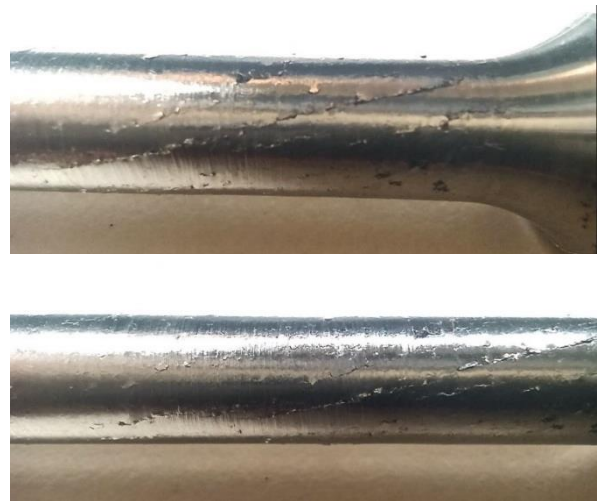
M10x1.5 thread was drilled on tip of the specimens in order to connect them to the tensile test device. During manual threading, visible discontinuous cracks shown in Figure 7 occurred on the body surface of the cylindrical SSS test specimen due to torsion. Because of this, it was decided that nondestructive testing techniques should be used to examine the surface of the tensile samples. The penetrant test, the results of which can be seen in Figure 8a, was performed by applying fluorescent spray material

Figure 7. SSS tensile specimens with surface cracks during threading

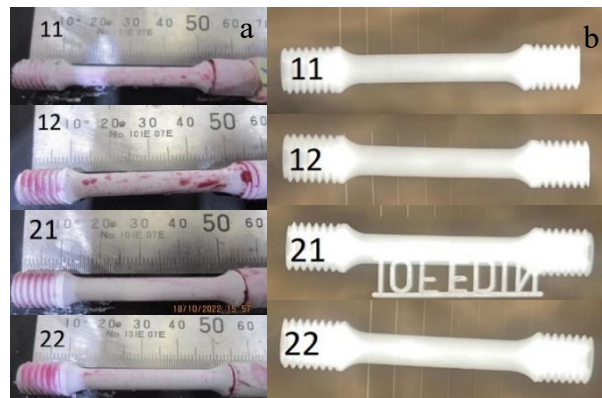
on the specimens. The dark red areas seen here indicate cracks formed on the surface during the threading of the specimens. In order to determine whether the cracks continued into the body of the specimen, radiographic examination was performed on the Balteau XSD 160 X-Ray imaging device. In the radiography results shown in Figure 8b, no trace of these cracks continuing into the sample body was found.

Figure 8. Penetrant test (a) and radiography result (b) photos

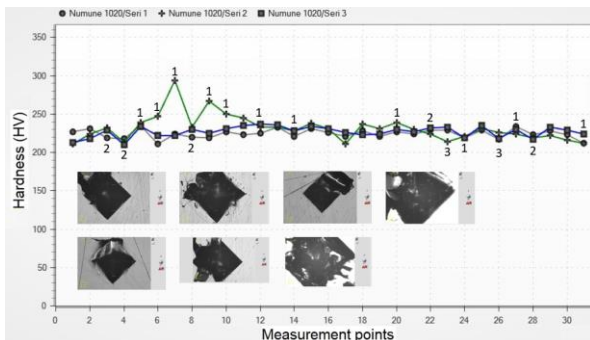
Figure 16. Vickers hardness test measurement results for SSS sample

Figure 16 and Figure 17 illustrates Vickers hardness values based on measurement points and series. On several measurement points in the illustrations, the numbers 1-3 correspond to the wrong measurement point numbers on the same horizontal axis. Figure 16 depicts the SSS sample measurement graph with Vickers hardness values from a total of 93 measurement points. 27 of these measurements cannot be obtained accurately because the indenter overlaps with the void. In the SSS sample, inaccurate measurements were changed with values obtained from the closest region, which appeared to be void-free in the horizontal direction. An example of this situation is seen in Figure 18. One side of the square shaped trace left by the Vickers indenter is approximately 60 μm . Figure 16 shows distorted indenter traces at problematic measurement points. Figure 17 of the CSS sample shows that the indenter impacted the void region in 4 of 39 measurements. In other words, the Vickers indenter coincides with the voids in 29% of the measurements from the SSS sample and 10% of the measurements from the CSS sample. The reason for this difference is that the fusion gaps in the SSS sample are higher than the CSS. The white spots seen on the sample surface in Figure 14 and Figure 15 are lack of fusion voids. These voids on the CSS sample surface, as seen in Figure 15, are substantially smaller and less numerous than those on the SSS one.

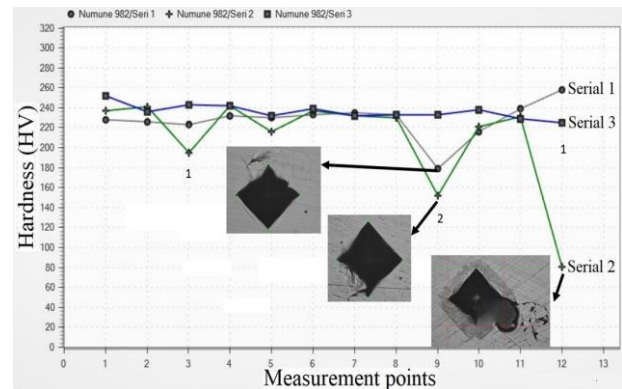
Figure 17. Vickers hardness test measurement results for CSS sample

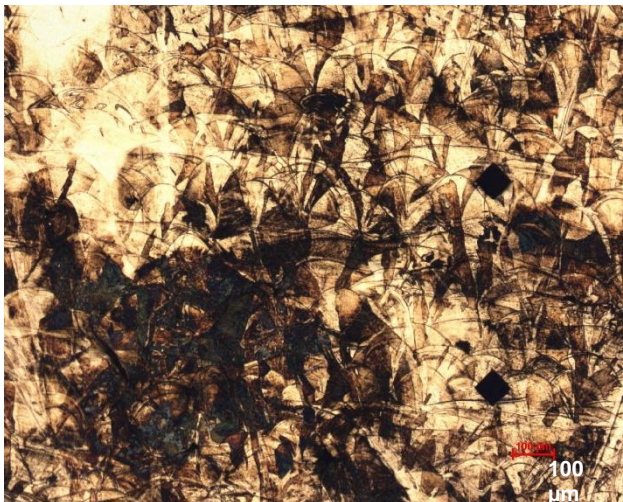
Figure 28. CSS sample; 50X magnification microscopy image of region CB as described in Figure 26

Figure 29. CSS sample; 50X magnification microscopy image of region CC as described in Figure 26

Figure 30. CSS sample; 50X magnification microscopy image of region CD as described in Figure 26

Figure 31. CSS sample; 50X magnification microscopy image of region CE as described in Figure 26

Detail photos of the middle layer are shown in Figure 23 for the SSS sample, and in Figure 29 and Figure 30 for the CSS sample. It is seen that the microstructures seen in these images show a regular distribution compared to the lower and upper layers. For the SSS sample, it was observed that the number of voids was relatively low in the images taken from the middle layer. At 50X magnification, very few voids smaller than 50 μm were seen in the CSS sample.

For both samples, the upper layers are the regions where delamination begins. Figure 24 and Figure 25 include detailed photographs of the SSS sample, whereas Figure 31 depicts the CSS sample. Specifically, in Figure 25 from the SSS sample, the delamination is visible on the fabricated part's outside surface.
