The Basilica Mosaic on Asar Island at Myndos

Abstract

Keywords: mosaic, Myndos, Asar Island, opus tessellatum.

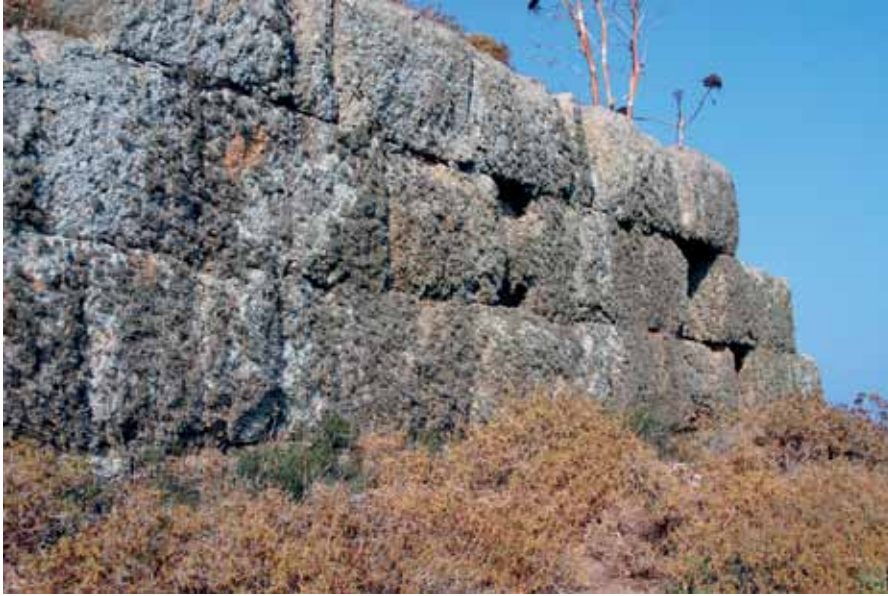
Figure 4
Myndos city wall from 4th century
(Myndos Excavation Archive)

was spread over a wide area. Myndos could have been a defense station for the capital city Halikarnassos against enemies, who could come from the west. The strategic location could be the reason that the city continued to develop in even the Roman period. Myndos and its harbor were protected by a city wall 5 km in length (Fig. 3). The city wall was designed in such a way that the harbor was preserved. The harbors were built so that they would protect against the northwest wind. The little island (Tavşan Adası / Rabbit Island), where the west city walls meet, is at the beginning of the connection with the mainland (Fig. 3). The traces of the preserved city walls confirm this. The city fortifications, which surround the city and are made of granite, were made with a pseudo-isodomic technique.

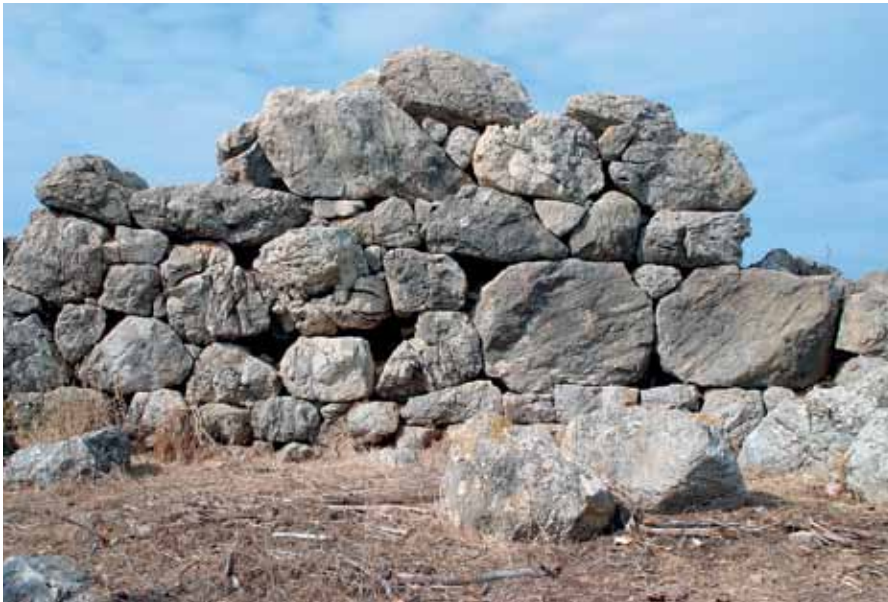
Figure 5
Lelegian Walls
(Myndos Excavation Archive)

In the city is a second city wall, which only surrounds the peninsula and is not connected to the other walls (Fig. 5). Larger stone blocks are used in the wall, and thus, it is called the “Leleges wall”. The technique and the gray stone distinguish it from the other walls. The stones are rectangular and polygonal. In some parts the thickness of the wall is 1,20 m. The appearance and technique of the

wall is similar to the city walls of Tiryns, which are dated to the second half of the 2nd millennium B.C.. This dating corresponds with Strabon's account and confirms that the foundation of the city has to predate Mausolos.

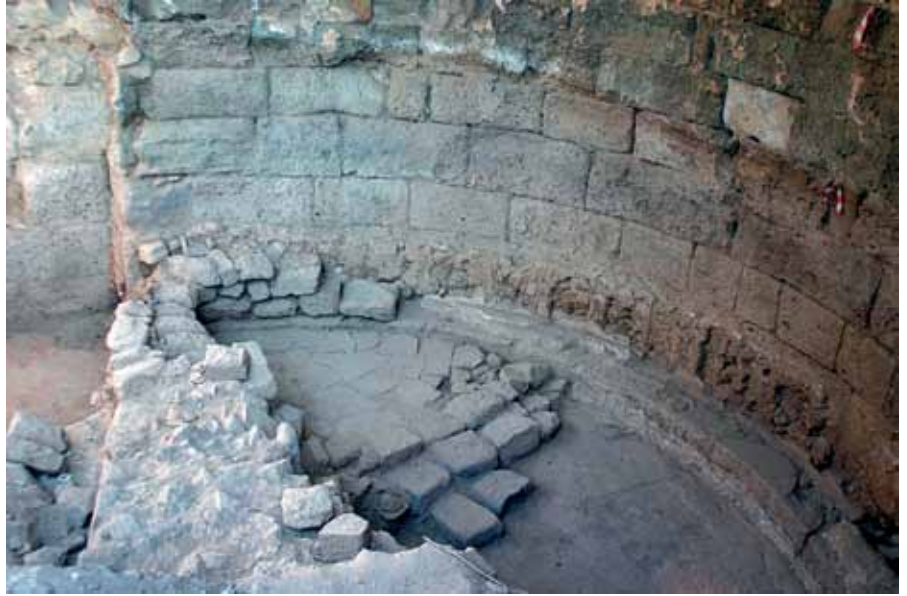
Figure 6
The Bath
(Myndos Excavation Archive)

Another preserved building could be an imperial bath and lies 20 m northeast of the church (Fig. 6). The preserved length is 38 m and the width 12 m. Only the caldarium with the apse is still standing. According to local inhabitants, many marble bath basins were taken out of a cistern 100 m to the south; the owner of the land eventually stopped this practice and covered the well. Another interesting discovery was the artifacts in the mouth of the artificial harbor, which would have protected the eastern harbor. Here, we found two rooms, which lie upright on the foot of the slope and parallel to the artificial harbor, with a girdled cover. Traces of a mosaic pavement remain on the floor. The threshold of the southern door leads us to believe that this place was.-

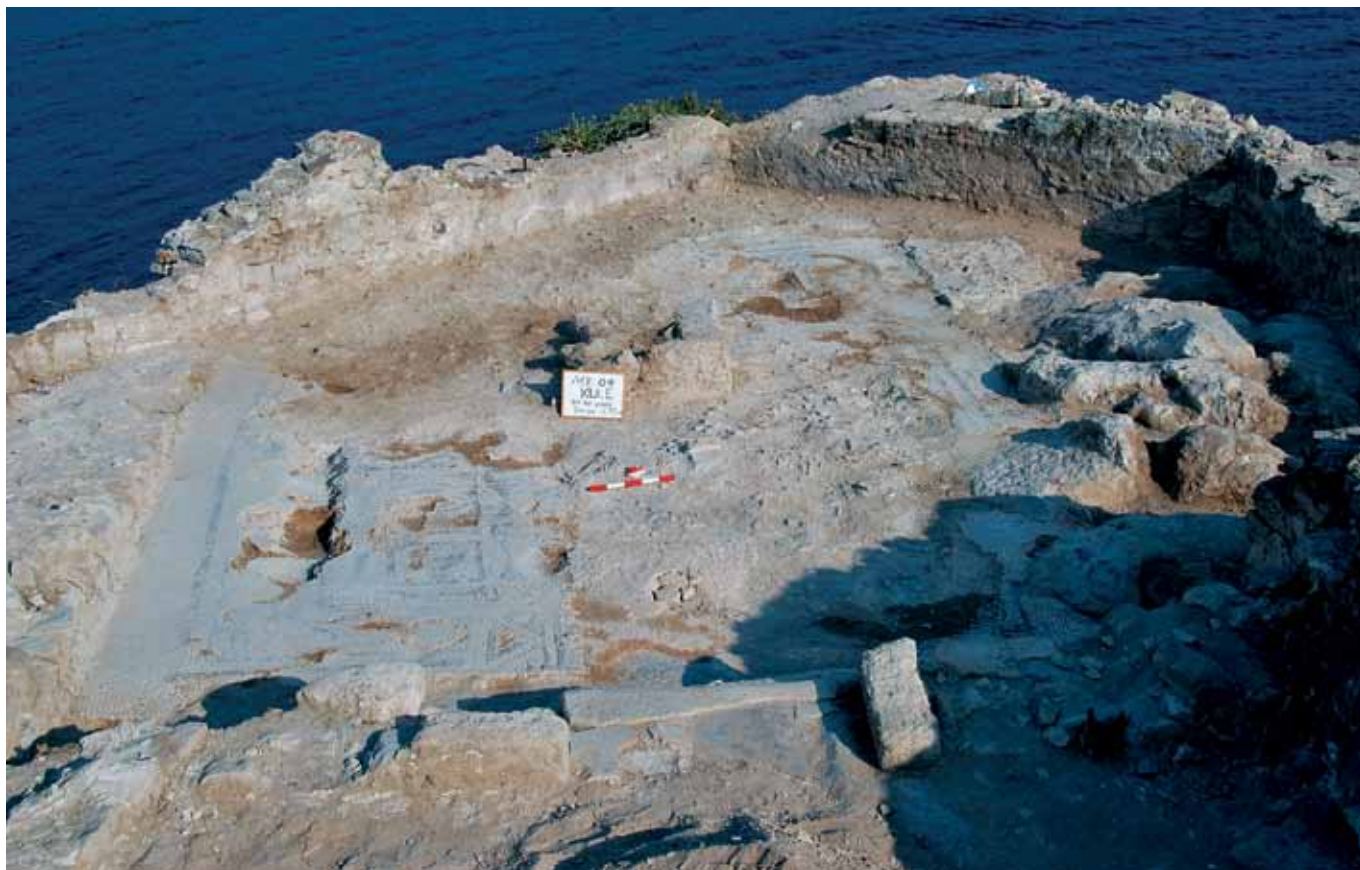
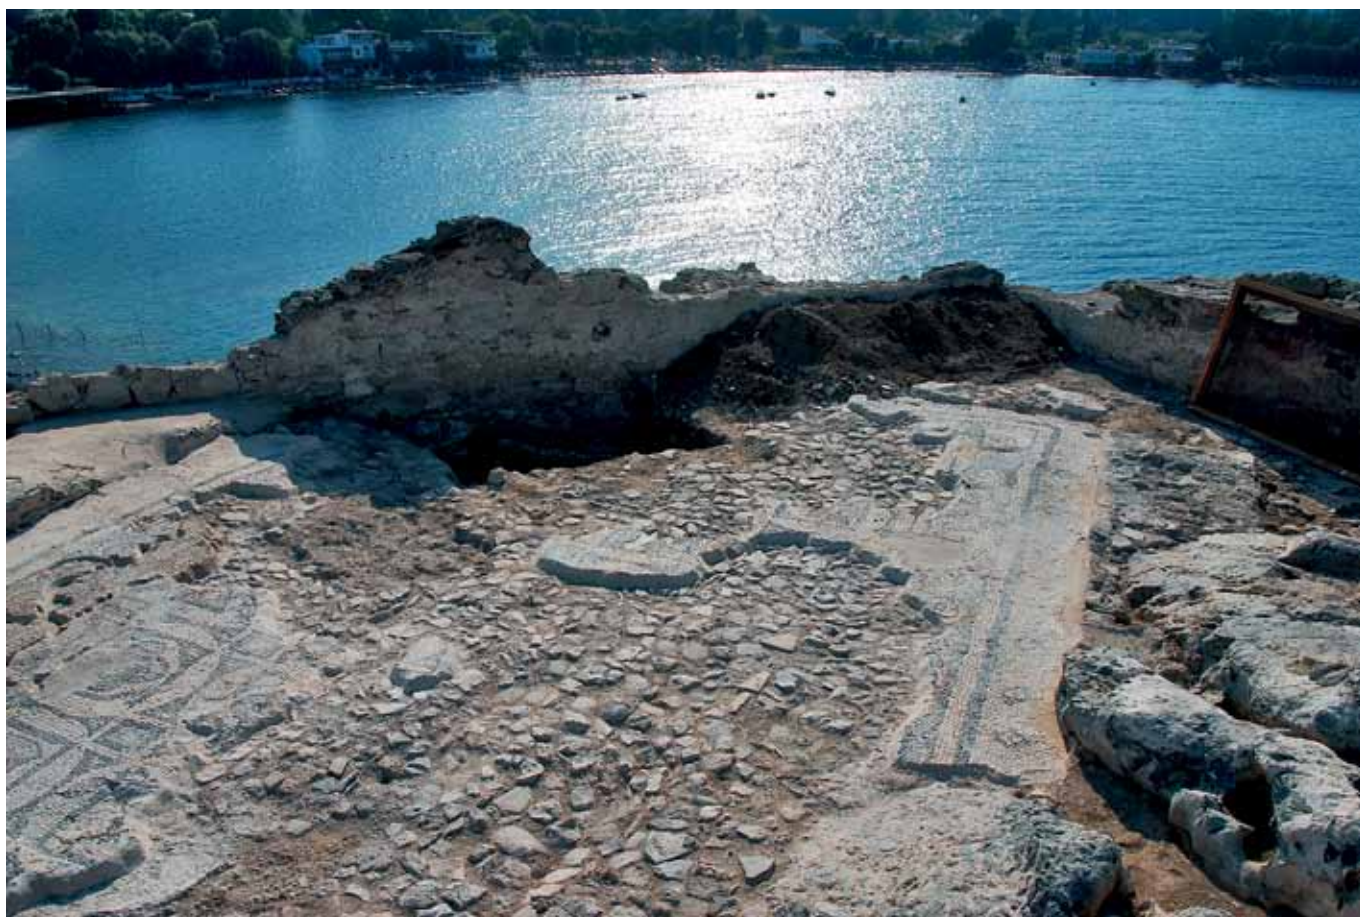
Figure 8
General view of the Mosaic
from Asar Island
(Myndos Excavation Archive)

Architectural Context: Mosaic 4 covers the middle nave within the basilica structure. Only a tiny area of 1 m² on the north nave is preserved; the south nave is totally devastated, and a later watchtower is built over it. Nevertheless, the mosaic pavement on the protected section of the northern nave includes the remnants of a contemporaneous area with mosaics. The watchtower was most likely built on a terrace just below the north nave, and the numerous palm-sized mosaic fragments unearthed seem to support this argument.

Measurement of the Mosaic: Protected size: 7.36 x 5 m
