A Part of Prusias Ad Hypium Waterways: Kemerkasim Village Aqueduct Architecture, Problems, Restitution, and Restoration Solution Suggestions

Ercan AKSOY*

0000-0001-7632-9257, EHA Cons. & Architecture, Ankara/ Turkey

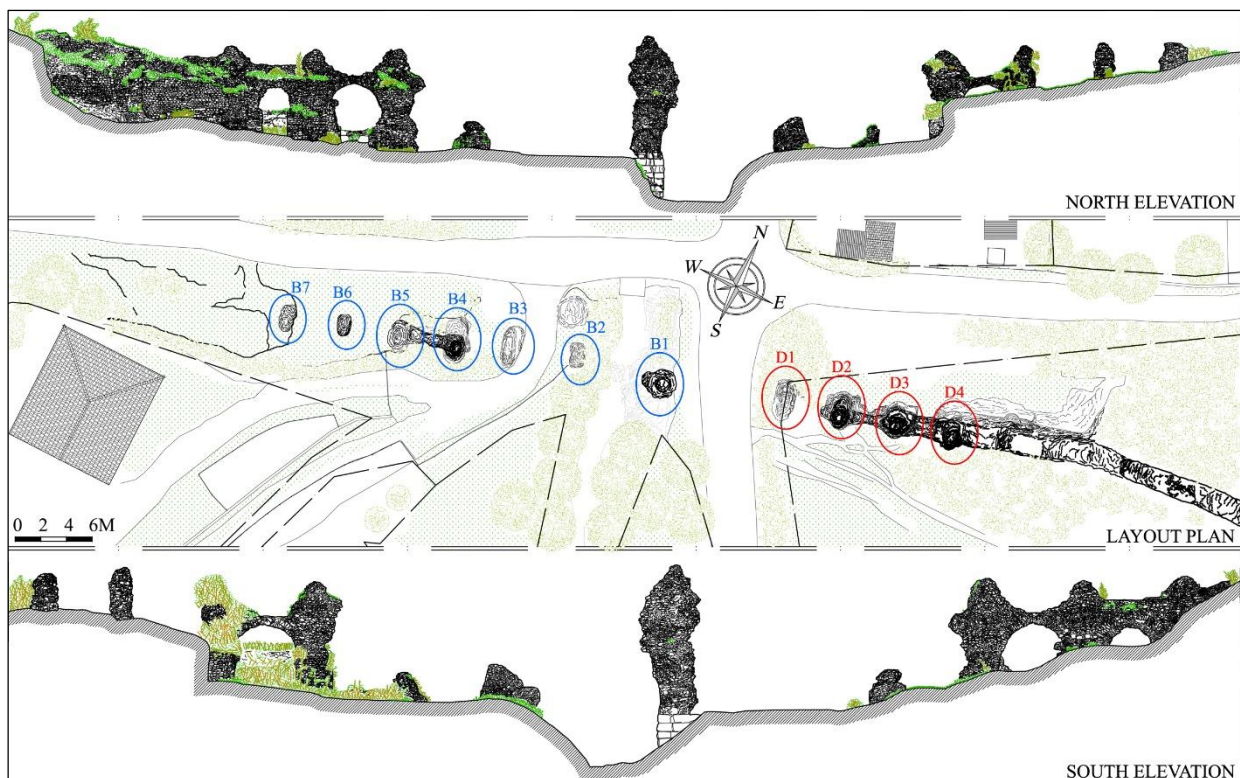
Figure 3. Layout Plan and Facades (drawing belongs to the author)

Despite the significant collapse of the aqueduct, some of the arch piers are still visible. The span between the surviving arch piers varies between 4,50 and 3,50 meters. However, the span between the arch pier to the east of the highway dividing the arches in the middle and the first arch pier to the west is more than 10 meters. The width of the structure reaches 3,70 meters in the thickest part and 1,10 meters in the narrowest part. The large losses in the paving stones in places cause thinning especially in the arch axes. In the repaired sections, the walls were found to be about 1,50 meters thick. The heights of the three surviving arches were determined to be 1,40, 3,30, and 4,20 meters in the west-east direction, respectively, when viewed from the north facade due to the earth fill. On the other hand, the largest of the arch piers is located in the middle of the stream bed and has a height of 14,50 meters. The structure, which can also be referred to as a waterway, has a length of approximately 102 meters (Figure 3).

The aqueducts are typically built with rubble stone, but in a few exceptional cases, the cut stone is used at the base. The cut stone material is generally preferred as a cladding material, but in some parts, it was also used to form a water basin at the ground level. Moreover, the use of bricks in addition to stone is limited to partial use in the form of 2-3 rows of brick arches, starting at the base line of the arch piers, while occasional single brick uses can also be seen in stone arched aqueducts. The measurements of the bricks are the same as those seen in the Roman and Byzantine periods (4,5/5 x 34 x 36 cm and 4,5/5 x 16 x 36 cm). The mortar used as joint filling material appears irregularly in the cladding stones and rubble stone masonry.

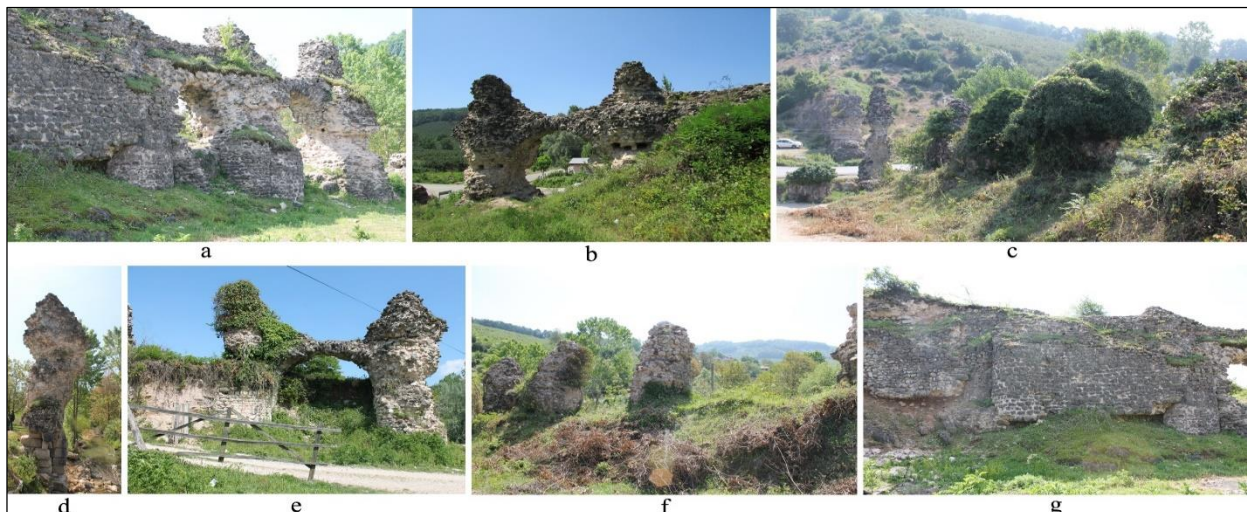
Figure 5. Kemerkasim Aqueducts Views (photos belong to the author)

To the east of the road, four aqueduct piers and an aqueduct wall are visible toward the eastern end. Between the 2nd, 3rd, and 4th arch piers, the arch has survived to the present day (Figure 5a). The arch pier, wall, and arch surfaces were left unprotected due to the collapse of the outer cover, salt deposition by rainfall and water absorption from the surrounding soil fill, and physical stresses caused by vegetative growth caused

structural problems such as losses in structural elements and masonry sections, joint openings in the masonry, joint mortar discharge and losses (Figure 5b). In addition, deterioration in building materials such as crumbling, abrasion, microbiological patina formation, and superficial deposition are also visible.

To the west of the road, seven aqueduct piers and an aqueduct wall are visible from the 5th arch pier at the western end up to the elevated land (Figure 5c). The 1st arch pier is still standing despite a lot of stone, joint, and mortar loss. In general, however, it is about to collapse. While there are cut stones at the base close to the ground, the body is made of rubble stone. Joint mortar loss throughout the arch pier, joint mortar discharge and losses in the masonry, and losses in the unit material and sections are visible. In addition, there are losses in pieces, abrasion, and crumbling in terms of building material (Figure 5d). The arch has survived to the present day only between the 4th and 5th arch piers. However, a part of it has remained under the soil due to the terrain shape (Figure 5e). Vegetation increases from the 5th arch pier onward, and almost all the 6th and 7th arch piers are covered with vegetation (Figure 5f). Especially the trees and/or plants, growing in the soil accumulated in the gaps in the wall joints and on the tops of the walls, are damaging both the masonry and the building materials with their roots and trunks (due to the mechanical pressures they create during the root and trunk growth). On the north side of the aqueduct, which is east of today's asphalt road, where there is no earth fill, it is observed that the arch sections between the piers, the arch interiors, and the openings between them were covered with rubble masonry. It is believed that this intervention was made in the 2nd or 3rd century after the initial construction, probably after an earthquake. Problems such as moisture and salt deposition, joint mortar discharge, and microbiological patina (Algae and lichen-like moss layering formations) are also visible on these wall surfaces (Figure 5g).
