Social Sustainability and Re-functioning of Cultural Heritage: Seljuk Bath and Ali Aydın House

Keywords: Historical building, sustainability, re-functioning, conservation, Seljuk Bath, Ali Aydın House.

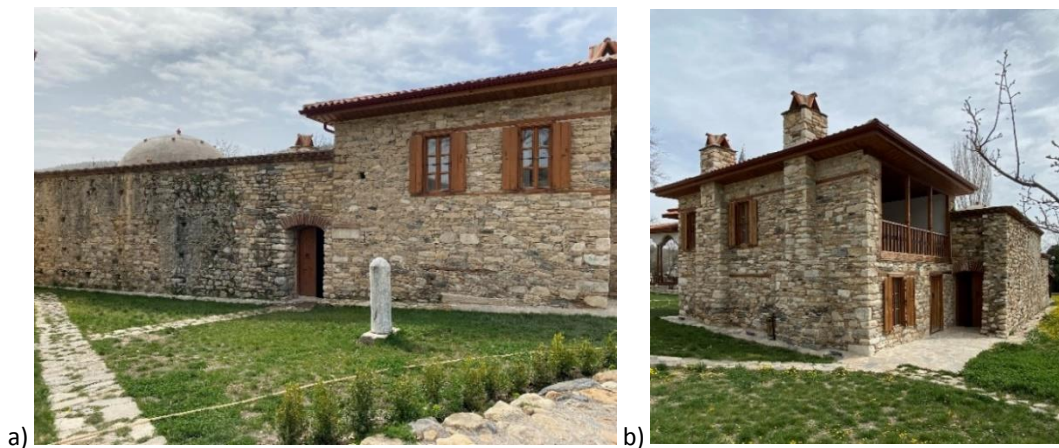
The fourth period covers the years between 2016 and 2022. In this period, survey, restitution and restoration projects were prepared between the years of 2016-2017, and with the financial support of the Southern Aegean Development Agency of the Republic of Turkiye and Pamukkale University, and the work of the excavation team. Within the scope of the projects, Seljuk Bath and Ali Aydın House were restored and ensured to reach our time by re-functioning (Figure 7).

Figure 7. a) Seljuk Bath; **b)** Ali Aydın House (Stratonikeia & Lagina Excavation Archive, 2022a)

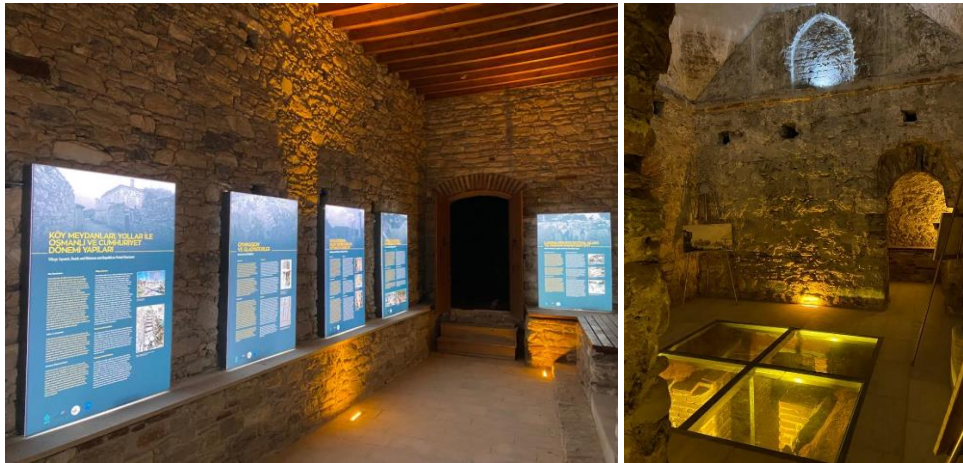
The conservation part of the bath and house structure, with their restoration, was completed in 2017 and was carried out and handed down to the next generations. These structures were later re-functioned to ensure their social and cultural sustainability. The historical structure of the Seljuk Bath has been preserved, and it has been converted into an exhibition area to both see the texture of the bath at that time and understand its interaction with its surroundings (Figure 9). While visiting the bath, which is still used as an exhibition area, the historical texture can be felt and information about other structures in the ancient city can be obtained at the same time.

Figure 9. Seljuk Bath Interior Photos (Stratonikeia & Lagina Excavation Archive, 2021)

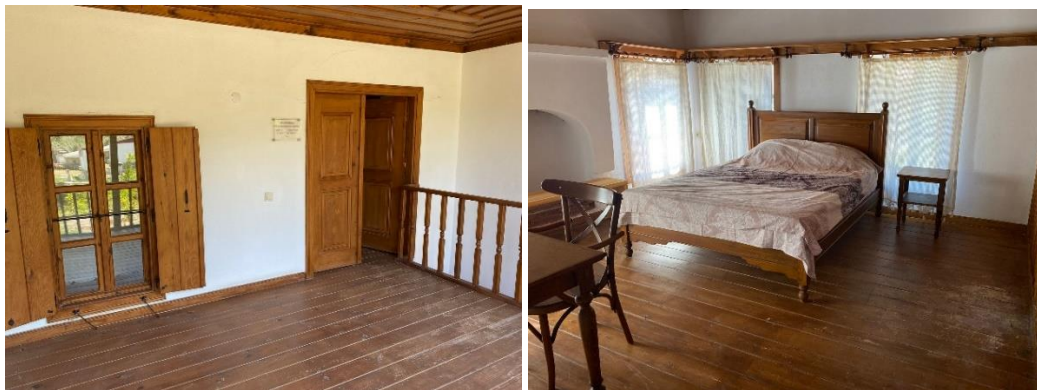
Ali Aydın House has also been re-functioned and turned into a place that the excavation team and committee members can use when necessary. In this way, the house was made sustainable by ensuring the continuity of use (Figure 10).

Figure 10. Ali Aydın House Interior Photos (Stratonikeia & Lagina Excavation Archive, 2022b)

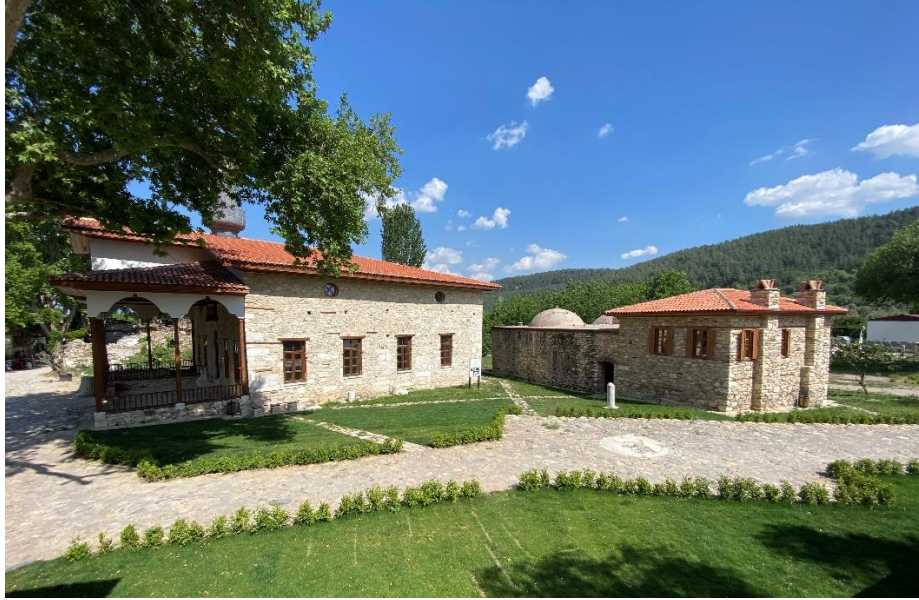
Since the Seljuk Bath and Ali Aydın House are structures which are re-functioned according to the historical environment they are in, social and cultural sustainability is ensured, and an environmental performance assessment has been conducted (Figure 11).

Figure 11. Seljuk Bath, Ali Aydın House and Landscaping (Stratonikeia & Lagina Excavation Archive, 2023)
