Bulletin of the Mineral Research and Exploration

AN APPROACH TO COAST EDGE LINE AT THE EASTERN ANTALYA MARGINAL-MARINE SEA SIDES

Research Article

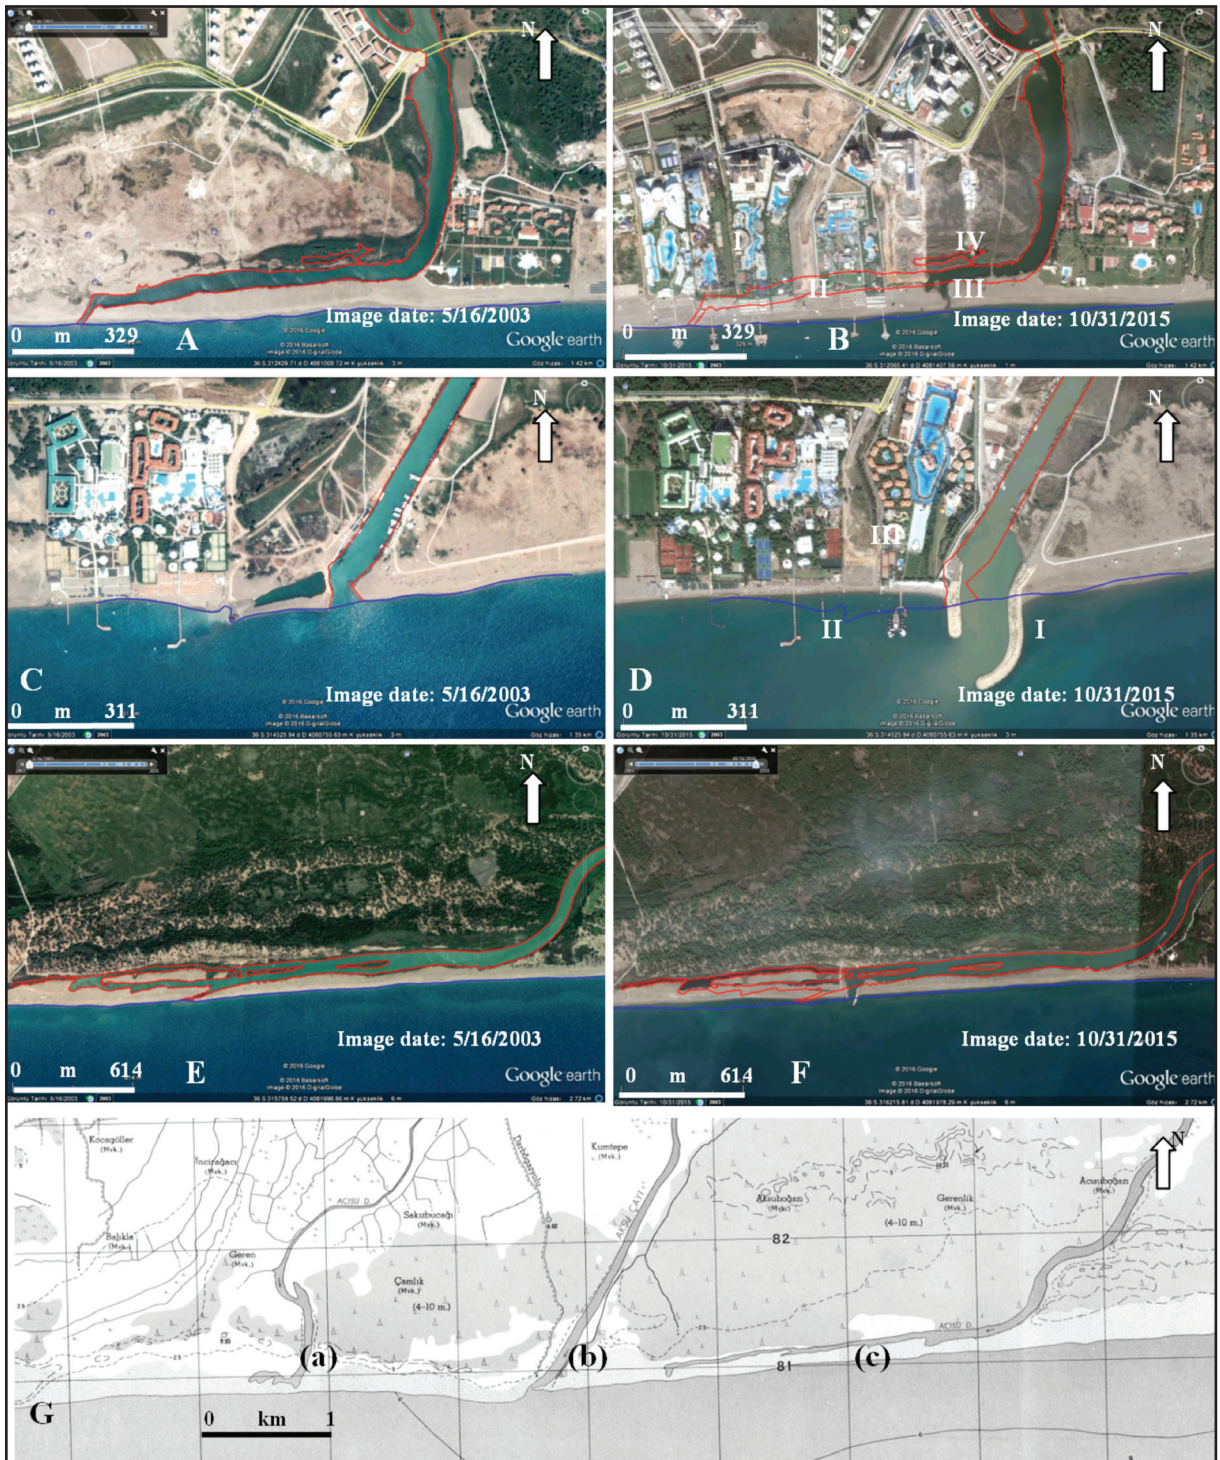
Figure 3- Google Earth satellite views of 2003 and 2015 for the following locations A-B. South of the Lara Main Road, C-D. exit of the Aksu Stream, E-F. exit of the Acisu Stream-2, G. topographical map of these three locations in 1962, (a) south of the Lara Main Road, (b) exit of the Aksu Stream, (c) Acisu Stream-2, numbers show changes in time.

The south of Lara Main Road: Touristic constructions and buildings on the sand dunes (I), flattened area around the exit of the one of the branch of the Aksu Stream (Acısu-1) filled by beach sediments (II), change of the exit of the stream (III) and changes in the size and locations of the swampy areas (IV) are seen as the main changes (Figures 3A- B). Longer beach or shore of the sea, and shorter stream angle are seen in the 1/25.000 scaled topographical map of the area dated on 1962 (Figure 3G).

Exit of the Aksu Stream: Mankind effects at the exit of the Aksu Stream (I), changes on the coast line (II) and buildings (III) are the important changes in the area (Figures 3C-D). Changes on the coastal edge line is seen clearly in 1962 topographic map, 1/25.000 in scale (Figure 3G).

Acısu Stream-2: Left side bending at the exit of the Aksu River is seen and called as Acısu Stream in the eastern part of the river (Figure 3E-F). Although some coastal changes are seen in the area, hollow of stream parallel to sandy dunes is more or less the same during the last fifty-sixty years. Widening sandy barrier (I), differences at the exit of the stream (II) are the main changes. Standard topographical map 1/25.000 in

scale and dated as 1962 show a natural water channel at the exit of the Acısu Stream in the land (Figure 3G).

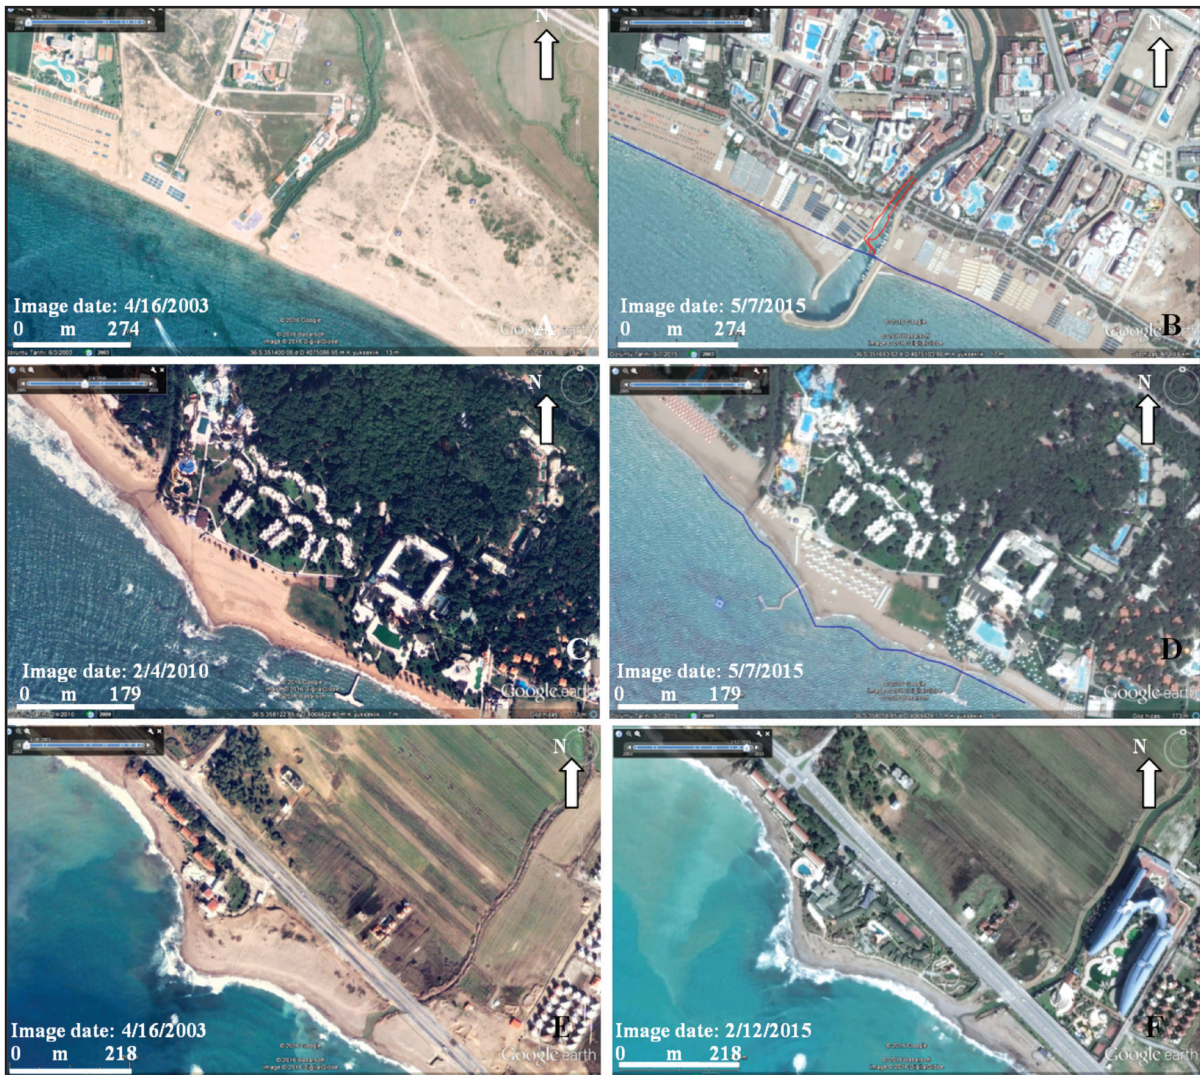
Figure 5- Comparative Google Earth satellite views of 2003 and 2015 for the south of the seashore at the south of Evrenseki , seashore at the east of Side and south of Kızılot.

Seaside at the southern Evrenseki: When comparing the views of 2003 and 2015 Google Earth satellite views, buildings or constructions and changes on the coastal edge line are seen clearly (Figures 5A-B).

Seaside of the eastern Side: During the last two decades, significant differences are not seen in the area when comparing the satellite views (Figures 5C-D).

Kızılot: Sheki occurred around the coast edge of the area during the last fifteen years is seen clearly in comparing of satellite views (Figures 5E-F).

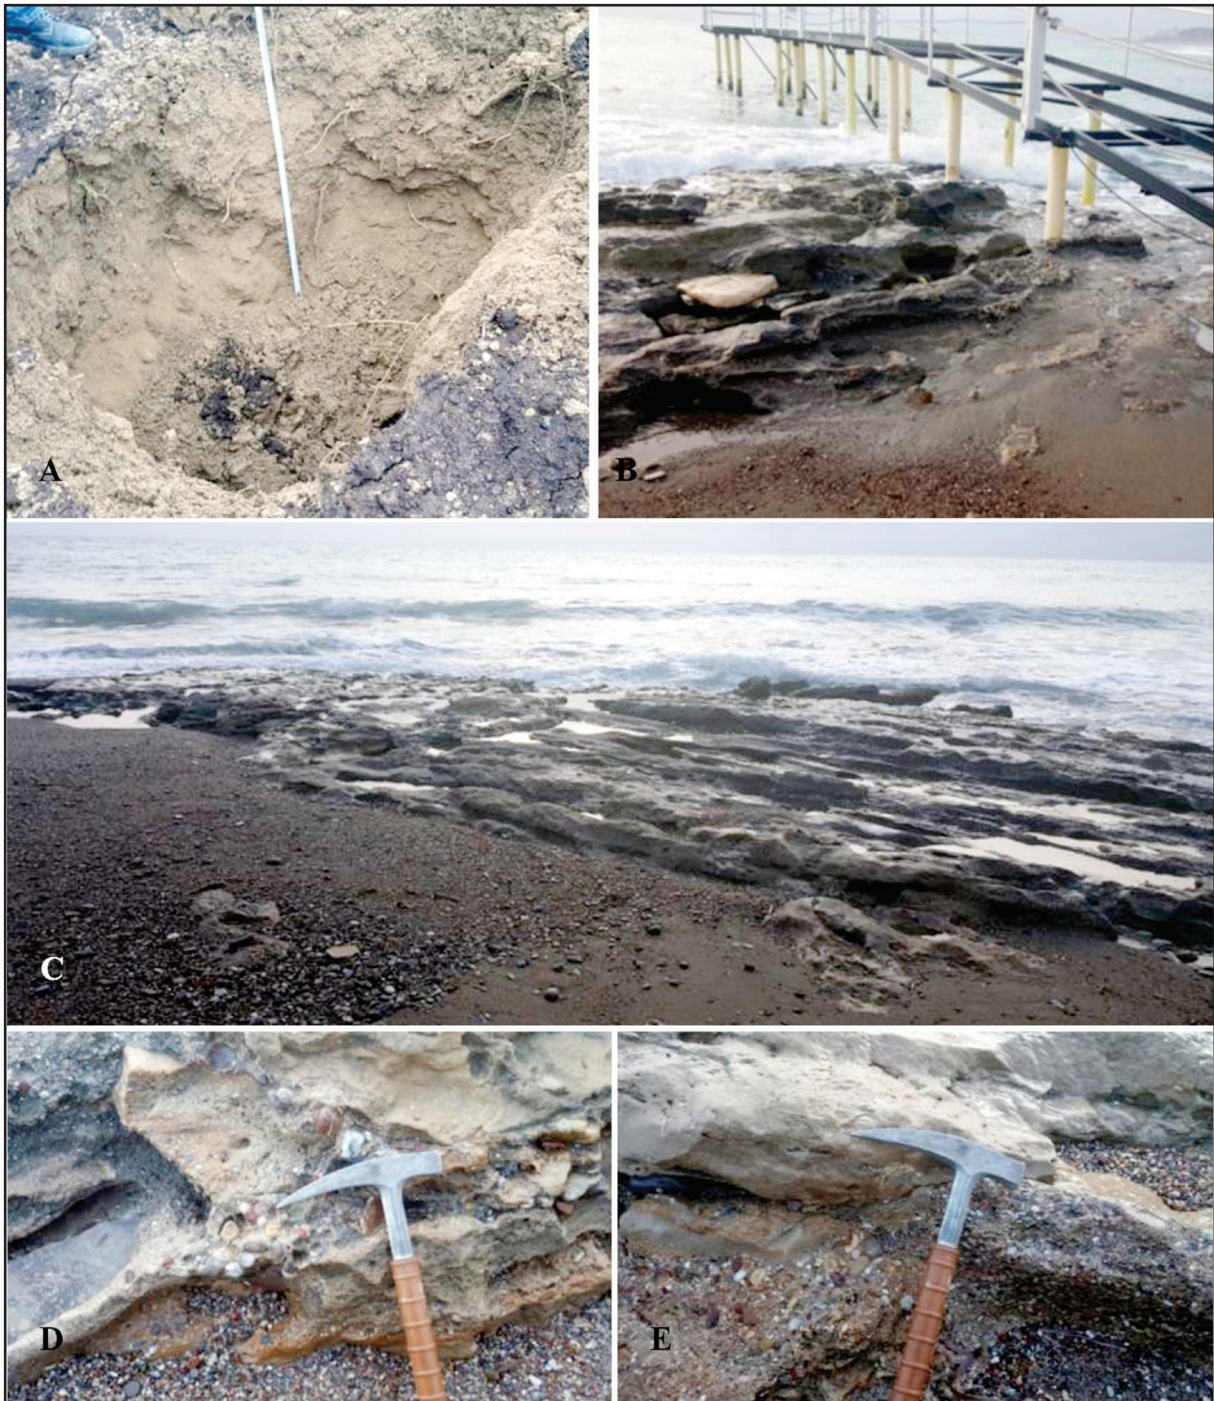
Figure 12- A general view from the beach area (A), observation hole at the north part of the beach area (B), a view from the Miocene aged (5-10 million years) conglomerate-sandstone, carbonate sandstone lithologies (C), closer views of the siliciclastics (D, E).
