New archaeological data from Claudiopolis in the light of stadion excavations¹

Davut Yiğitpaşa²

Bolu/Claudiopolis Stadion Excavation (2022)

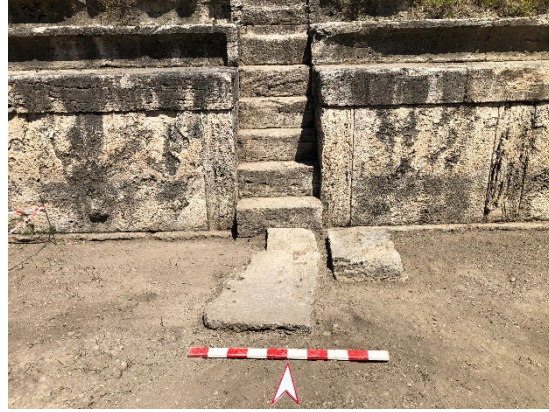
Figure 10 In-situ stones in front of the steps

There are three in-situ stones in front of the 1st step on the 7th staircase. The stones measure 39x37x17 cm, 97x62x21 cm, and 50x68x30 cm (Figure 10).

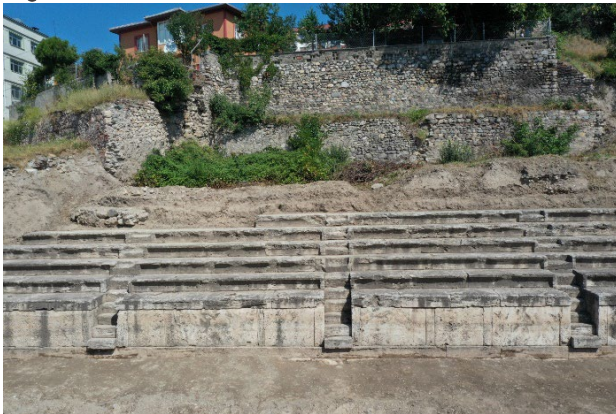
Figure 11 Seating rows and keiles

years. The 2nd row of seats is 45.85 m, the 3rd is 39.83 m, the 4th is 36.78 m, and the top 5th row is 23.97 m long (Figures 7-8, 11). Like Claudioapolis, Laodikeia is known to have two theaters and a stadium, and Apameia and Kelani are also considered to have two theaters, but this is yet to be confirmed, and inscriptions indicate a double sphendone stadium structure.

On the 2nd staircase, the 10 cm high section between the 6th and 7th steps is not set on top exactly but protrudes from 4 to 9 cm. On the 3rd staircase, 5 cm was left protruding between steps 6 and 7. Its height is 9 cm. On the 4th staircase, it was left protruding from 6 to 13 cm between the 6th and 7th steps. Its height is 10 cm. On the 5th staircase, there is no protrusion between the 6th and 7th steps, and it is placed exactly on top. The 6th staircase has a 2 to 1 cm protrusion between steps 6 and 7. On the 7th staircase, no protrusion was left between the 6th and 7th steps, and it was placed exactly on top. There is also a 71x15.5x0.4 m frame on the facade of the 7th step. On the 8th staircase, there is a 1 cm protrusion between steps 6 and 7 (Figure 11).

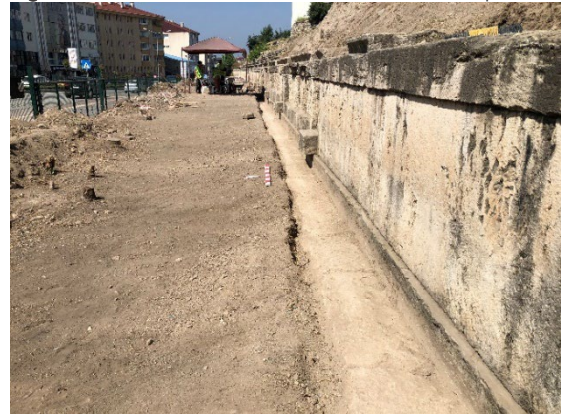
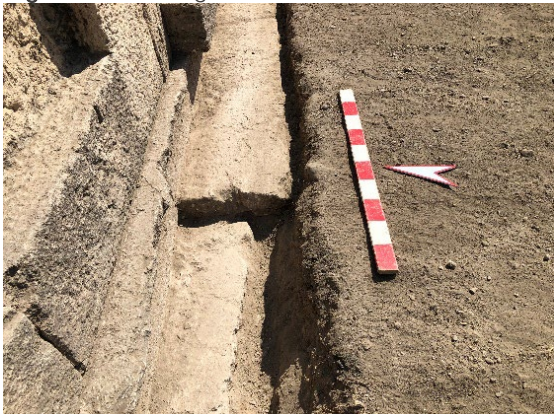
Figure 12 Blockage in front of the stadium

Figure 13 Blockage in front of the stadium

As mentioned above, the remains of the stadion continue towards Plots 42 and 43 to the east and towards Plots 61 and 64 to the west and southwest of Plots 15-16-17-18. In order to reveal the extensions of the stadion in other plots, it is necessary to continue rescue excavations in layout 9, block 248, plots 42, 43, 61, and 64. Essential works to reveal the stadion in its entirety, which has been partly uncovered, are being carried out today. Therefore, excavation and earthworks started here in 2022. The four plates of the inscription, which could not be found in 2008, and the continuation of the seating rows may be recovered with new excavations. If the top seating row is identified, the audience capacity can also be estimated. Since the present settlement was built on top of the ancient city, no structure has survived standing to this day. Although the building was considered to have a one-sided seating arrangement as far as it is observed on the soil surface today, the studies of 2022 suggested it had sphendones. The partial size of the building is 94.50 m. It can be suggested that the building must have been larger for the agons organized in the city in the Emperor's name. Constructing stadions on the hillside slope is a widely used technique in Anatolia. The one-sided appearance of the Claudiopolis Stadion today is similar to these stadions. However, there is a possibility that the opposite tribüne was on a vault while one side was on a slope. Our recent studies suggest that the stadium had a sphendone. It was stated that it was divided into 15 keiles in the 2008 excavation (Figure 11) (Güneş, 2010, pp. 160-161). The scientific excavations of 2022 evinced that the seat rows descending in the north-south direction into 16 keiles, not 15. We found that the blockage continued in front of the balustrade wall. We also observed that the blockage was reinforced by making a compacted base with small river stones, black slate soil, and other materials (Figures 12-13).

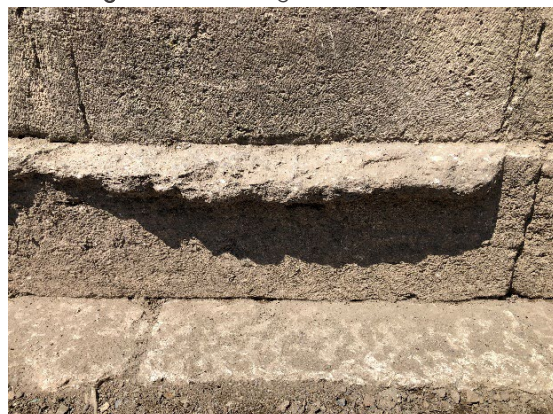
Figure 14 Blockage in front of the stadium

this level difference. The stone between the 1st step and the blockage has a 5-13.5 cm protrusion (Figure 14). Since destroyed by the shops, it is unknown how many cm the protrusion actually is (Yiğitpaşa, Kaya & Öntaş 2024, p. 10).

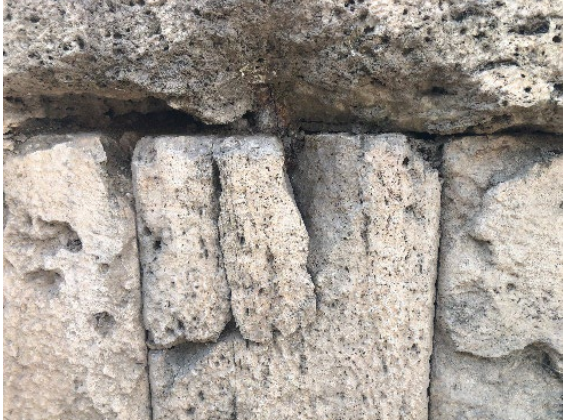
Figure 17 Iron clamp in balustrade

second vertical stone northeast of the 1st staircase is fractured, allowing the iron clamp to be seen (Figure 17).

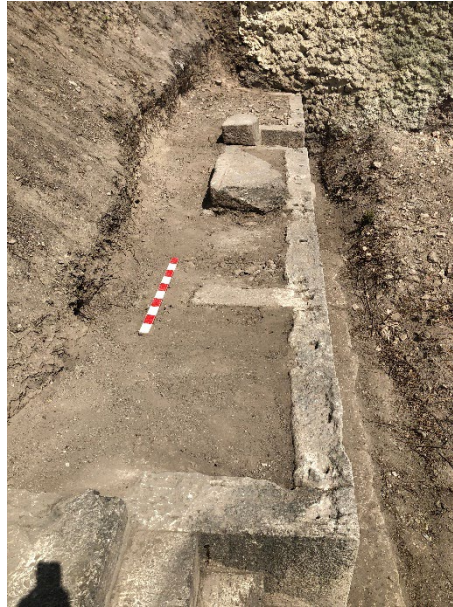
Figure 18 Internal view of the balustrade

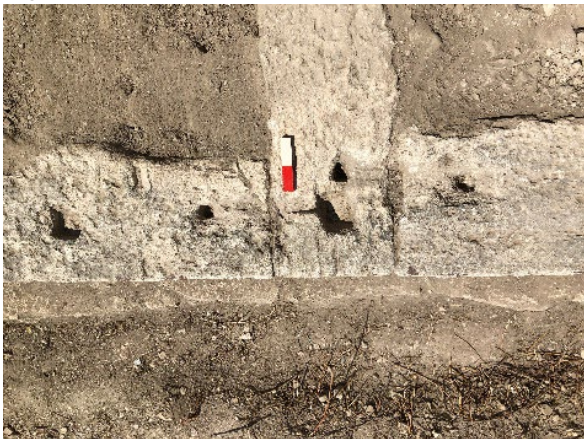
Figure 19 Clamp slots in balustrade

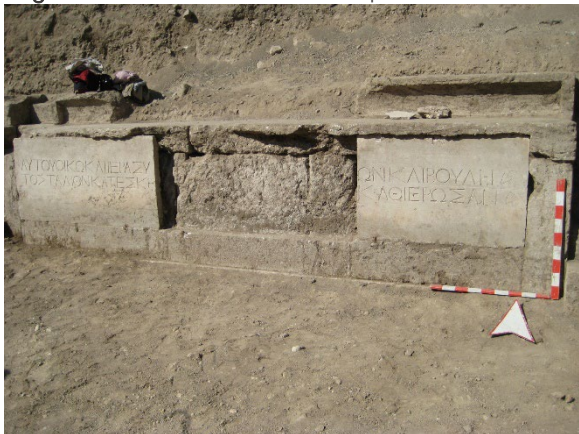
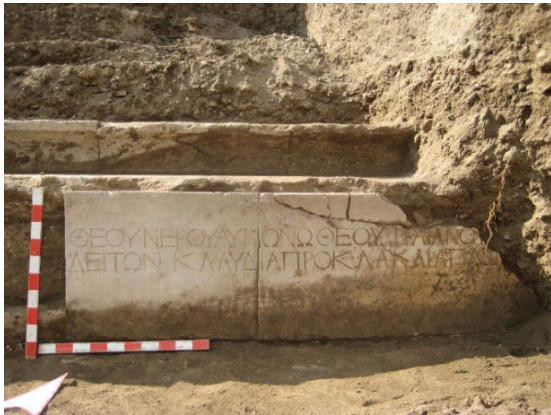
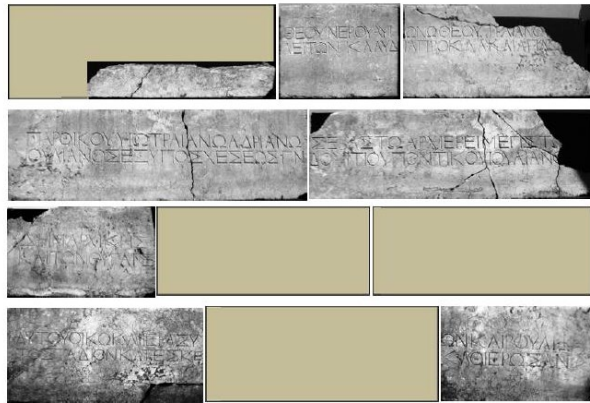
Figure 22 Stadium inscription (Bolu Museum)

Figure 23 Stadion inscription (Bolu Museum)

Figure 24 Stadion inscription (Bolu Museum)

The fact that these four panels with the inscription were visually brought to the fore gives the impression that this part is the very center of the stadion. Only a small part of the lower edge of plate no. 1, which must have been located at the inscription's beginning, remains to this day. The writing part of plate no. 1 and the plates that should be in 3 separate pieces after plate no. 6 are missing (Güneş, 2010, pp. 159-173; 2011, pp. 294-308). The Turkish translation of the building inscription, of which four plates were not found, reveals that the building was financed by Domitius Ponticus Iulianus and his family and dedicated to Emperor Hadrian, the ruler of the period. The Domitiuses, who undertook all the expenses related to the construction of the stadion, are recognized as one of the city's wealthiest families from other inscriptions found in Bolu. Celebrated for Antinoos and Hadrian, who made the city of Claudiopolis famous throughout the empire, these festivals included music, gladiatorial performances, wild animal fights, and sports competitions. It would not be wrong to think that the stadion financed by Domitius was used for these competitions. Unfortunately, we cannot tell the exact year the stadion was built, as the fragment with the year of the Emperor's reign among the plates bearing the building inscription could not be found during the excavation. We think that by finding these

These inscription plates were attached to the stadion wall (Balustrade) with iron clamps. Panel 1 is between stairs 9-10, 82x4.96 m in size and 38 cm in height. It is fixed with three iron hooks from the bottom (Figure 25). Panel 2 between stairs 10-11 measures 82x5.30 m and 38 cm high. It is fixed with one iron hook on the left side and four iron hooks below. Panel 3 measures 82x4.95 m and 38 cm high between stairs 11-12. It has one hook slot on the left side and four at the bottom, but no hooks. Panel 4 between stairs 12-13 measures 82x5.13 m and 38 cm high (Yiğitpaşa, Kaya & Öntaş 2024, p. 12).

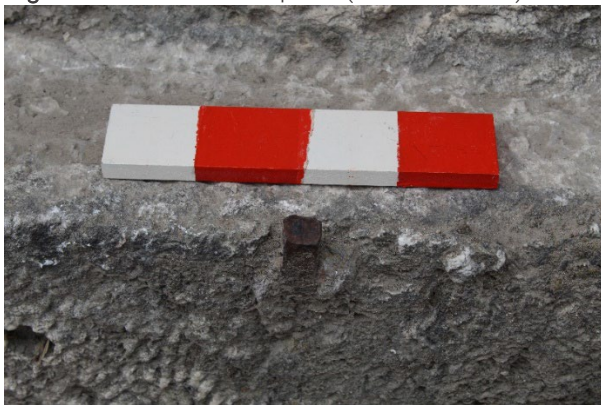
Figure 25 Hook holding inscription plates

The depth is 11.5 cm. One hook on the left side is broken. There are four hooks at the bottom. There are five hook slots on the bottom and one on the right side, without hooks. Either they were destroyed, or the Roman stonemason failed to place them. The back part where the plates were placed was left unfinished as it was not visible. The remains indicate that the hooks were reinforced by pouring lead (Yiğitpaşa, Kaya & Öntaş 2024, p. 13).

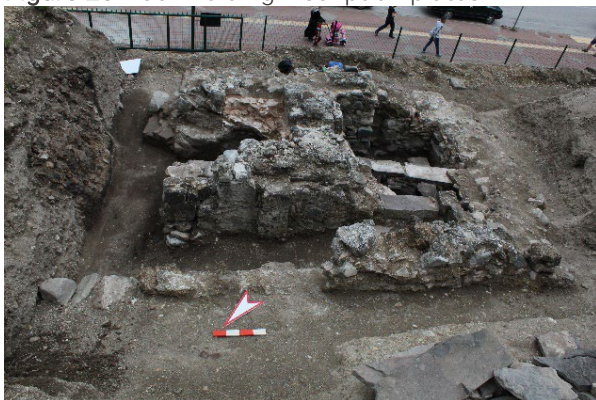
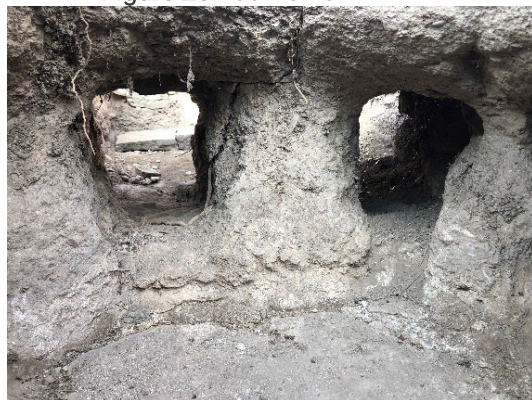
Figure 27 Mansion (Pavilion) bath

Figure 28 Heating system

During the 2008 excavation, the remains of an architectural structure were found, concluded to belong to an Ottoman Period building from the terracotta nozzle and ceramic sherds recovered, but the function of the building could not be determined (Figure 26) (Güneş, 2010, pp. 159-173; 2011, pp. 294-308). In my article where I re-evaluated the results of the 2008 museum rescue excavation, I stated that it could be a bachelor (Girçık, Çıkçık) bathhouse based on the excavation reports (Yiğitpaşa, 2023, p. 68; Yiğitpaşa, Kaya & Öntaş 2024, p. 13). However, in the 2022 2nd Term excavation carried out under my coordination, it was determined that the building remains were the Mansion (pavilion) bath from the Late Ottoman Period. In many cities in Anatolia, it is a common tradition for the notables of the city to build bathhouses in the gardens or on the premises of their mansions or pavilions. Mansion (pavilion) bath consists of a changing room in the north, a hot room in the southwest of the changing room, a water tank and a stove in the southeast (Figures 27-28).

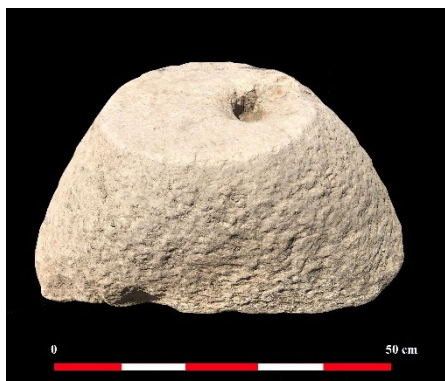
Figure 31 Column base

Fragments of a terracotta oil lamp, terracotta nozzle, metal fragments, and broken potsherds were recovered. Moreover, an inverted marble column base was found 2.30 m southwest of the southeast corner of the bathhouse (Figure 31). The flat section on which the pedestal sits is

61x35 cm in diameter and 29 cm high, the top of the column is 30 cm in diameter, and there is a round clamp pit measuring 5x5 towards the edge (not in the center). It is considered that it may have been rolled down from the Acropolis of Hisartepe. A spolia marble architectural element measuring 44.5x35x19 cm was found in the remains of the modern building above the stadion (Figure 30), which is also considered to be taken from the Acropolis. It was also understood that a few stadion stones were cut and used in the foundation of this modern building. Metal nails, hooks, ceramic and oil lamp fragments were recovered during the excavation (Figures 32-35, 40) (Yiğitpaşa, Kaya & Öntaş 2024, p. 12). In addition, a total of 7 coins were found behind the inscription, 5 with inscriptions and depictions faded due to their condition, and one each belonging to Emperor Septimius Severus (AD 193-217) and Emperor Pautalia Marcus Aurelius (AD 161-180). Excavation Inv. No 4 (729) of these, 2.8 cm. diameter bronze coin. Obverse: One countermark. The descriptions are faint. Reverse: One countermark. The descriptions are completely blurry (Figure 41). Excavation Inv. No 9 (734) 2.3 cm. diameter other bronze coin. The front face is completely faded and oxidized. On the reverse side, there are two standing figures in a faded condition (Figure 42).
