An Investigation on Faulty Renovation Practice in Hotel Facility Management: Adıyaman Grand Isias Hotel (GIO) Example

Keywords: Hotel facility management, hotel renovation, Adıyaman Grand Isias Hotel.

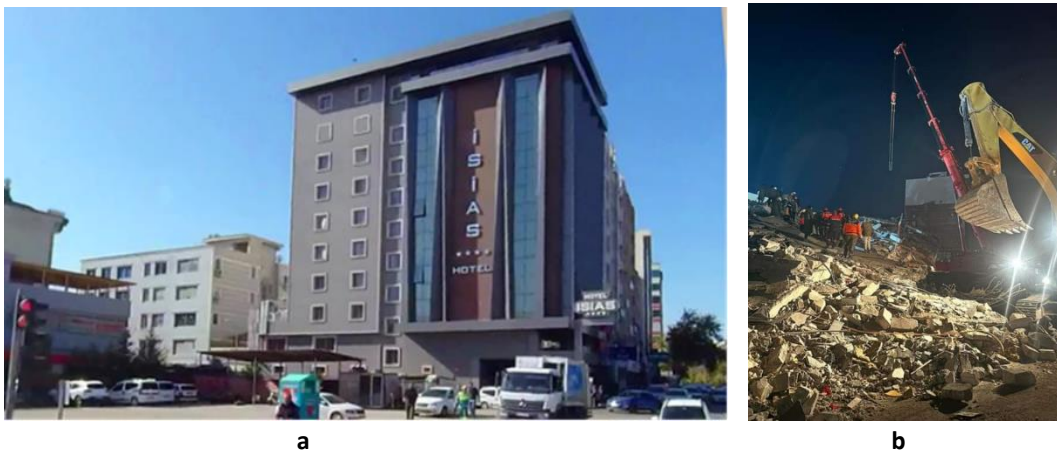
It is known that 65 people lost their lives as a result of the collapse of the 4-star Grand Isias Hotel (GIO), which is located in the city center of Adiyaman province, in Figure 1a. The wreckage of the Grand Isias Hotel after the earthquake can be seen in Figure 1b (News Kibris Int., 2023).

Figure 1. a. View of Grand Isias Hotel (GIO, 2023). b. Hotel Wreckage of the Grand Isias Hotel after the earthquake in Adiyaman (News Kibris Int., 2023)

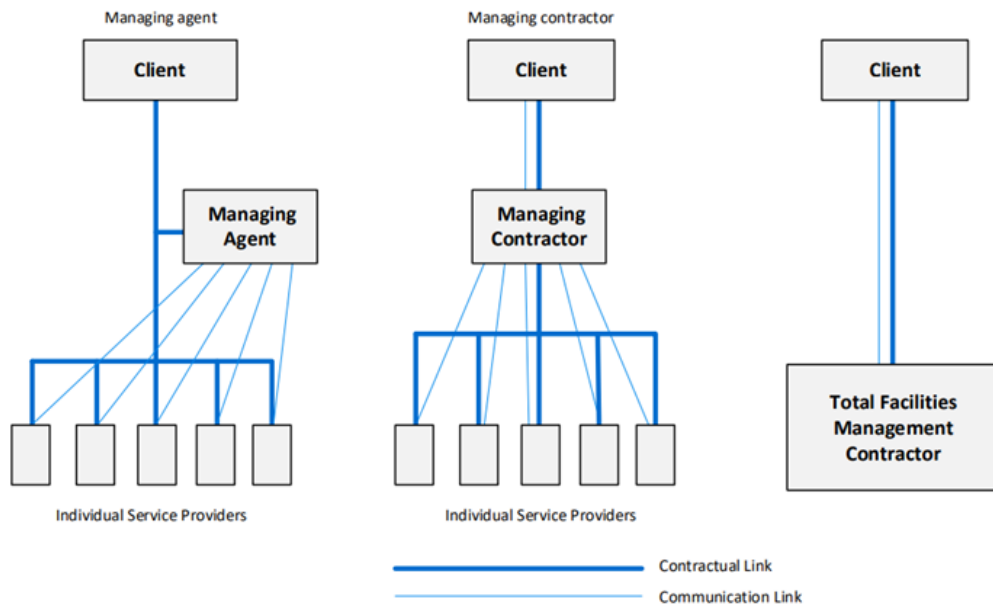
Figure 2 shows the three main types in terms of contract and communication links.

Figure 2. Types of contract arrangements (Atkin & Brooks 2000; Dirgeme, 2005)

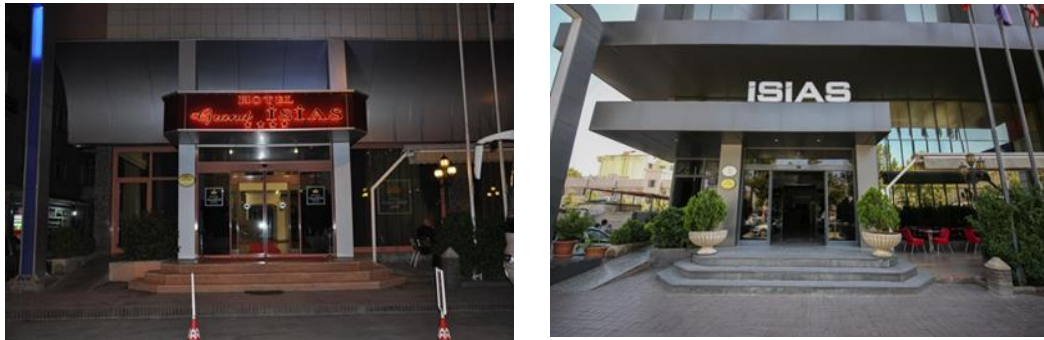
Figure 6a-b. The exterior is observed to be clad with aluminium composite panels in a manner that conceals the underlying structures; an extensive-major renovation.

Figure 6. a-b. Hotel entrance after extensive- major renovation (GIO, 2023)

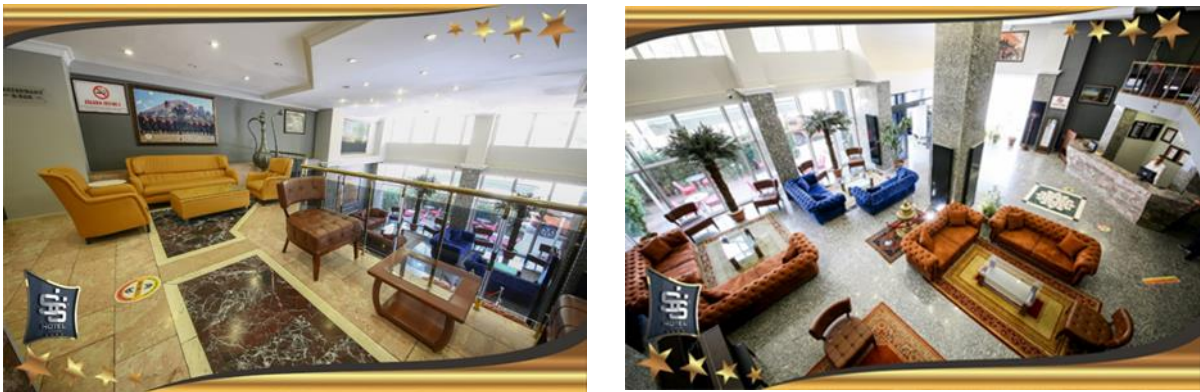
In the lobby, it is seen that the opening on the mezzanine floor is very wide, the column has been cut, the floor coverings and movable furniture have been changed (major renovation) (Figure 7a-b).

Figure 7. a-b. Hotel lobby after major renovation (GIO, 2023)

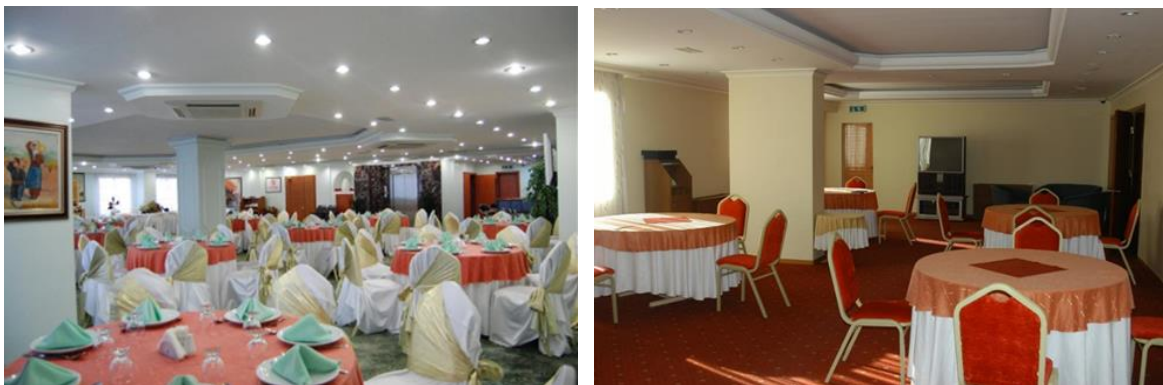
The floor and ceiling coverings, movable furniture seen in the multi-purpose hall in Figure 8a-b. are outdated. In order to compete in the market, as seen in Figure 9, ceiling coverings, floor coverings and all movable furniture claddings have been replaced with fashionable styles. Since the renovation was done in an amateurish manner, beautiful visuals were provided, but it has been experienced that the details about the durability of the structural system, which is vital to the work, are not discussed.

Figure 8a-b. Picture of the hotel's multi-purpose hall before extensive-major renovation (GIO, 2023)

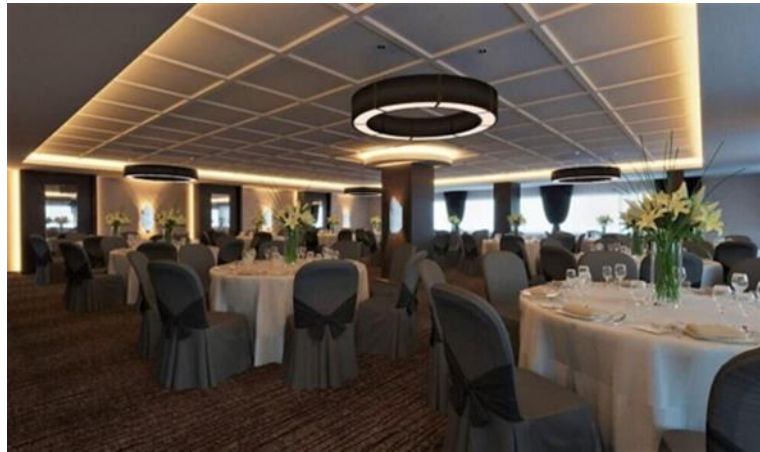
Figure 9. Hotel's multi-purpose hall after the extensive-major renovation (GIO, 2023)

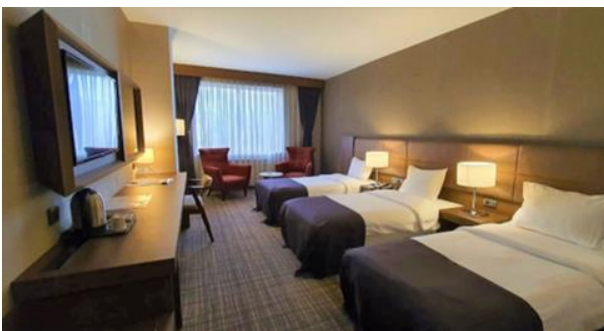
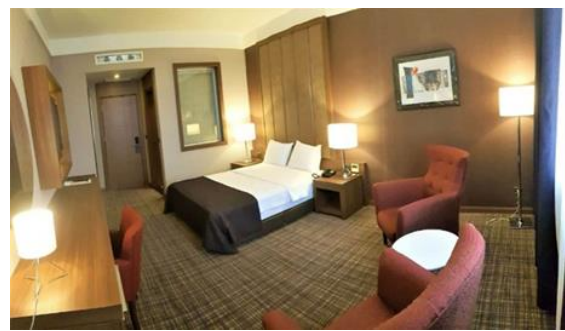
All furniture, lighting elements, and all fittings seen in Figure 10a-b. have been renovated in accordance with fashionable styles, as seen in Figure 11a-b. However, it is known that these rooms have become graves for many people.

Figure 11.a-b. Pictures from hotel rooms after extensive-major renovation (GIO, 2023)

The decoration of the rooms seen in Figure 10a-b are outdated. In order to compete in the market, as seen in Figure 11a-b., ceiling, floor and wall coverings, all movable furniture, fixtures and equipment and, claddings have been replaced with fashionable styles.

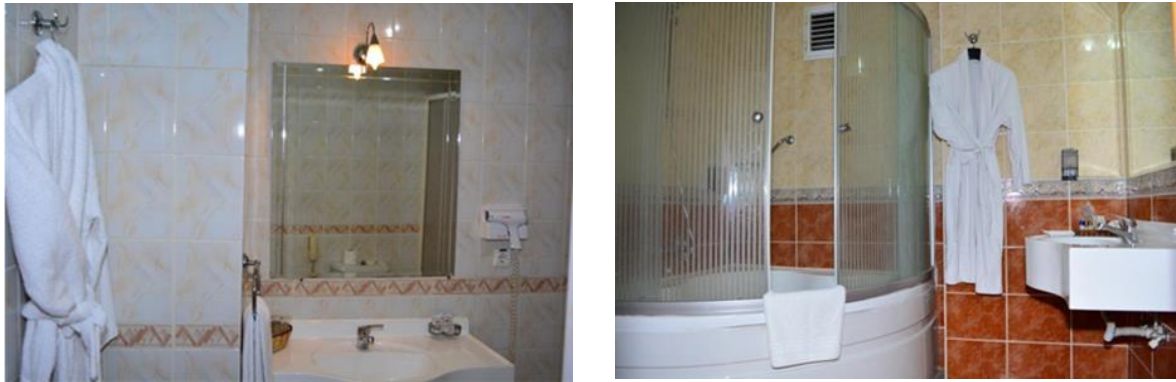
It is seen that the bathrooms in Figure 12a-b. have been renovated with contemporary building materials and fittings in Figures 13a-b.

Figure 12.a-b. Pictures from the hotel bathrooms before the extensive-major renovation (GIO, 2023).

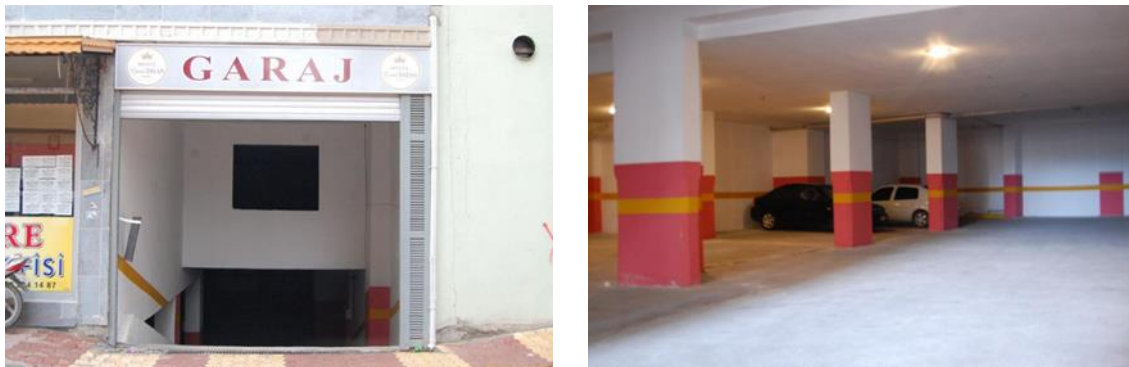
The basement garage entrance of the hotel is shown in Figure 14a, and the columns in the garage that were destroyed during the earthquake are shown in Figure 14b. In a professional renovation, evaluating the performance level of the existing structure requires analyzing core samples taken from columns that have been deemed suitable by engineers specializing in the field.

Figure 14.a-b. Images from the basement garage of the hotel (GIO, 2023).

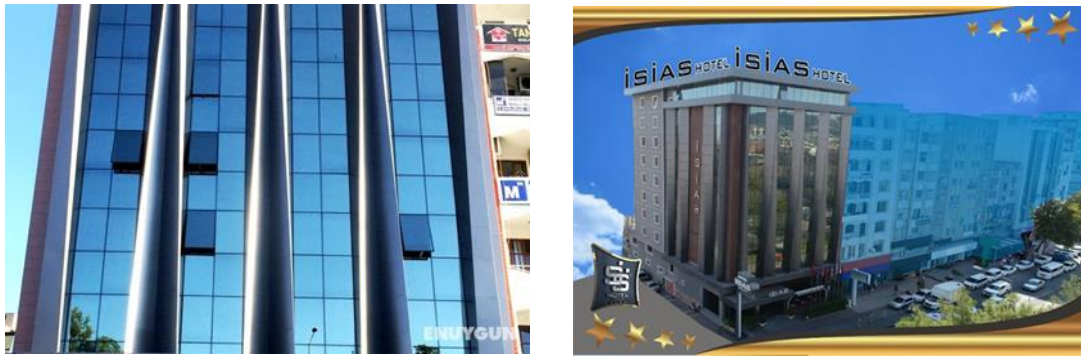
The aluminium composite and glass curtain wall used on the exterior hides the entire exterior wall and structure of the hotel as seen in Figure 15.a-b. At figure 16.a-b. the hotel can be seen before and after the earthquake (GIO, 2023).

Figure 15.a-b. Exterior image of the hotel after renovation (GIO, 2023).

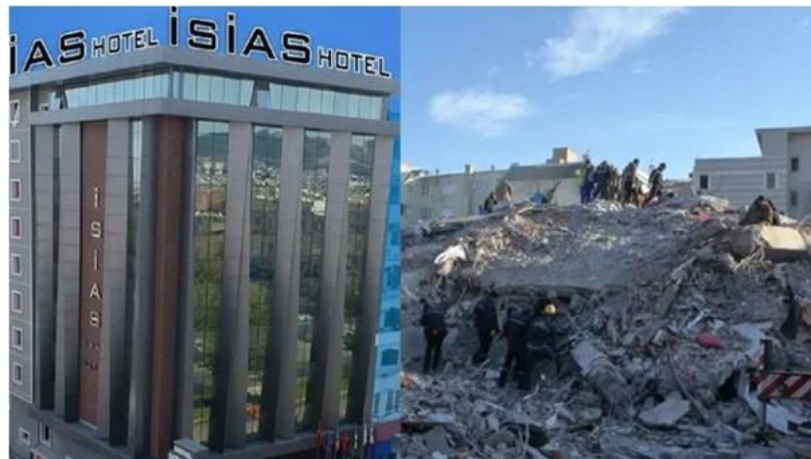
Figure 16. a-b. GIO before and after the earthquake (GIO, 2023).
