An Overview of Historical Traditional Wooden Structure Conservation Techniques

Abstract

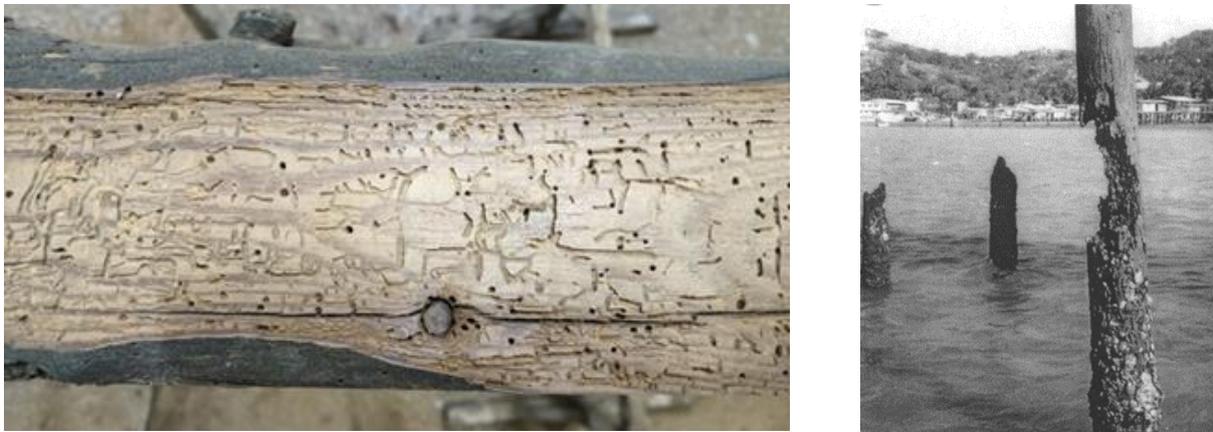
Figure 1. (a) Flight holes created by insects at the wooden beam; (b) Port Moresby, Papua New Guinea: CCA-treated hoop pine pilings destroyed by infestation in the intertidal zone by *Sphaeroma triste* [11].

The damage caused by marine species on wooden elements has become visible since wood, especially wooden poles, were used on beaches. Although the spoilage of wooden poles can be mitigated using certain preservatives, the problem of spoilage still persists. The wooden element parts under the sea are mostly invaded by marine borers. More specifically, the wooden elements in the mild sea are severely damaged by these marine species [14]. A relevant study by Cragg [11] noted that wood-boring isopoda from the Limnoriidae family constitute a significant threat against the wooden elements in mild waters, while Sphaeromatidae threaten the wooden elements in tropical waters (Figure 1b). According to that study, the dimension of the damage caused by the aforementioned crustaceans and wood-boring crustaceans with double shells (shipworms and *Martesia*) depends on the environmental conditions. Contrary to shipworms, the attack of these crustaceans can be easily detected even in the early phases [11].

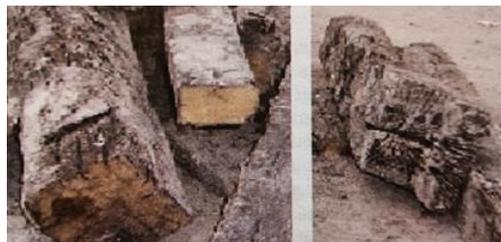
Figure 2. Cross sections of water-logged hardwood, Yenikapı Wrecks, İstanbul [9].

Another atmospheric impact covers the effect of water and moisture. Presence of water and moisture plays a significant role in the distortion of wooden element. The contact between water and wood directly affects the strength and dimensional traits of wood. Moreover, coexistence of water and suitable temperature makes wooden elements a convenient place for certain organisms to survive [8]. The study by Erdin [9] reported in regard to the devastating effect of water that distortions were present on the surfaces of wooden elements extracted from sunken wrecks or the soil even in the oxygen-free environments, adding that these distortions were not in the inner parts of wooden elements. The external sections of the wooden elements extracted from the İstanbul Yenikapı wrecks suffered severe distortions due to the aquatic effect, and the internal part of the elements had a solid section with a solid core (Figure 2) [9].

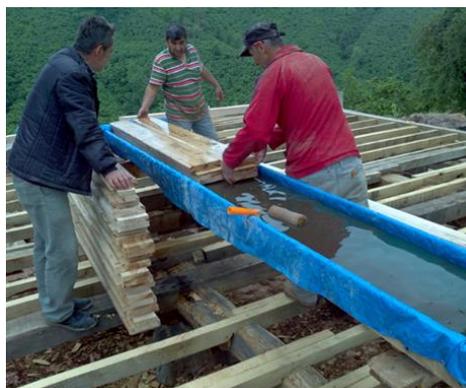
Figure 3. The procedure of impregnation done on new wooden elements to be used for restoration[20].

A clear example of impregnation procedure performed on historical traditional wooden structures can be seen on Kutluca Mosque in Perşembe, Ordu, Türkiye. Having undergone a restoration process in 2015, this mosque consisted of wooden elements that were impregnated through immersion (Figure 3). Relevant cases where wooden elements were processed through impregnation can be seen in the repairing activities performed with chemical preservatives in Türkiye since the impregnation method is practical and easy to use. Therefore, it is safe to state that practicality and ease of use is a major criterion considered while selecting a wooden structure conservation method.

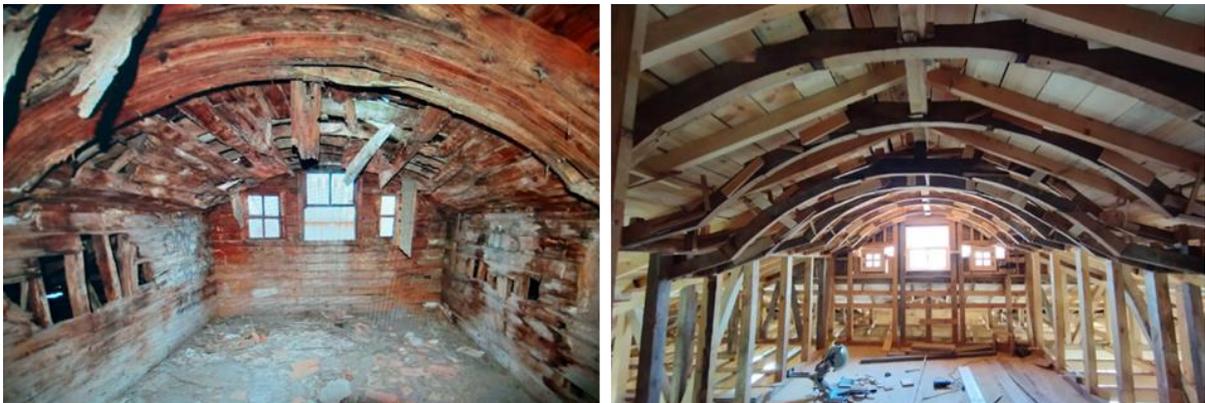
Figure 4. Complete replacement on the historical wooden roof that is still being restored [23].

One of the complete replacement efforts performed on historical traditional wooden elements can be seen on Selimiye Mansion which is present in Ordu and still being restored now. The load-bearing capacity of authentic wooden elements was reduced due to the large amount of decay on the wooden elements of the roof which, therefore, was repaired with new wooden parts (Figure 4). Complete replacement was also performed on the load-bearing wooden studs present outside the structure. Moreover, decaying studs were replaced with the new wooden ones. The wooden elements that had a physical contact with the ground in their original form no longer touched the surface since a metal plate was placed between the rock on the ground and the wooden pieces. Therefore, repairing was conducted by fixing the wooden elements to the metal plates (Figure 5).

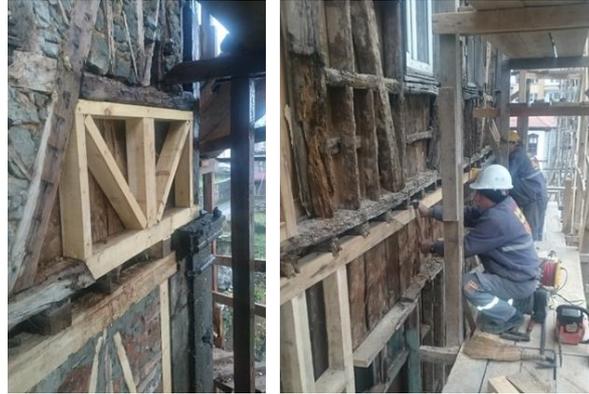
Figure 7. Partial replacement in the historical and traditional wooden carcass wall system [25]

One of the partial replacement procedures performed on historical traditional wooden structures can be seen in the restoration efforts made for the historical wooden buildings in Zeytinlik Neighborhood of Giresun. The decaying wooden elements in these structures were removed and replaced with the new wooden elements to conserve the authentic junction details (Figure 7). Accordingly, it is safe to state that wooden structure conservation procedure is an essential method to ensure the authentic wooden sections and junctions are protected and maintained.

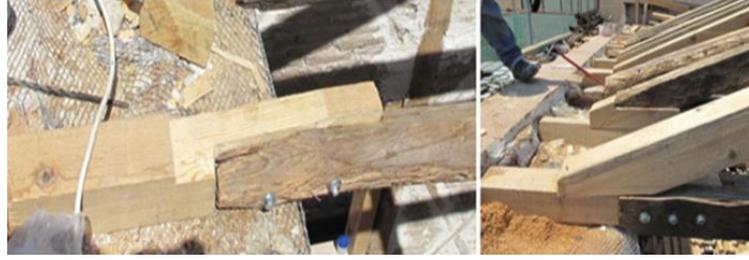
Figure 9. Prosthesis application with steel screws [30]

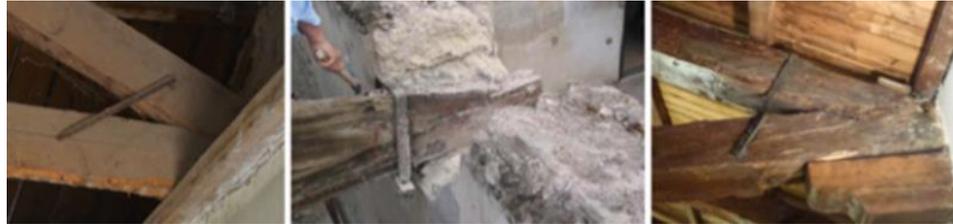
Figure 10. Prosthesis application with traditional steel straps [30].

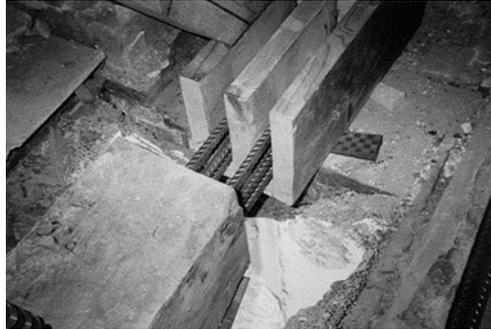
Figure 11. The decayed beam end is removed, and the prefabricated softwood replacement beam end is nearly in position. Reinforcement bars are placed in holes drilled in the existing oak [21].

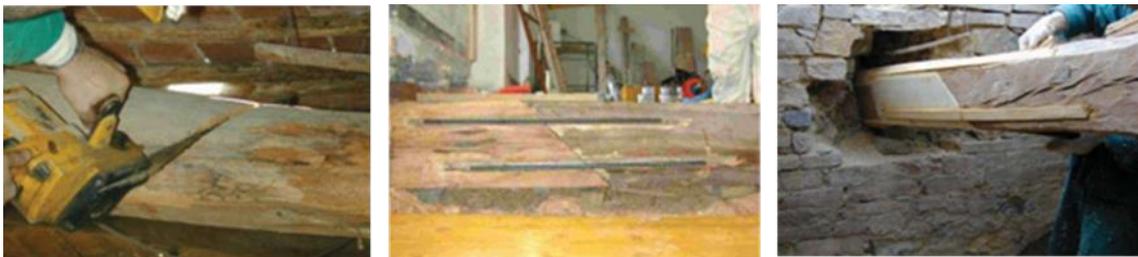
Figure 12. The beam end prosthesisation effort made with FRP rods are performed in the following order: inclined cut of decayed end, linking grooves and insertion of a final wedge [31]

The prosthesisation procedures performed with FRP elements are classified as modern reinforcement techniques in the literature. FRP rods are mostly used in the prosthesisation of beam ends (Figure 12) [31].
