Evaluation of Methods and Materials on Examples of Restoration for The Disabled

Abstract

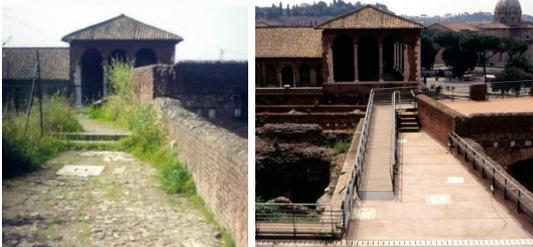
<p>Figure 1. Transformation of Biberatica street (left; before, right; after) (MA) [14]</p>	<p>Figure 2. Whitby Abbey steel and timber balustrade (MA) [15]</p>

Ramp	The surface must be coated with a smooth, stable, enduring, and slip-resistant material that performs effectively in both wet and dry conditions [11].	Portable; steel, iron ramps Ramps added using flooring material There are ramp samples applied with concrete coating.	Figure 1 Figure 4 Figure 5 Figure 6 Figure 7 Figure 8 Figure 9
Doors	To facilitate effortless detection, it should not align flush with the wall and should feature a contrasting color that distinguishes it from the surrounding surfaces. Additionally, sensor-activated lighting is the preferred choice for entrance doors, and thresholds should not be installed on the doors [11].	There are sensor mechanisms applied to wooden doors. Door width is one of the problematic areas in historical buildings. At this point, there are examples where the door passages are widened or both wings of the doors are used.	Figure 22 Figure 25

<p>Floor Coverings</p>	<p>All pedestrian pathways should be level, stable, long-lasting, and surfaced with slip-resistant materials that perform effectively in both wet and dry conditions. The anti-slip characteristics employed in these areas must conform to the standards outlined in "TS 13882-Classification Rules of Pedestrian Walking Surfaces: Basic Requirements and Evaluation Methods." [11]. In general, any type of upholstered seating with cushions can pose significant challenges for individuals using wheelchairs, walkers, or maneuvering with other mobility constraints [35]. Tactile ground and guide tracks are manufactured in compliance with the Construction Materials Regulation and its fundamental requirements, as officially published in the Official Gazette No. 24870 on September 8, 2002 [11].</p>	<p>Solid or engineered hardwood: Hardwood floors have several advantages over other floor types that make them well-suited for handicap accessible applications. Hardwood can be reprocessed if scratched, which is common when using wheelchairs or walkers. Hardwood floors are also very easy to maintain. This tissue can help prevent slips and falls [12].</p> <p>Ceramic tile Floors: Tile is an easy and very durable option for wheelchair use. Textured, non-slip tile is a great option for the disabled accessible home [12].</p> <p>Sensible ground and guide tracks: Plastic, Thermoplastic Polyurethane (TPU), stainless steel, stone material is used. It can be adhered to the ground with strong adhesives, applied as a paving stone or fixed to the floor with screws.</p>	<p>Figure 1 Figure 3 Figure 4 Figure 9 Figure 23 Figure 24 Figure 25 Figure 33 Figure 34</p>

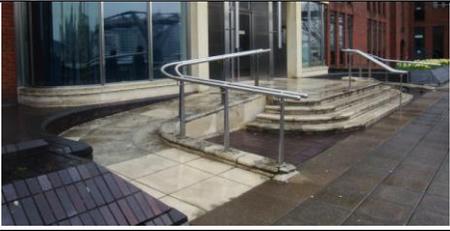
<p>Figure 3. Example of disabled ramps and stairs with iron railings and wooden flooring- Trajan's Market (MA) [14]</p>	<p>Figure 4. London School Disabled Ramp(MA) [16]</p>

Stair	<p>Escalators are not deemed as an accessible solution. Additionally, spiral staircases are considered non-accessible due to their challenging usability. In the case of buildings open to public use, excluding those with specified uses according to legislation, all staircases must be equipped with tactile warning surfaces at both the beginning and end of the stairs [11].</p>	<p>Steel stairs Concrete stairs covered with flooring material Escalators are used, but escalators are not considered an accessible solution.</p>	<p>Figure 3 Figure 11 Figure 12 Figure 13 Figure 16 Figure 20</p>

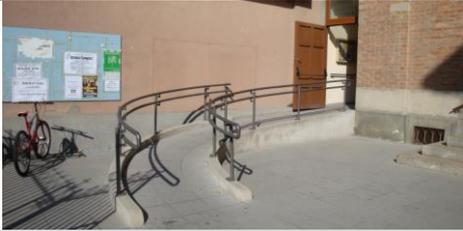
<p>Figure 5. Barnabati Church Disabled Ramp (MA) [16]</p>	<p>Figure 6. Carmine Church Disabled Ramp (MA, EQ) [16]</p>

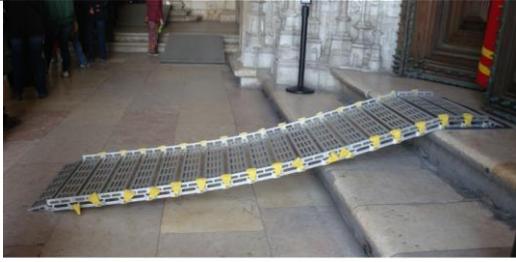
<p>Figure 7. St. James of Piccadilly Portable Disabled Ramp (MA) [16]</p>	<p>Figure 8. Mosteiro dos Jeronimos in Lisbon steel portable disabled ramp (EQ) [16]</p>

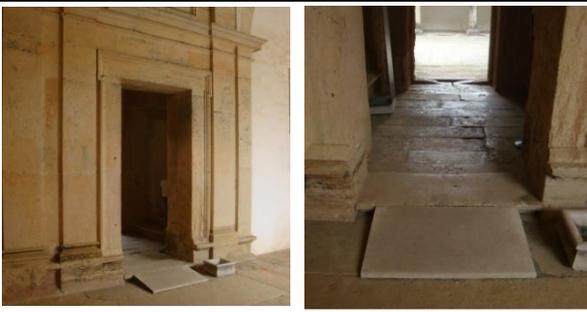
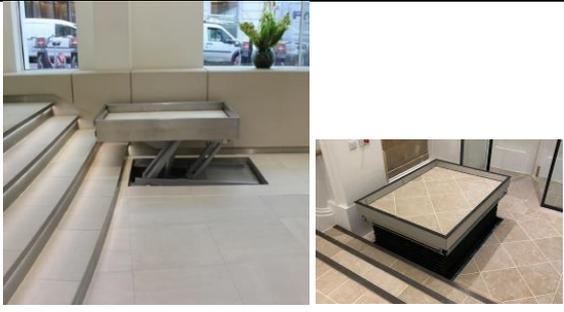
<p>Figure 9. Ramp created indoors using flooring material (stone) from Convento de Cristo, Portugal (MA) [16]</p>	<p>Figure 10. Concealed scissor platform disabled lift (EQ) [17] [18]</p>

Disabled WC	<p>Accessible toilets, including their entrance, maneuvering space, and all accompanying fixtures, are designed to ensure safe and comfortable use for individuals with mobility restrictions. One of the fundamental principles in the design of accessible toilets is the provision of a maneuvering area with a minimum diameter of 150 cm, excluding the toilet bowl, sink, and fittings [11].</p>	<p>The colors of equipment such as faucet mixers and grab bars employed in disabled toilets may differ, with adjustments tailored to the specific attributes of the building in which the installation takes place. Toilet bowls and sinks, on the other hand, adhere to standard specifications and are installed accordingly.</p>	
Elevator	<p>Multi-story buildings are required to have elevators to guarantee accessibility. The installation of accessible elevators in all publicly accessible buildings is mandated by relevant legislation. In the case of residential buildings, it is compulsory to incorporate accessibility features in elevators based on the number of floors specified by the legislation [11].</p>	<p>Glass elevators are preferred because they have the least effect on the facade. There are examples applied using facade cladding (wood, aluminum etc.) In addition, disabled lifts and mobile stair climbers are used.</p>	<p>Figure 10 Figure 13 Figure 14 Figure 15 Figure 17 Figure 18 Figure 19 Figure 20 Figure 21 Figure 27</p>

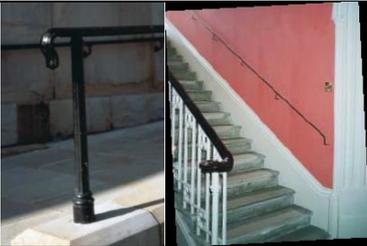
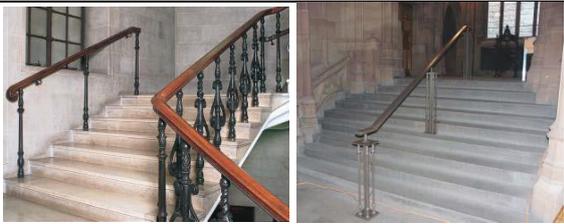
<p>Figure 11. Iron handrail (MA) [16]</p>	<p>Figure 12. Wooden and aluminum handicapped handrail (MA) [13]</p>

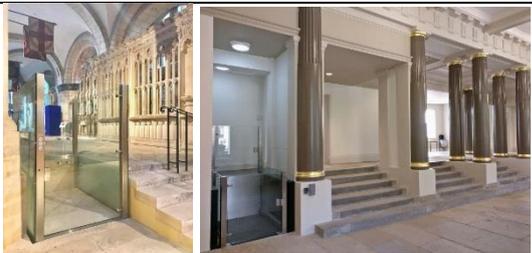
<p>Figure 13. Winchester Cathedral disabled stairlift (EQ) [19]</p>	<p>Figure 14. Disabled lift (EQ) [20]</p>

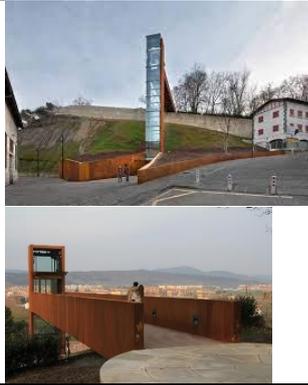
Figure 15. Media Luna elevator built using wood and glass (MA, EQ) [21]

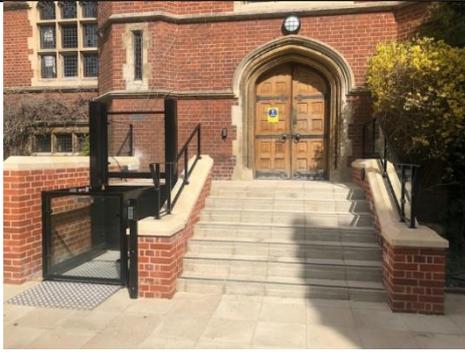
Figure 17. Disabled Lift (EQ) [18]

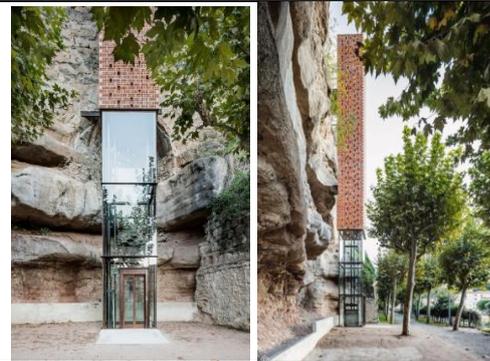
Figure 18. Gironella's Historic Center elevatör (MA, EQ) [23]

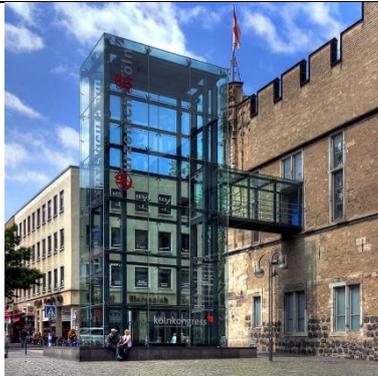
Figure 19. Glass elevator and bridge connection-Guerzenich Building (MA, EQ) [19]

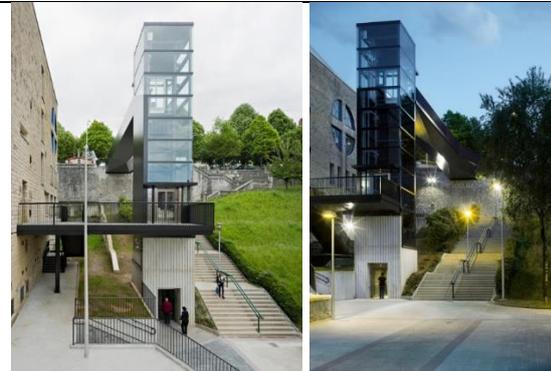
Figure 20. Elevator using Hernani, glass and composite coating (MA, EQ) [24]

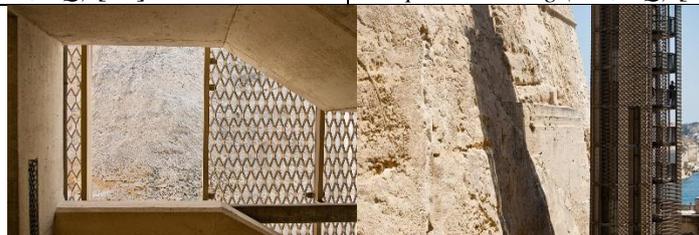
Figure 21. Close-up of elevator shaft (MA, EQ) [25]

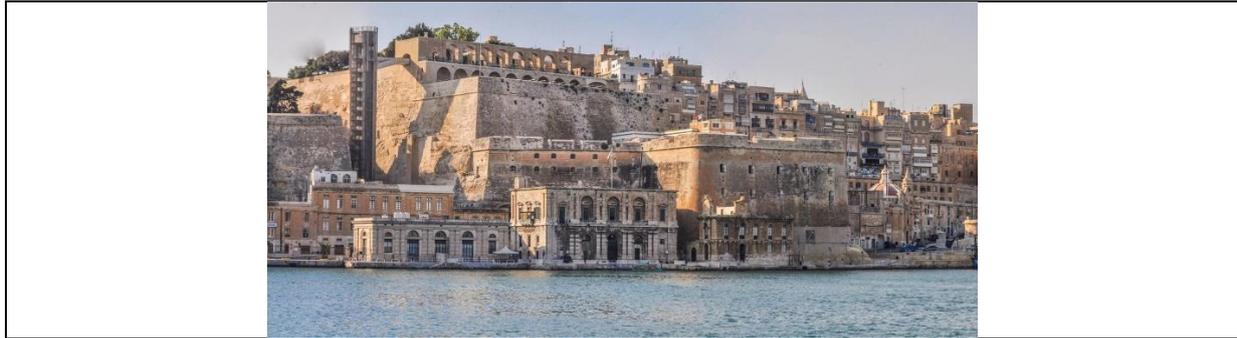
Figure 21. 20-storey aluminum-coated panoramic elevator that provides access to the walls (MA, EQ) [25]

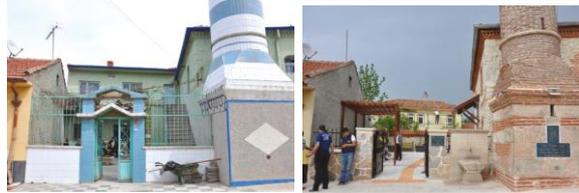
Figure 22. Entrance arrangement for the restoration of Hacı Hasan Mosque (left; before, right; after) (MA, EQ) [22]

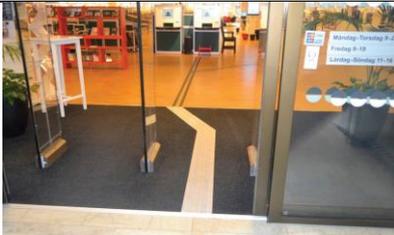
Figure 24. Sensible surface on a special production carpet (MA) [26]

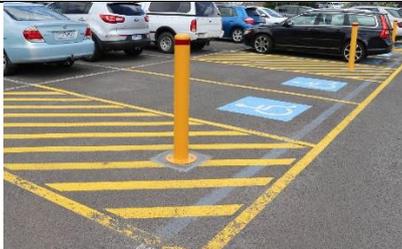
Figure 26. Disabled carparking (SI) [27]

Application area	Materials Used and Properties		Image
	Requirements	Material and Quality Used	
Carparking	Parking spaces designated for disabled individuals must feature markings that are highly visible, straightforward, easy to read, and universally comprehensible. The material chosen for these markings should possess qualities of durability, ease of cleaning, repairability, and the ability to be replaced when required. Furthermore, it is essential to shield the disabled parking area from adverse weather conditions such as snow and ice, and where feasible, provide overhead coverage [11].	The markings for the parking spaces allocated for the disabled must be visible, simple, legible and understandable for all. The material to be used for these markings must be robust, cleanable, repairable and replaceable when necessary. Disabled parking lot should be protected from weather conditions such as snow and ice, if possible, it should be covered.	Figure 26

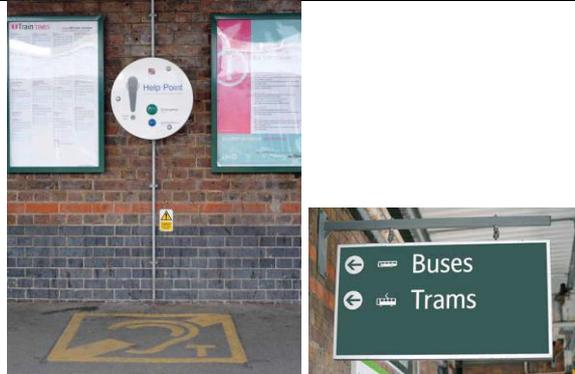
Figure 28. Sign (SI) [29]

<p>Voice Sign</p>	<p>Irrespective of a building's designated purpose, it is essential to implement an adequate quantity of directional and informative signage. Particularly in publicly accessible buildings, informative signs should be prominently displayed to caution against potential hazards, provide guidance to various locations, and ensure the safe and independent use of the building and all its facilities [11].</p>	<p>These markings and routes often cannot conform to specific standards and may require placement in various locations with different color options as needed.</p>	<p>Figure 28</p>

<p>Guidance Signboard</p>		<p>WC plates are purpose-designed products intended to provide clear distinctions and prevent confusion within male, female, and disabled restrooms. These plates incorporate universal symbols, making them universally understandable regardless of language. Magnetic WC plates are a preferred choice due to their user-friendly and aesthetically pleasing design. The front surface can be constructed from materials such as plexiglass, aluminum, or stainless steel. Their modular system allows for interchangeable parts of similar dimensions. WC sign boards are indispensable fixtures in general-use areas. Thanks to the robust neodymium magnets used in the background, these panels securely adhere to each other and resist falling when touched. Additionally, they feature a modular system that facilitates easy removal without causing damage to the underlying surface when desired or when replacement is necessary. Comprising lightweight materials, these systems can be easily installed without the need for drilling or screwing. They leave no lasting damage that would necessitate extensive surface modifications when disassembly is required [13].</p> <p>Brail embossed voice kiosks are used by mounting their feet to the floor [13].</p>	<p>Figure 28</p>

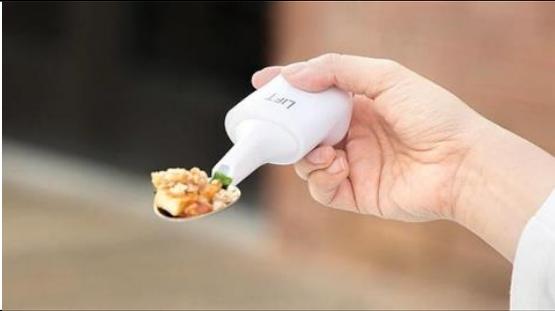
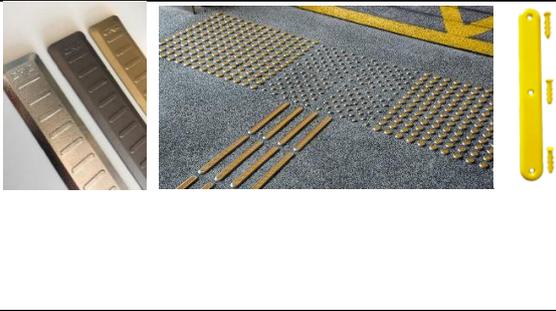
<p>Figure 32. <i>Liftware</i> (TE) [33]</p>	<p>Figure 33. <i>Steel and polyamide surfaces paving</i> (MA) [34] [35]</p>

<p style="text-align: center;">Figure 34. <i>Stone dot and line tactile paving foot path</i> (MA) [36]</p>	
<p>Material (MA), Equipment (EQ), Signage (SI), Technology (TE)</p>
