ANALYSES AND COMPARISON OF MUDBRICK BUILDING MATERIALS FROM SEYİTÖMER HÖYÜK EARLY BRONZE AGE-III AND MIDDLE BRONZE AGE

Eda TAŞÇI* - Hale YILDIZAY - Nazan ÜNAN*** - Merve Dağcı TEKİN******

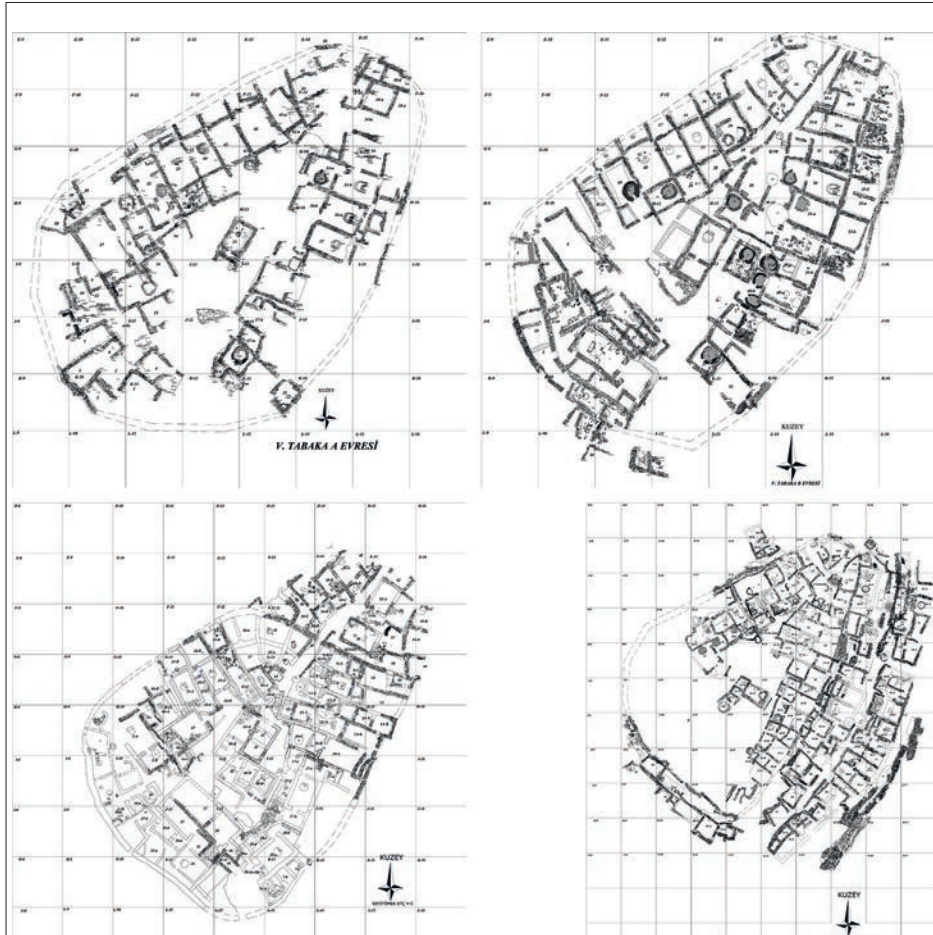
Figure 3. Plan of the levels A, B, C and D of Seyitomer Hoyuk level V / *Seyitömer Höyük V. tabaka A, B, C ve D evrelerinin planı*

The settlements surrounded by walls contain workshop spaces, religious structures, and administrator buildings. There are bull-headed hearths, dome ovens, and partitions among the interior equipment of the areas (Unan *et al.*, 2020). Figure 3 shows the plan of the A, B, C, and D phases of the Level V of Seyitömer Höyük. The use of mud brick in EBA-III (Level V) settlement

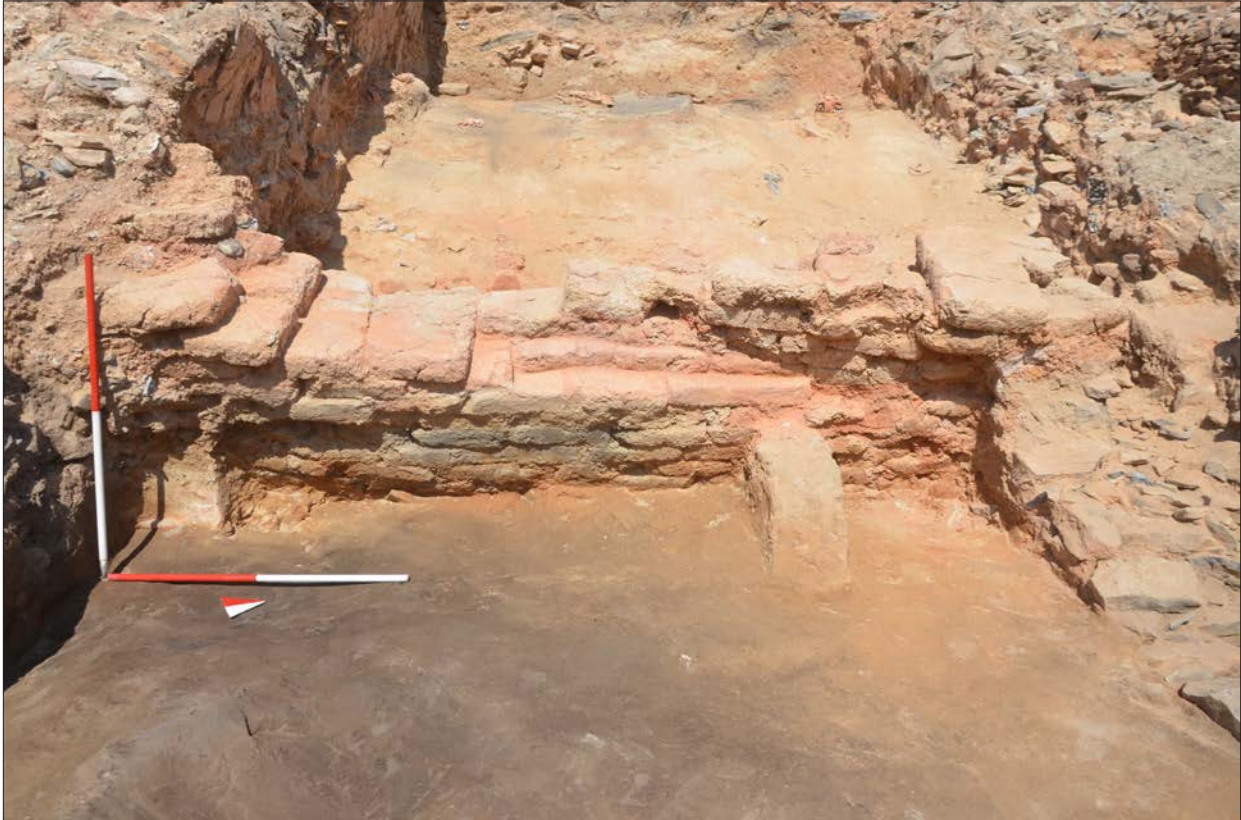
Figure 4. Seyitomer Hoyuk Phase V/D, Room 82, mud brick partition / *Seyitömer Höyük V/D evresi 82 no'lu mekan, kerpiç ara duvar.*

appears similarly in every step. In addition, in Figure 4, the intermediate mudbrick wall of Seyitömer Höyük V/D phase space 82 is seen. As seen in the photo, the intermediate wall can be used as a common wall in more than one space. The double-faced, solidly built walls are often raised with stone up to the roof.

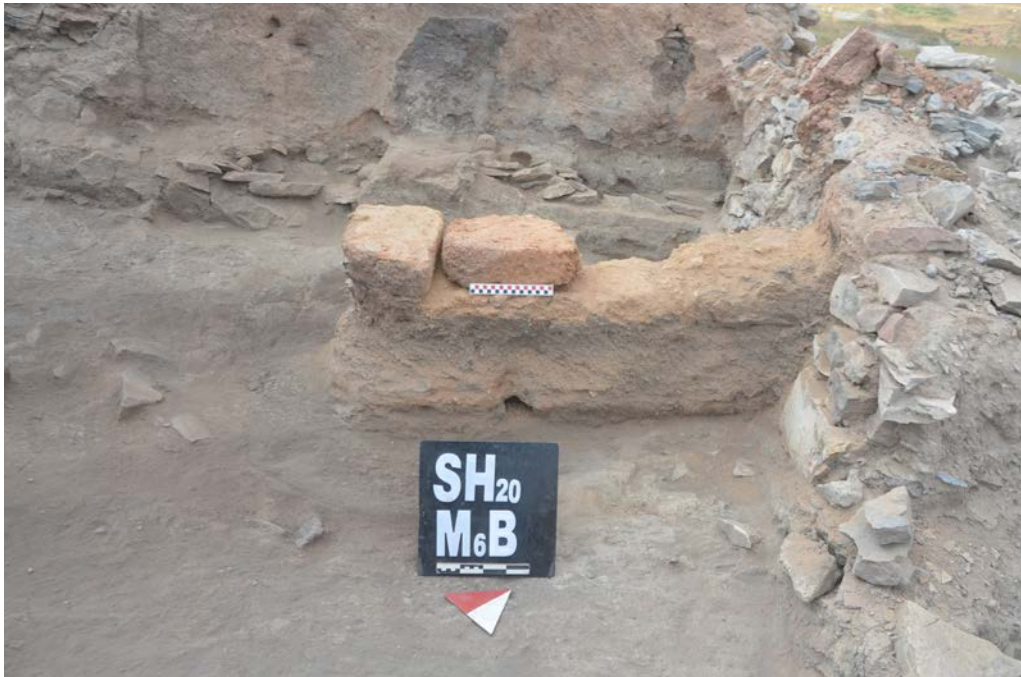
Figure 5. Seyitomer Hoyuk V/D phase mudbrick detail / *Seyitömer Höyük V/D evresi kerpiç detay.*

In phase D, one wall of the space was made of mudbrick or was used to divide a large room into two. Fig. 5 shows the mudbrick detail of Seyitömer Höyük Phase V/D (Unan, 2019). In addition, mud brick was used to create storage compartments, usually located in the corners of the spaces. In phase C, although the use of stone in the construction of the walls continues, one of the room's walls was built with mud brick, or the wall built with

stone was raised with mudbrick. The average dimensions of the mudbricks used in this phase range from 0.01 x 0.35 x 0.35 m to 0.10 x 0.40 x 0.70 m (Unan, 2013). In this phase, the use of mudbrick is more intense than in other phases (Bilgen *et al.*, 2015). In Phase B, two rooms were built with mudbrick on a stone foundation and only mudbrick was used to divide the rooms. In phase A, mud-brick piles were encountered in a few rooms.
