RELATIONSHIP BETWEEN RECONSTRUCTION AND SUSTAINABILITY WITH EXAMPLES

Article citation : Hattap, S., Tarım, A. (2023). Relationship between reconstruction and sustainability with examples. *KAPU Trakya Journal of Architecture and Design*, 3(2), 117 - 126.

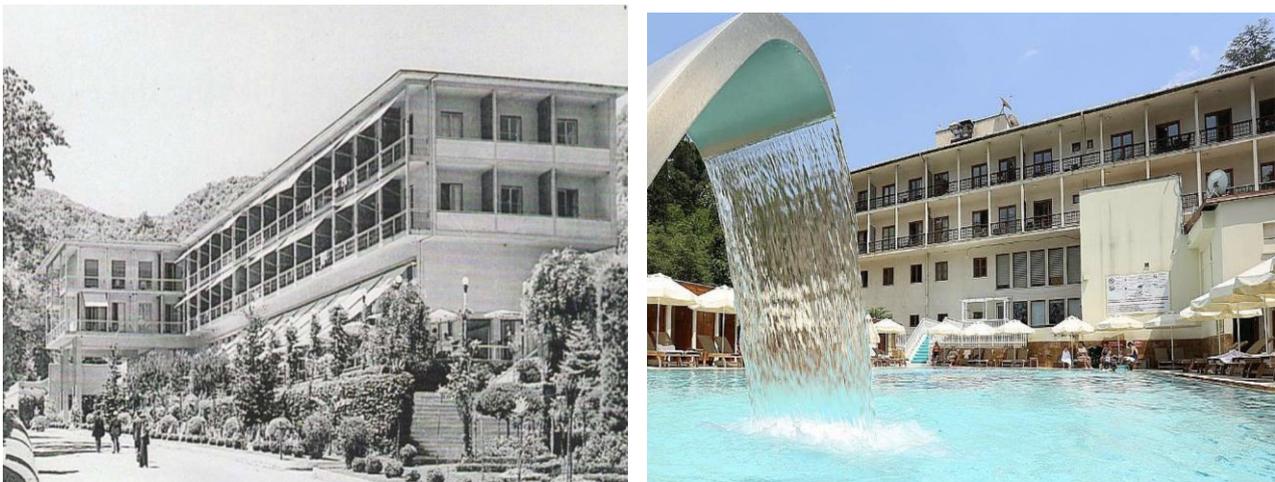
Figure 1(a, b). Yalova Thermal Hotel, 1934-1937 (Tanju&Tanyeli, 2009) before and after Reconstruction (Yalovathermal, 2023)

Yalova Thermal Hotel is considered by Eldem as "the first product of the National Architecture movement". Yalova Thermal Hotel is the first important design that Tanyeli claims to have successfully combined modernism and tradition in Türkiye (Tanyeli 2001). Thermal Grand Hotel was opened for use on January 22, 1938. Atatürk also became the hotel's first customer. The building was demolished in 1983 because it was too corroded to repair. This destruction, the reasons of which the people of Yalova question and seek answers to almost every year on September 12, has a different meaning not only because it is a structure of Sedat Hakkı Eldem, one of the most important names of the Turkish architecture scene, but also because it is seen as "Atatürk's legacy" sits on the path of discussion (Mimarizm, 2023). 30 years after the demolition of the building, it was reconstructed in accordance with its original form within the scope of first-class antiquities restoration with the support of Gazi University (Fig.1a, b).

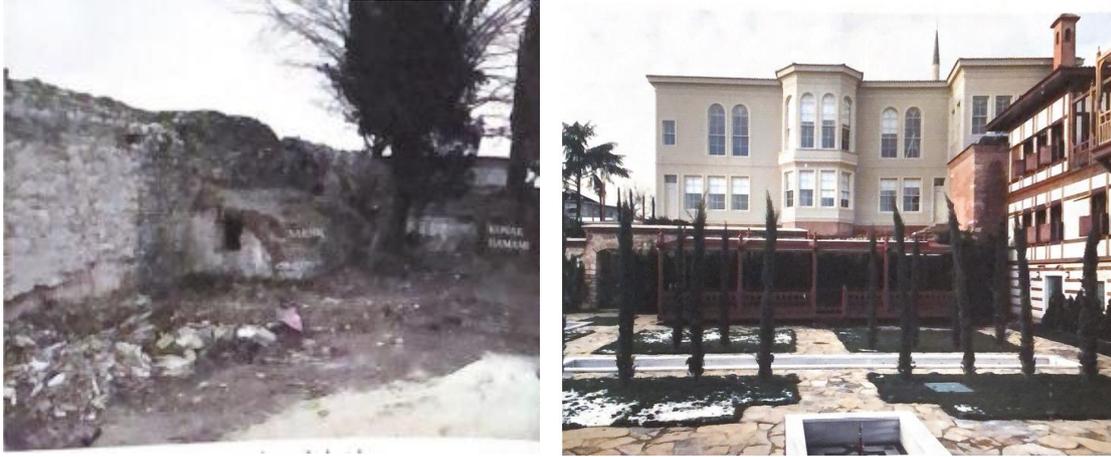
Figure 2(a, b). Tunisian Hayrettin Pasha Mansion before and after Reconstruction (Tok, 2017)

The mansion, thought to have been built in the 18th or 19th century, burned down in 1912 and became unusable. The building, which opened as a veterinary school in 1900, was abandoned after a fire. In a photograph dated 1937, the condition of the mansion after the fire was determined. A mixed system of masonry and timber was also constructed. It consists of a basement and two normal floors. From old photographs, Geo-radar scanning and archive documents, the Mansion's bath, stove, spirit level and cistern were identified and reconstructed (Fig.2a, b) (Tok, 2017).

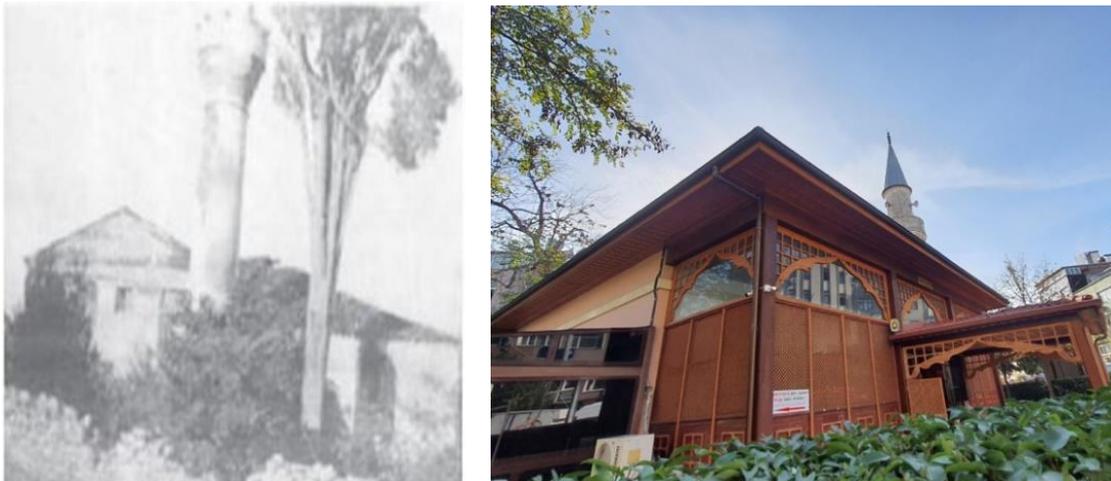
Figure 3(a, b). Visuals of Kasap Halil Mosque (Kabaoğlu, 2013) before and after Reconstruction (Tarım, 2023)

Built by chief butcher, Kasap Halil in 1547 upon request by Süleyman the Magnificent, the Mosque of Kasap Halil disappeared due to a fire, which took place in 1915 (Kabaoğlu,2013). The premises of the mosque, which is an area surrounded by shanty houses until 2006 was cleared of shanty houses because of the studies by Metropolitan Municipality and surveys and excavations were performed under the supervision of Directorate of Archaeological Museums in accordance with the decision by Istanbul Regional Board of Preservation No. IV as well as the application, made by General Directorate for Foundations in 2008. As a result of the excavations, it was observed that minaret base, main walls, and some parts of the foundations as well as the sections in Cevdet Pasha Street remained in the neighboring parcel. Building surveys were prepared following the studies (Fig. 3a, b).

Because old photographs and drawings of Kasap Halil Mosque are not available, several works such as Davut Aga Mosque, Bostan Mosque, built in the Period of Süleyman the Magnificent, were analyzed and these works were taken as an example in the construction of architectural items such as gabarite, minaret and arch.

As sufficient data and documents are not available for the reconstruction of Kasap Halil Mosque, the projects, reviewed by Regional Directorate of Preservation, were not considered to be sufficient; however, it was found acceptable to build a new mosque if ruins are preserved.

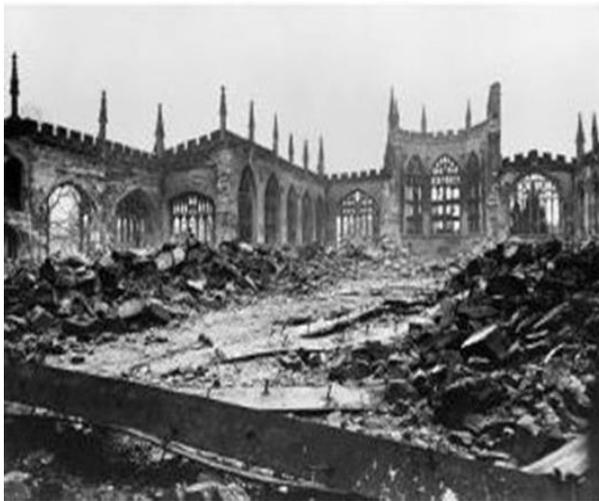
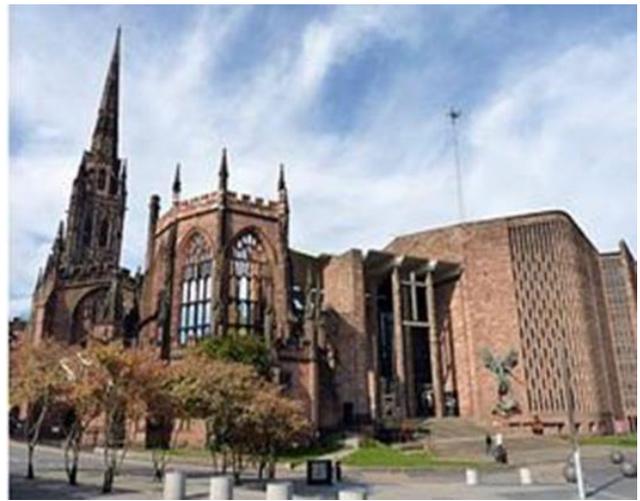
Figure 4(a, b). Visuals of Coventry Cathedral before and after Reconstruction (Fitch,1990)

The issue of how to evaluate Coventry Cathedral, only the external walls of which survived during World War II, resulted in so many discussions. As a result, it was decided that the cathedral should remain in the form of ruin, which was damaged in the war and that a church should be built near it. In this respect, slightly damaged bell tower was restored and red holystone main walls were only consolidated without a roof being unprotected. As part of the project, carried into effect because of a national competition, a new church was built in the direction of northern transept axis. Red holystones were applied on the concrete framework in the recently built church (Fig.4a, b) (Fitch,1990).

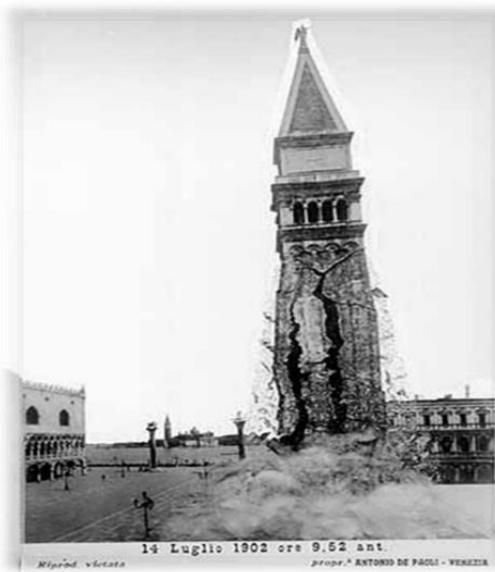
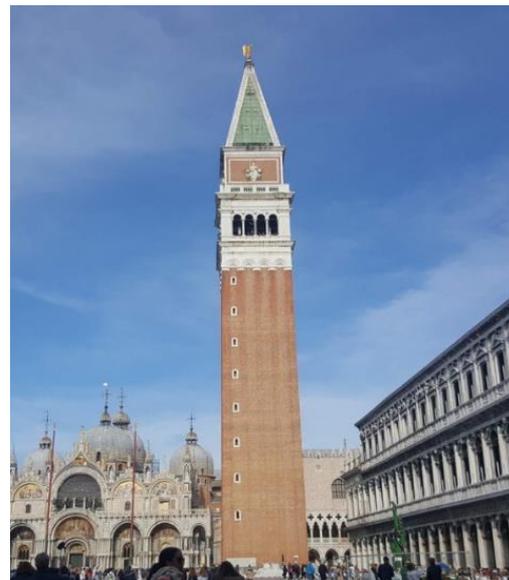
Figure 5(a, b). Venice San Marco Square before (Ahunbay,2019a) and after Reconstruction (Tarım, 2019)

Old photographs were utilized in restoration Venice San Marco Bell Tower, which collapsed due to material fatigue. One of the landmarks of Venice, reconstruction of this monument was an issue that doesn't give rise to a discussion in terms of integration of San Marco square and its immediate vicinity (Fig.5a, b) (Ahunbay, 2019a).

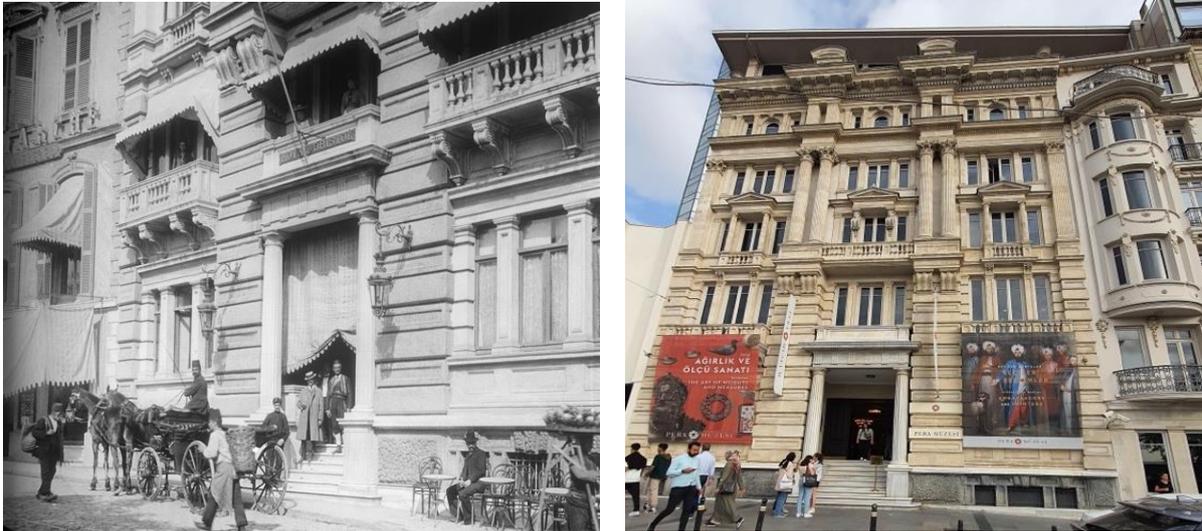
Figure 6(a, b). Visuals of Pera Museum (Pera Müzesi,2005) before and after Reconstruction (Tarm, 2023)

Pera Museum is a private museum established by the Foundation of Suna and Inan Kiraç on 8 June 2005. The building of Bristol Hotel, designed in 1893 by Architect Archille Manoussos was started to be used as a museum by preserving its front facade following the reconstruction process (Fig.6 a, b).

Bristol Hotel falls out of use over time. It was purchased by Eskişehir Bank in 1980 and was demolished, preserving only its façade. It is rebuilt as Esbank Headquarters Building (Arkiv, 2023). Since it was rebuilt by preserving only the front façade, it was evaluated within the scope of reconstruction.

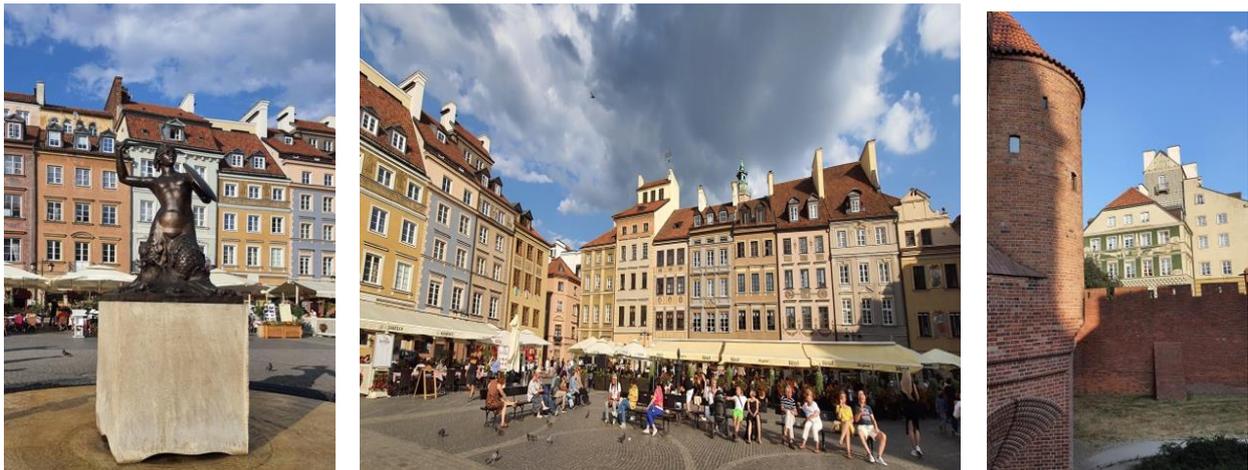
Figure 7(a, b, c). View from Historical Centre of Warsaw, Street View of Historical Centre of Warsaw (Tarm, 2023)

That the significant monuments, which bear the value of a landmark for the city and the country, were lost due to wars, earthquakes and similar disasters prepare a suitable ground for reconstruction. For instance, the monuments and the elements of urban texture, which are the irreplaceable parts of historical centers in **Warsaw (Poland)** and Münster (Germany), damaged during World War II were reconstructed or repaired as if they were rebuilt (Fig.7a, b, c) (Ahunbay,2019a).

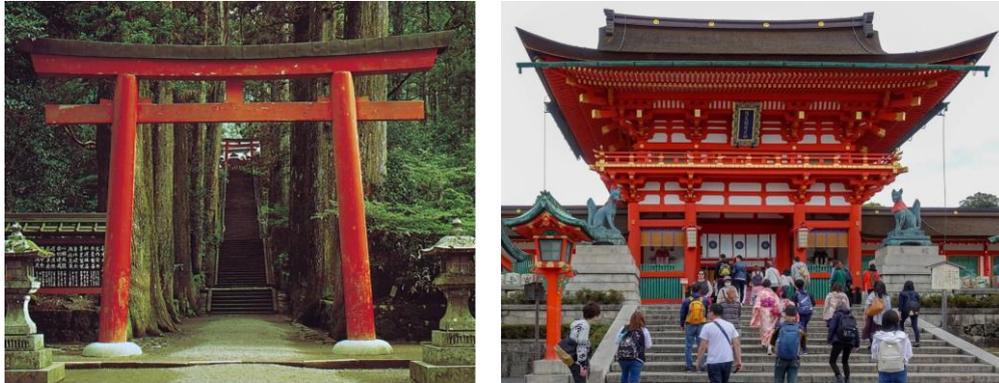
Figure 8(a, b). Shinto Shrine, Japan (Britannica, 2023, October 18)

Wooden architectural elements of **Shinto Shrine** in Japan have been treated and made with the same details in every twenty years since the first day of its construction up to now.

With this method, it was ensured that original shape and construction techniques of this shrine, which was made of Cypress that is not long lasting in humid climate of Japan, reach the present day. If this process wasn't repeated, it is probably that even no information regarding this shrine and its details have reached the present day (Fig.8a, b).

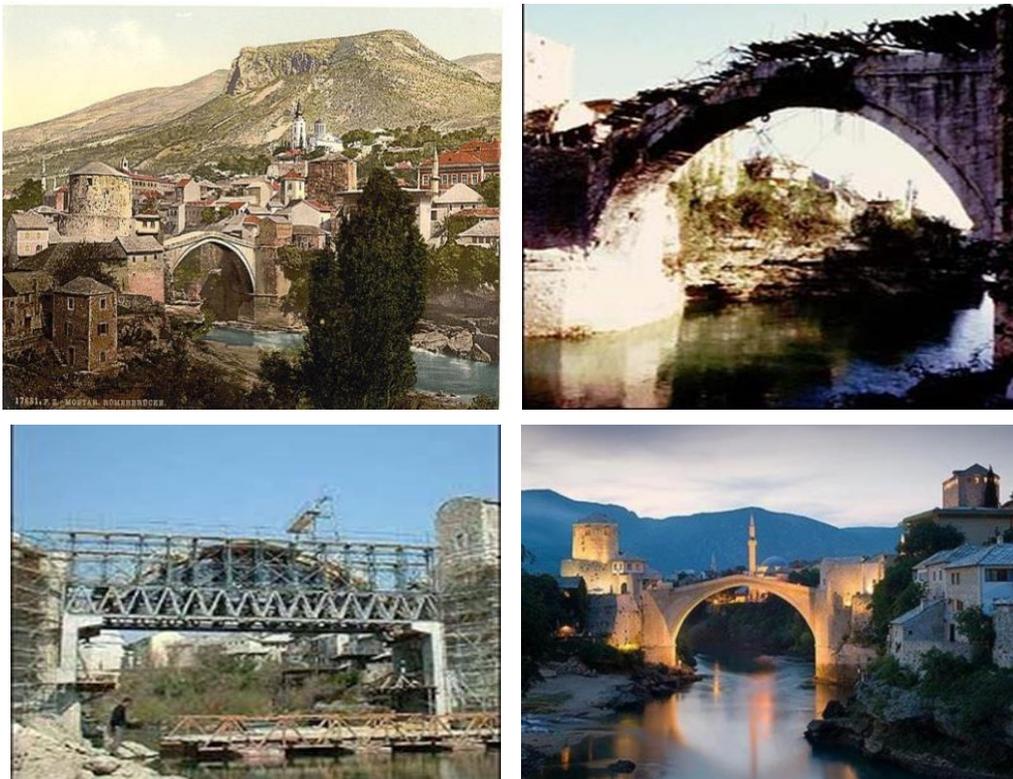
Figure 9(a, b, c, d). Reconstruction of Mostar Bridge (1781-1993-2003, 2021) (Forum/mimarlık, 2023, October 15) (Karadayı, 2022).

In the restoration work of the building, surveys made before the war were primarily used. The stones in the river were removed and numbered, and the remaining feet were reconstructed with their size and shape (Fig.9a, b, c, d) (Ahunbay,2019b).

Mostar Bridge was built over the Neretva River in 1566 by Mimar Hayrettin, a student of Mimar Sinan. However, it was deliberately and consciously destroyed during the civil war on November 9, 1993. The demolition of the bridge received great criticism because it prevented public transportation. Although a temporary bridge was built for transportation, the demolition of such an important structure was not welcomed and its reconstruction was completed in 2004 (Karadayı, 2022).

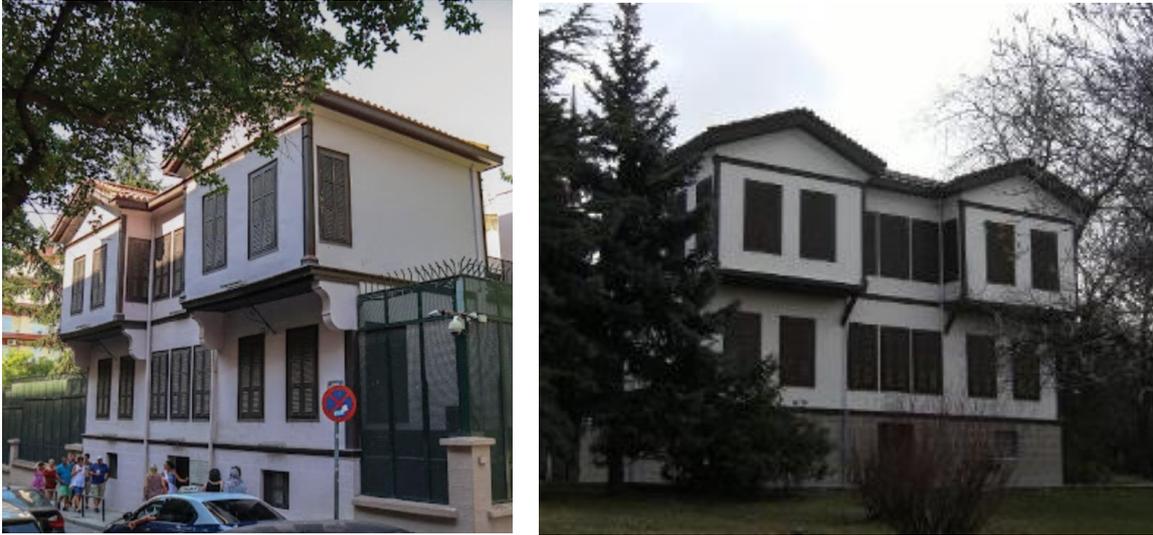
Figure 10(a, b). The house in Thessalonica in which Atatürk was born (Çekirdekgezi,2023, October 18), The Reconstructed house in Ankara in which Atatürk was born (AnkaraNet, 2023, October 18)

For instance, the replica of the house in which Atatürk was born, was carried out in Ankara in 1988 during the celebrations of hundredth year of birth. This museum building is a model that makes it accessible and that helps to visualize a special construction, original of which is outside our borders and that we all dignify it as a nation due to its relation with Atatürk (Fig.10a, b).

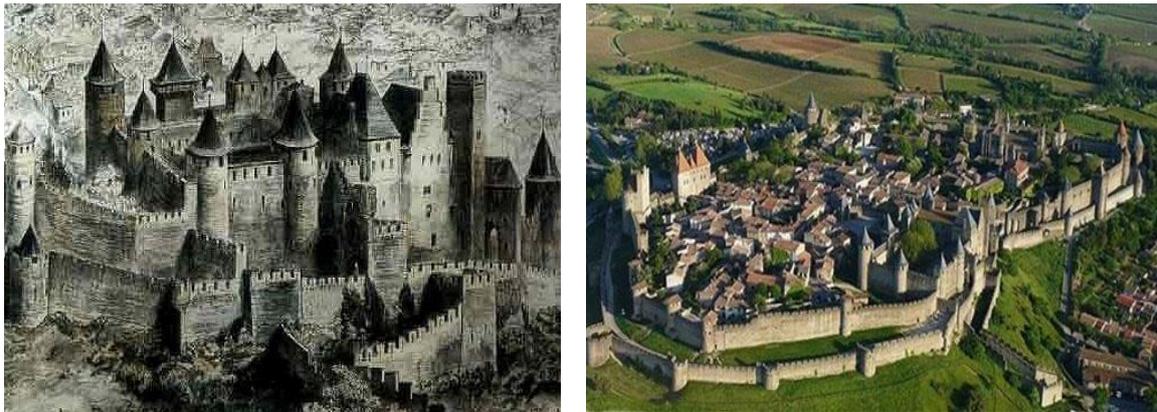
Figure 11(a, b). Carcassonne / France – After Reconstruction (Catharcastles, 2023, October 15).

Cultural heritage represents the source of cultural identity and non-renewable human assets. This consciousness, which started with the reconstruction of the city walls of Carcassonne during the reign of Viollet Le Duc, who pioneered the concept of conservation in Europe, has evolved over time and changed direction by making many developments until today, although the reasons have changed (Fig.11a, b).
