## Assessing the Acoustic Comfort Conditions of a Historical Mosque: Pergamon Great Mosque

## Tarihi Bir Caminin Akustik Konfor Koşullarının Değerlendirilmesi; Bergama Ulu Cami

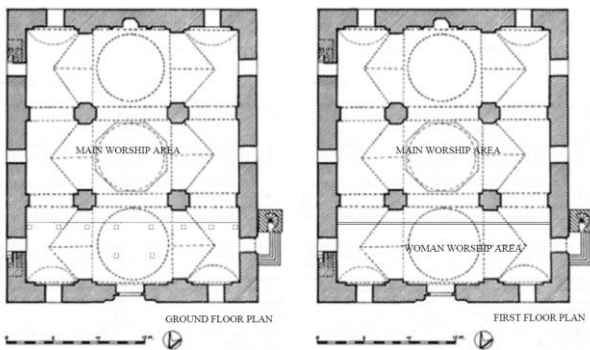
The main worship space, which has a longitudinal rectangular plan, is covered with a top cover using a

combination of domes and vaults (Figure 1). The dimensions of the plan are 21.75x 27.85 m, and the height from the floor to the pulley is 11.35m. The volume of the mosque is 6450 m<sup>3</sup>. The rectangular plan is divided into three aisles perpendicular to the mihrab wall. The three domes on the mihrab axis have a diameter of approximately 7.5 m. The height of the middle dome (4.95 m) is about 60 cm higher than the others (4.35 m). The side aisles are covered with vaults. The women's mahfil is in the southern part of the mosque and is supported by wooden pillars. It is visually separated from the main prayer hall by perforated wooden surfaces. The mimbar is made of marble, and the preaching platform is made of wood. The mihrab niche was made by using plaster. The frame surrounding the mihrab niche contains many floral motif decorations. The mosque is illuminated by non-wide opening windows (Picture 1).

**Figure 1.** The plan of Bergama Great Mosque [21]

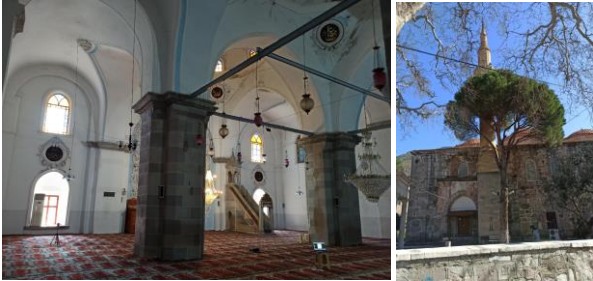
**Picture 1.** Main worship area and exterior view of the mosque

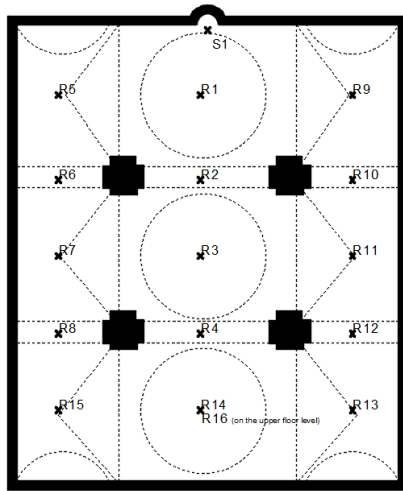
Religious rituals take place in mosques where intelligibility of speech and clarity of music are important. The rituals in mosques include the imam's sermon, the reading of the sermon, the hymn recited on important religious days and individual and collective acts of prayer. For this study, the field measurement was based on the prayer ritual and the positions and heights of the imam, and worshippers were adjusted in accordance with this scenario. The prayer ritual can be performed collectively with the congregation or individually. During the congregational ritual, the imam (the source) recites verses and suras from the Qur'an and leads the congregation in prostration, giving commands at regular intervals. Throughout the entire act of prayer, the imam stands facing the mihrab. The congregation performs the ritual, sometimes standing and sometimes sitting on their knees, in accordance with the requirements of the prayer. Objective acoustic parameter values were obtained with the acoustic field measurement performed in the mosque following ISO 3382-1:2010 [23]. Dirac Room Acoustics Software Type 7841 v.6 is used to assess the measured impulse response from receiver points. One preamplifier, one power amplifier, one dodecaedric speaker, one microphone and a microphone tripod were also used in the field measurement. A total of 16 receiver points (R1- R16) were determined for the acoustic measurement. 15 of them are located in the main worship area, and the last one is located in the women's worship area. For each receiver point, the microphone is placed at 0.85 m, considering the ear level of the worshipper sitting on the ground. The front of the mihrab was determined as the omnipower sound source point at the height of 1.50 m, considering the standing Imam position (Figure 2) (Picture 2).

**Figure 2.** Locations of the sound source and receiver on the plan view of the mosque (S1; Sound source, R1-R16; Receiver points)

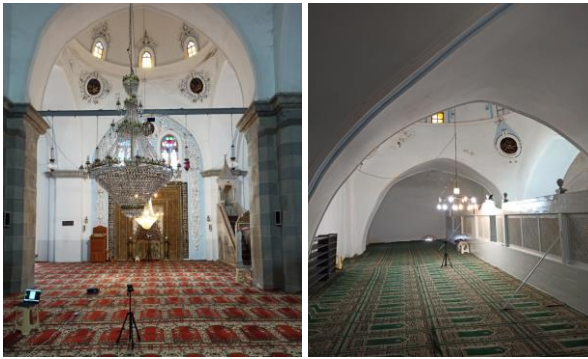
**Picture 2.** The location of R2 and R16

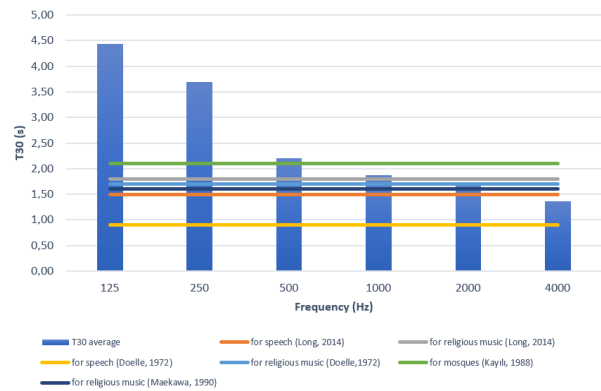
Based on reverberation time information, a quick preliminary assessment of the suitability of a space for music or speech can be made. Because of this reason, reverberation time remains one of the most valuable measurable quantities for room acoustics [24]. In this building, the average T30 value in mid frequencies is 2.04 s. The minimum value of the average T30 is 1.91 s at R6, and the maximum is 2.16 s at R7. While T30

average values are obtained close to the recommended ranges for music functions, they were found to be high for speech (Figure 3). It is observed that average T30 values decrease from low to high frequencies. This may have been caused by the fact that carpet, a material with high sound absorption at high frequencies in volume, and a different insulation layer underneath were applied to the floor, one of the mosque's most extensive surfaces.

**Figure 3.** Measured reverberation times in octave bands and the recommended ranges [10, 27, 28, 29]

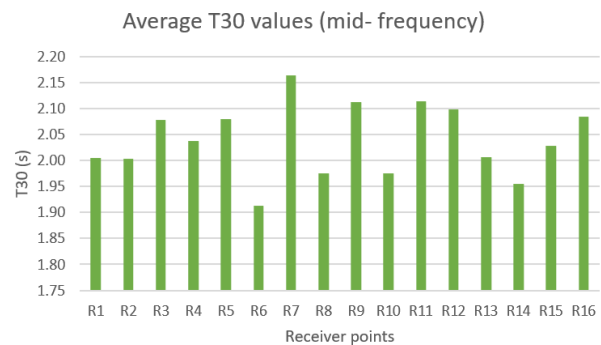
**Figure 4.** Measured average reverberation times at receiver points (R1-R16)

When the average reverberation time values according to the receiver points are analyzed, it is seen that the lowest T30 values are obtained at the receiver points (R6, R8, R10) under the arches located in the transition sections in the side sections and at point R14 under the women's worship area (Figure 4). It is thought that these differences in values may be due to reasons such as the form of the upper cover of the mosque, the height difference between the middle section and the side sections, and the fact that the transition sections are located behind the columns.

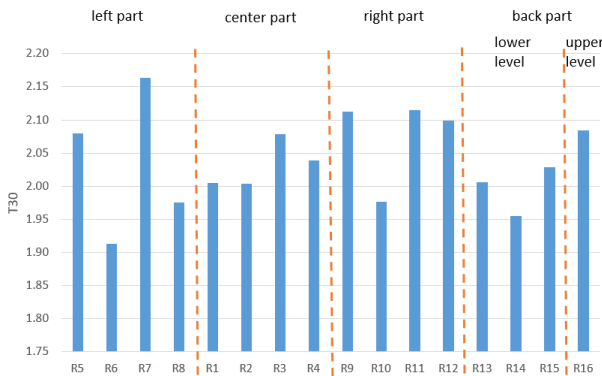
**Figure 6.** The average T30 values at receiver points

When Figure 6 is examined, it is seen that the T30 value distribution at the receiver points in the center of the mosque is close to each other and more balanced. In the left and right-side sections where the ceiling height decreases, T30 values show a more variable distribution.

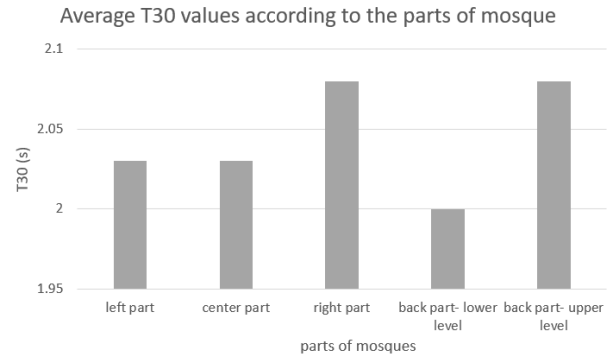
**Figure 7.** The average T30 values according to the parts of mosque

In Figure 7, the average T30 values for the four main sections of the mosque are calculated and compared with each other. According to the graph, the lowest T30 average was obtained in the back part- lower level, the highest in the right part and back part- upper level as 2.08 s, and the left and the middle parts were obtained at a value of 2.03 s. In general, as a result of obtaining average values close to each other, it can be said that the average T30 values in the parts of the mosque show a balanced distribution.

According to the measurement results, it can be said that the T30 values are high in the right section, but there is no difference that the ear can understand (JND), and in general, the reverberation times are distributed evenly in the main worship area. The use of recessed and protruding surfaces such as niches, domes and vaults on the upper cover and walls, which are common in historical mosques, distorts the mutual flat surfaces. This situation can be explained by the fact that it has a positive effect on the scattering and diffusion of sound and helps the balanced distribution of sound by creating an equivalent sound field at different receiver positions within the volume. T30 values close to each other in the center part (mihrab axis), a more irregular T30 distribution was obtained in the side stages (left and right parts). The reason for this is that the height of the side sections is less than the center section, the dome pulleys in the center section have windows and their surfaces are covered with glass, which has a high reflectivity value, and the receiver points behind the thick-section columns remain in the acoustic shadow areas, so T30 values are generally lower in the side sections than in the center section. The use of marble with high reflectivity value in the pulpit element in the right section can be considered to contribute to the increase in T30 values in that section. Although there is no difference (JND) that can be perceived by the ear between the receiver points R16 in the women's worship area covered with domes and vaults and R13, R14, R15 on the lower level, differences in T30 values were detected. The T30 value at R16 in the area covered with curvilinear elements was higher than the T30 values at the receiver points in the area covered with wood and flat surface on the lower floor. The increase in T30 values can be explained by the fact that curvilinear surfaces (dome/vault) increase the volume, and plastered

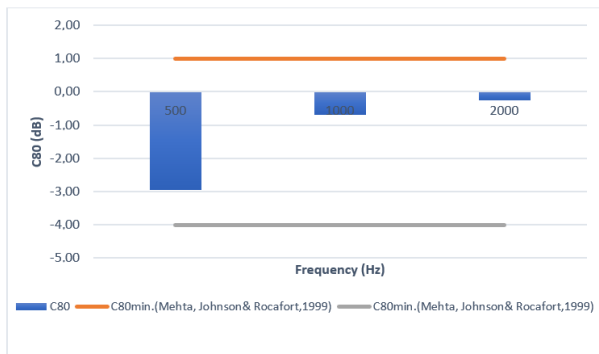
In the literature, the allowable C80 limits for listening to music at 500-1000-2000 Hz in the volumes are 1- (-4) dB [30] or 2 and (-4) range [31]. The average C80 for 500 Hz is -2.95 dB, the minimum value is -6.14 in the women's worship area (R16), and the maximum value is 5.37 dB close to mihrab (R1). The average C80 for 1000 Hz is -0.70 dB, while the minimum value is -5.49 at R16, and the maximum value is 4.89 dB at R1. The average C80 for 2000 Hz is -0.26 dB, while the minimum value is -3.94 at R16, and the maximum value is 4.92 dB at R1.

**Figure 8.** Measured clarity (C80) for 500- 1000- 2000 Hz and the recommended ranges [30]

According to the recommended ranges, the average C80 (clarity) values presented for the mosque in Figure 8 are considered acceptable. The obtained C80 values show that the desired otherworldly feeling in this mosque reaches the users. In the context of the obtained average C80 values, this mosque can be said to be able to give the feeling of being surrounded by music, which correlates with a sensation of “spaciousness”.

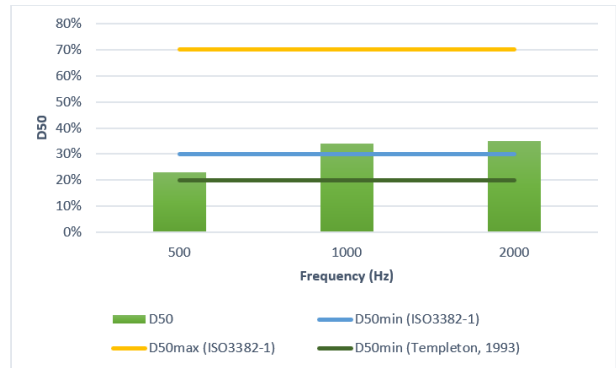
Definition (D50) is an objective acoustic parameter related to speech, and higher D50 values are desired for better speech intelligibility in the volumes. The optimal range for D50 should be between 30% and 70% according to ISO3382-1 and greater than 20% for music and speech functions according to Templeton. [23, 32]. When the recommended values and measurement results are compared, the averages are

close to the lower limit but within the optimum range (Figure 9).

**Figure 9.** Measured definition (D50) for 500- 1000- 2000 Hz and the recommended ranges [23, 32]

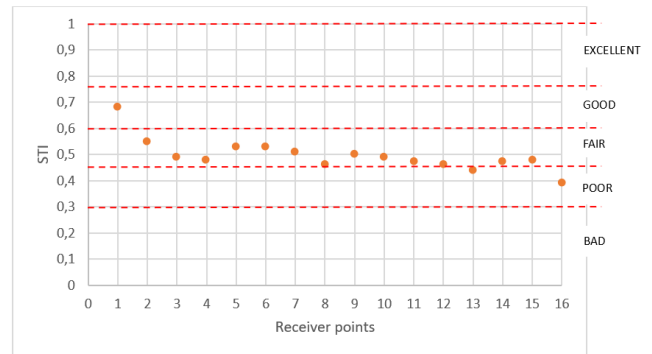
**Figure 10.** Average of STI values on the receiver points (R1-R16)

In this mosque, the average STI value is measured as 0.5, which means the speech intelligibility is considered as fair. The minimum STI value in the mosque is 0.39 at the woman worship area (R16) while the maximum STI value is 0.68 at R1 in the front of mihrab (Figure 10). STI values decrease in each

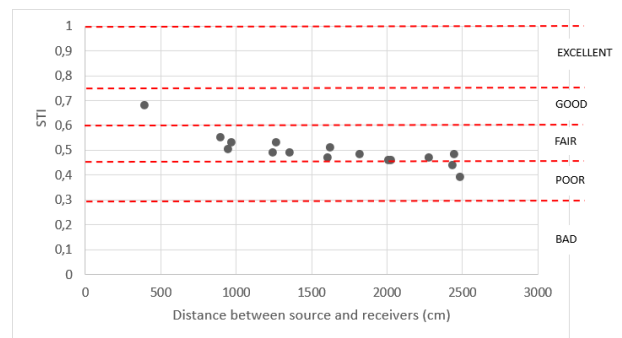
**Figure 11.** Average of STI values according to the distance to S1

corridor due to increasing distance to the source (Figure 11).

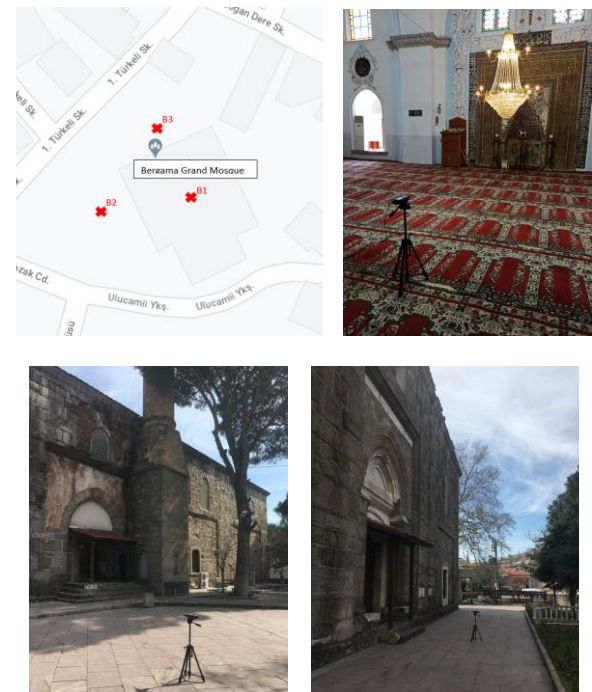
building and noise factors inside the volume (mechanical equipment, human noise, etc.). In historical mosques, the sound insulation properties of building elements such as wall thicknesses, roofs, properties of windows and doors show positive features in the absorption of environmental noise into the interior volume. It is also important to consider the sound insulation properties of these building elements in repair works of historical mosques. Therefore, A-weighted sound levels (LAeq) were measured at 3 locations (two on the courtyard, one in the building) for this mosque using the Bruel & Kjaer sound level meter type 2250. (Picture 3) Internal and external measurements were made to understand the acoustic conditions around the mosque and to reveal the effect of the building envelope on the difference between the sound level inside and outside of the mosque. The background noise levels for inside and outside of the mosque are listed. (Table 2)

**Picture 3.** The locations of background noise level measurement points (B1, B2, B3)

According to the results, the mosque's background noise level was 24.1 dBA, within the optimum range. The noise levels measured in the courtyard (B2 and B3) are very close and 47.9 dBA, 48.7 dBA were obtained, respectively. The difference between inside and outside is approximately 24 dBA. The measured values are within the appropriate range because the
