Conservation and Restoration Works in England: Conversion of Barns

Ekin ÜÇLER BİLMEZ¹, Can Mehmet HERSEK^{2,*}

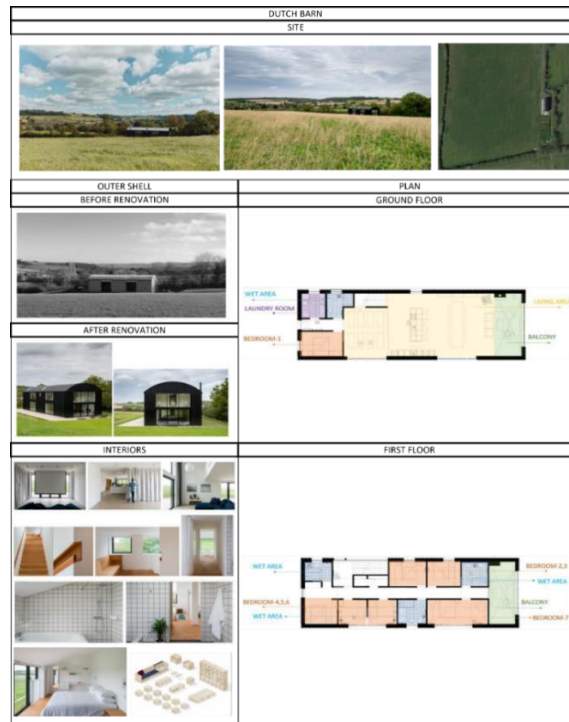
Figure5. Dutch Barn Visuals, [19], [20], [21]

The barn conversion project aimed to turn a functional agricultural building into a contemporary and spacious holiday home. Dutch Barn is located at Cotswolds, United Kingdom which is one of the largest protected landscapes in the country. The design celebrates the pure form and industrial qualities of the existing kit structure with an architectural intervention based on simplicity and minimalism that is carried through from the scale of the overall site, to the very smallest details (TurnerWorks, Dutch Barn, 2020). The outer shell was covered in matte black corrugated steel to add texture and rhythm to the building's 23-meter-tall elevation and curved roof.

The building features new openings that frame the surrounding landscape and has seven bedrooms, with six located upstairs to take advantage of the natural surroundings. Inside, the house is arranged on two floors (Figure 5). The ground floor layout is an open plan designed as a living space created for various activities. The vertical form of a double-story living space with a balcony on the upper floor is emphasized by a chimney and two-story glass.

Material used in the building include white walls and sliding doors complemented by fir wood, concrete, ceramic, and stainless steel elements. The furniture is predominantly fir with simple and clean lines and is designed as modules. Different types of elements are obtained by juxtaposing a single square module.

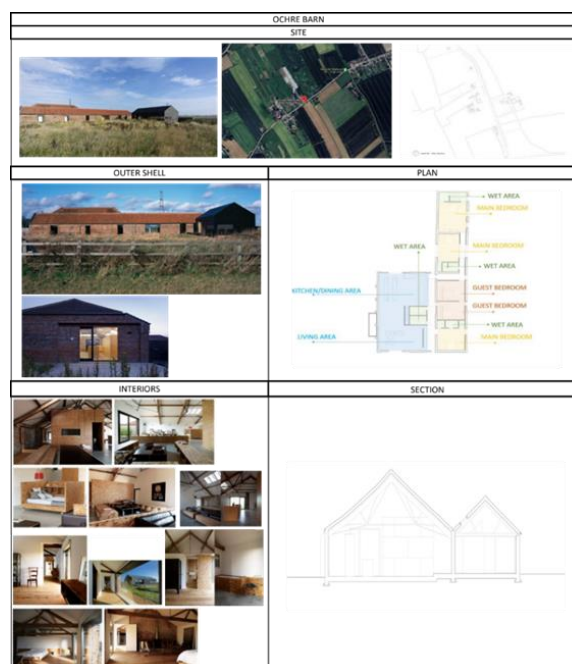
Figure6. Ochre Barn Visuals, [22], [23], [24], [25]

This barn conversion located at Walpole St. Peter, Norfolk, United Kingdom exemplifies the importance given to the preservation of the existing structure. Turner Works (2011) explains their interest on protection of the outer shell with these words on their website ‘Having seen too many agricultural buildings destroyed by over-domestication, we were keen to leave the exterior of this old barn in tact whilst transforming the interior into a flexible living space’.

The building was originally a threshing barn and has two structures, one large and one small (Figure 6). To maximize space, furniture was designed to create space within the space. The kitchen units were detached from the wall to provide more space. Large-scale designs were preferred to provide different functions using the same furniture. Recycled materials were used throughout, with OSB plates being the most preferred. The white walls dominate the interior, but there is a noticeable brick wall in the master bedroom, which continues after the white parapet in the children's room.

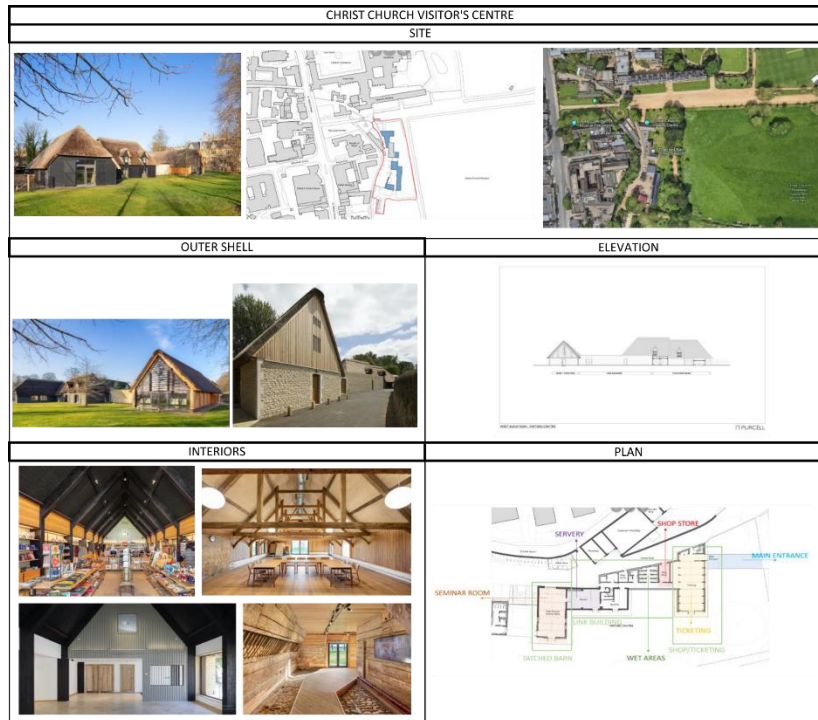
Figure 8. Christ Church Visitor Centre [28], [29], [30]

Christ Church College, Oxford, has requested that the historic thatched barn in Christ Church Meadows converted into a visiting centre. The center includes a shop and café. With the transformation, the barn gained a new function and the Priest House, which was previously used as a tourist shop, was restored. The Christ Church campus is situated adjacent to a meadow that is home to longhorn cattle and is classified as a Grade 1 listed area. Purcell (2020) defines their conservation strategy in the project as 'We simultaneously developed a design to extend the thatched barn in a way that eloquently integrated it within its historic context. Extensive consultation with stakeholders, Historic England and the local council informed the final proposals'.

Within the meadow, there is a 19th-century thatched barn which was previously used as a store by the facilities department for many years. The barn's structure has been extensively modified, with two large additions added to provide adequate space for a ticket office, shop, seminar room, and other visitor facilities. Furthermore, new work areas have been designed for maintenance and gardening activities, which are located right next to the visitor center (Figure 8). By using traditional building materials such as wood, thatch, slate and stone, the new additions were made to blend in with their surroundings. The orientation of the additions has been adjusted to help frame the view of the surrounding meadow and Christ Church.
