THE DECORATIONS OF THE TRADITIONAL TURKISH HOUSES IN DENİZLİ'S NEAR DISTRICTS

İhsan KÜRELİ¹, Kadir ÖZKAYA², Rahmi ARAS³

Keywords- Traditional Turkish houses, Denizli's near districts, Wood material, Decoration.

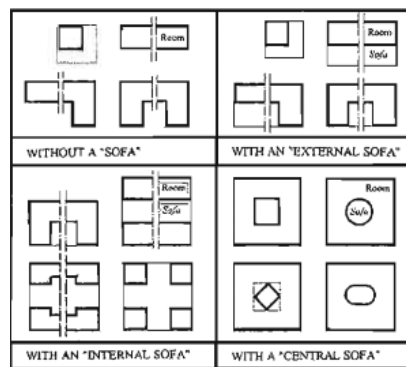
Figure 2. Plan types of the traditional Turkish houses [6 from 7].

2. Plan features: In general, plan types may be grouped into four categories according to the order in which they evolved: plans without a sofa, plans with an outer sofa, plans with an inner sofa, and plans with a central sofa (Fig. 2). The main differences between the types emerge according to the differences in the shapes and dimensions of sofas [4 from 5].

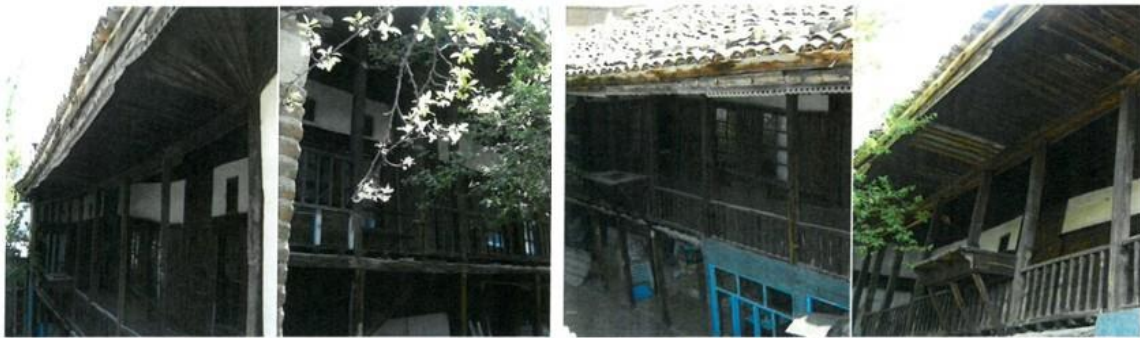
Figure 3. The general view of Ahmet Işlak House.

This house was built by Ahmet Işlak, who was the second mayor of Babadağ, in 1932 and was inhabited by him and his brother Mehmet Işlak. Now it is being used as a summer house. The house has the plan of the outer sofa type and rooms in a line. The whole structure is made of wooden material and visual quality is emphasized by a qualified and laborious carving as well as various ornaments. The house consists of two rooms, both of which having the same craved ornaments. There are two pantries downstairs, in which harvested wheat and barley crops used to be stored. The walls are made of soil-based material, and the protrusion on the front aspect of the house used to be used for dish washing and ritual cleansing of the body (Fig. 3).

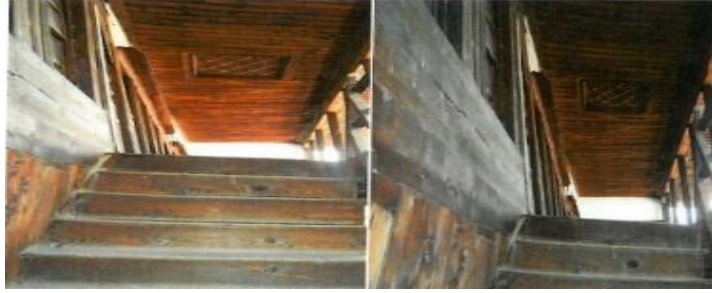
Figure 4. The staircase of Ahmet İşlak House.

The staircase made of pine wood was built to connect two storeys in the house of Ahmet Işlak (Fig. 4).

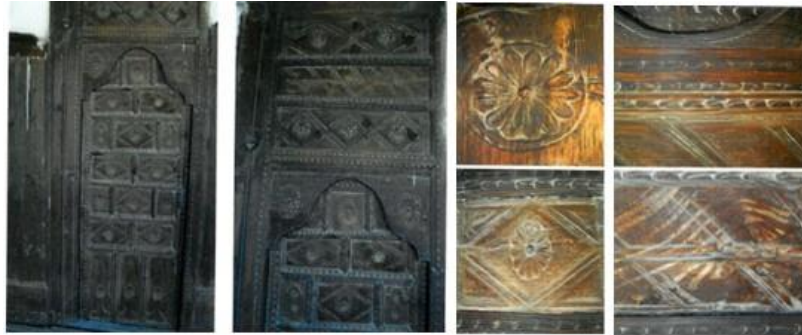
Figure 5. The door with ornaments in Ahmet İşlak House.

Rectangular door wing is incorporated with side closets and arched door frame which continues to the ceiling. Different applications of motifs are seen on the surfaces. For instance, notch carvings on the rails of frame and door leaf; quadratic and rhombus carvings on panel surfaces and flower carvings on the frame surrounding it; and finally tree of life motif on the lower part of door wing were applied (Fig. 5).

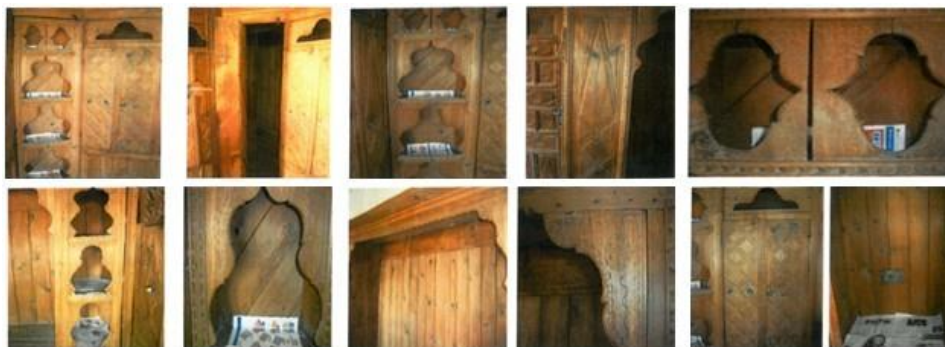
Figure 6. Closets and their ornaments in Ahmet İşlak House.

Closets were produced as winged and wingless. The racks of wingless closets are arched. Closet rails are notch-carved as in doors. 45° angle rhombi and floral motifs carved within tree of life motifs are seen on the wing panels (Fig. 6).

The external view represents a closet which has an emphasized visual appearance with open shelf systems and ornamentations, whereas the internal view represents bathrooms found in every master's and kid's rooms. Two-door closets with flower ornamentations and carvings on

the doors to create a nice appearance and open shelf with carving work above the doors and open closet system with a curvy shape at the crown, with flower figures and ornamentations on the sides can be seen in Figure 6.

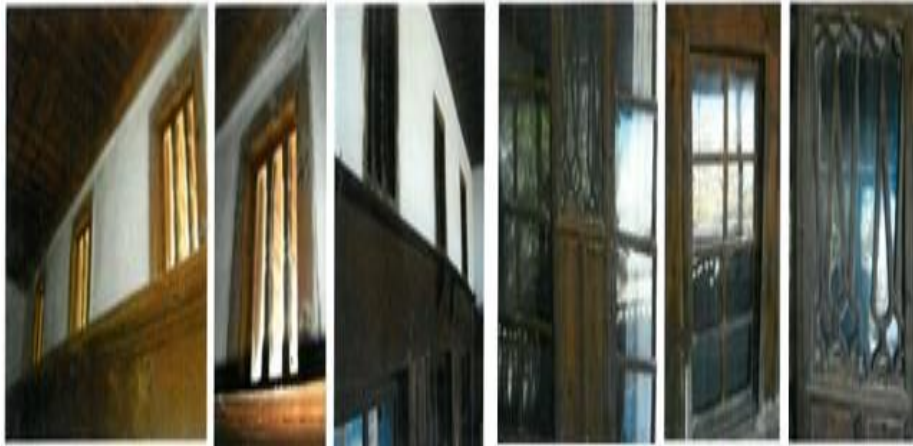
Figure 8. Windows and their ornaments in Ahmet İşlak House.

Large windows spaced with a certain distance engage attention on the “facing outward” aspect of the house. Smaller windows were placed above the others to provide more enlightenment. Laths were placed in front of the window glasses forming railings in a certain pattern (Fig. 8).

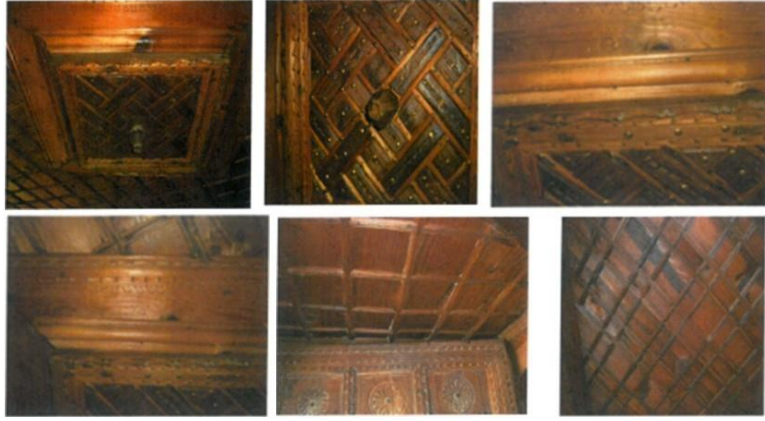
Figure 9. Centrally “Kündekari” and lattage (Çıtakari) techniques in the ceiling of Ahmet İşlak House.

Ceiling core: A nice view in the center was established by forming a ceiling rose with solid braided cords embellished with “kundekari” technique. Notching and less deep carving were applied on the corded edge bars of the square shaped central piece. In the section out of the central piece, a rich look was created with bars and lattage (Çıtakari) technique in the ceiling (Fig. 9).

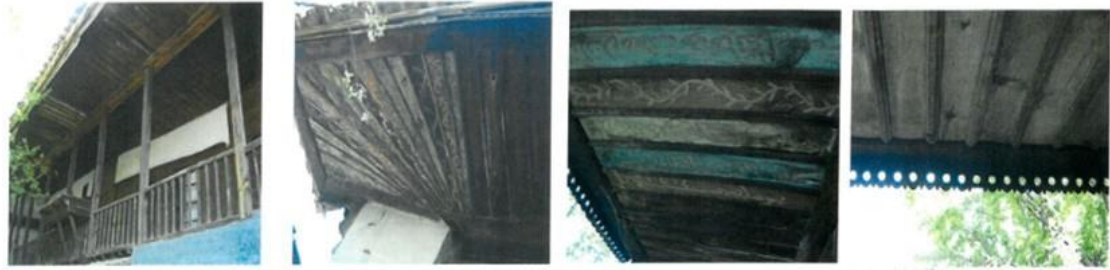
Figure 10. The eaves of Ahmet İşlak House.

Eaves were shaped in the form of a ring at the crown portion. Paintings in leaf patterns and inscription of construction date (1932) in Arabic letters are seen (Fig. 10).

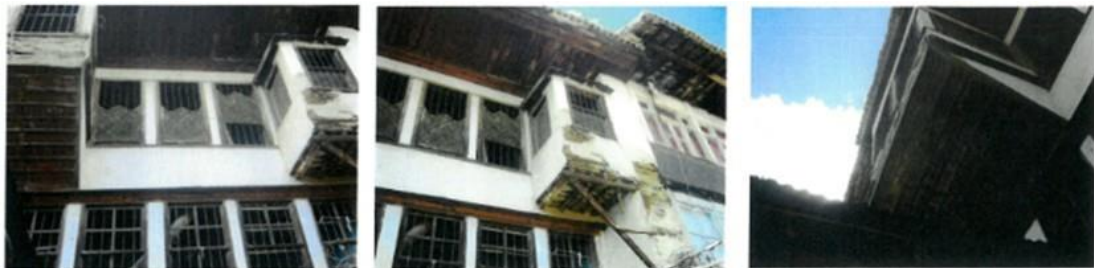
Figure 11. The general view of Ragıp Bey Residence.

This house was built in 1932. There are no houses in the house currently. The house has corner sofas, 9 rooms, 1 kitchen and 3 oriels (cumba) are found in this houses addressed to Ragıp Bey Street. Because the owner is not known, this house is called "Ragıp Bey House" with the name of the street where it is located. The three oriels, which are the characteristic feature of this house, look like closed when viewed from outside because of their localizations. Balconies open to exterior through windows which have shutters made up of wooden laths up to the mid-height. There is a toilet table with drawers integrated into the wall in the bedroom on the third floor. There are built-in closets in every room of the house. The house is now tumbledown as a result of neglecting (Fig. 11).

The house has a straight-flight staircase which can be seen when looked carefully on the left in Figure 11.

Lattice work shutters over the windows of Ragıp Bey House (Fig. 11 and 14).

Eaves were shaped in the form of covering with boards side by side. They are seen in the middle figure (Fig. 11).

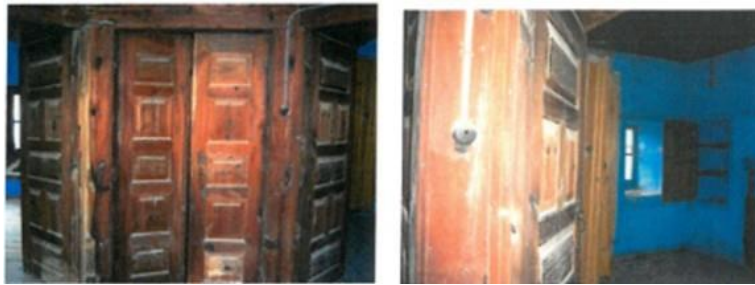
Figure 12. Raised door panels of Ragıp Bey House.

The figure below shows the main components of a traditional timber door. The whole components (rails, casements, and panels) of the door are solid wood. Raised panels are fitted into frames. It is a carpentry technique that has been around for hundreds of years. The edge of a “thick” panel or board is reduced down so that it can be fitted into a rebate in the frame (Fig. 12).

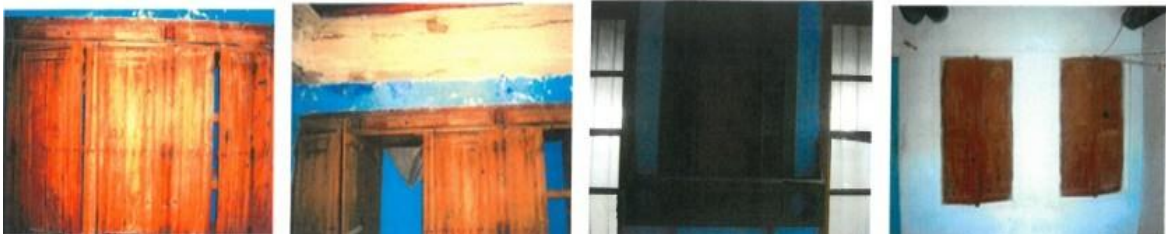
Figure 13. The closets of Ragıp Bey House.

Closets have ledged and lined wings. This basic type of door/closet consists of lining boarding which is held together by ledges (Fig. 13).

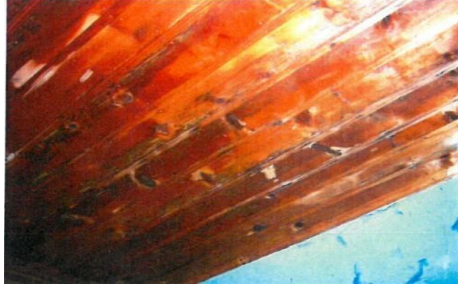
Figure 15. The ceiling of Ragıp Bey House.

This house has a flat ceiling. It is the most widely used ceiling type in the traditional Turkish house [16]. Its application is done by putting the wood pieces which have been prepared for ceiling covering side by side and assembling them with lower parts of the wooden boards (Fig. 15).

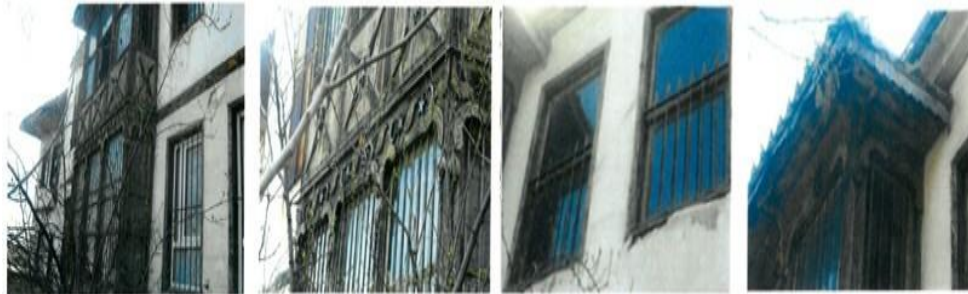
Figure 16. The general view of Talat Tarakçı House.

Talat Tarakçı served as the mayor of Buldan between 1926-1929. The house of interest was built during his mayoral term. Star and crescent ornamentations predominate on the exterior aspect (Fig. 16). This three-storey house has one front yard, one backyard and three garden entrances. Two rooms and one basement are found on the lower floor. There is a vestibule enclosed with a showcase on the mid-floor. There are 4 rooms leading to this vestibule. In the center of this vestibule there is a fountain used to cool the house in summers. A bathing cubicle is located under the stairs (Fig. 17, left). As for the top floor, there are four rooms, two on the right and two on the left side with indoors connecting them to each other, opening to the same vestibule. On this floor there is a bathing cubicle in a built-in closet (Fig. 17) and there are toilet rooms on each floor. The vestibule on the top floor has a dome-like ceiling.

The types of windows are single-hung (Fig.16 and 20).

The balcony eaves of Talat Tarakçı House are solid wood board (Fig. 16). The others are masonry.

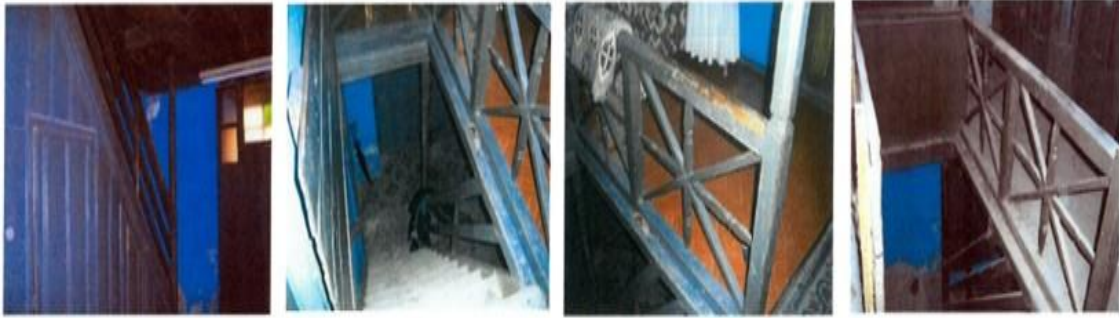
Figure 17. The stairs of Talat Tarakçı House.

The house has a straight-flight staircase with a stairwell opening cover. The balusters are adorned with superimposed cross patterns (Fig. 17).

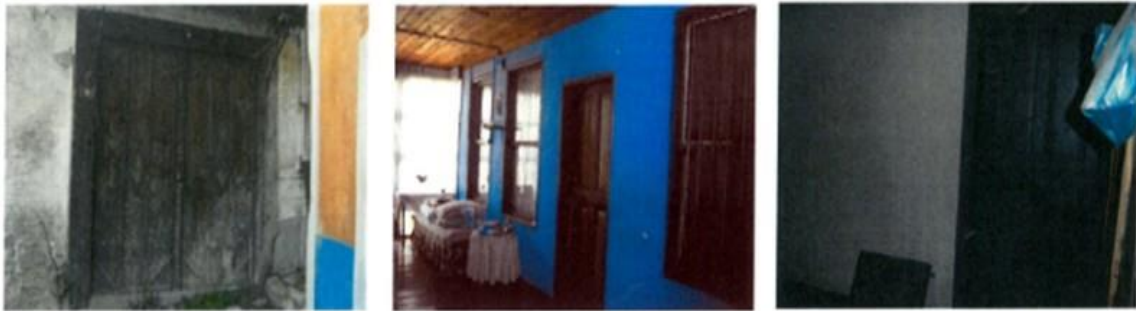
Figure 18. The doors of Talat Tarakçı House.

Outer door has ledged and lined wings. This basic type of door consists of lining boarding which is held together by ledges (Fig. 18, left). Solid wood interior door has raised panels fitted into frames (Fig. 18, middle and right).

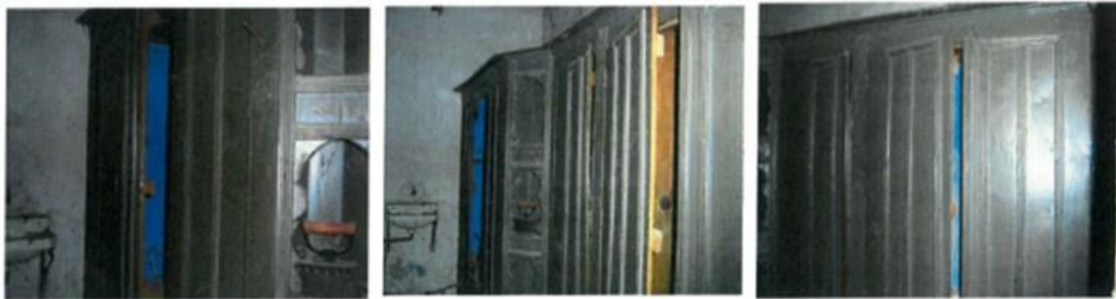
Figure 19. The closets of Talat Tarakçı House.

Closets of this house have ledged and lined doors. Frame construction was applied to the closet doors (Fig. 19).

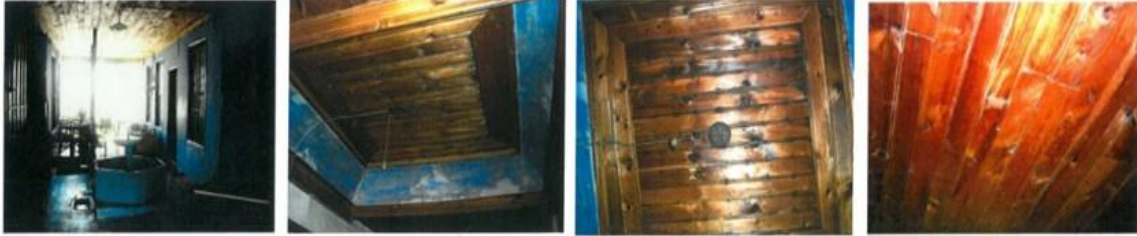
Figure 21. The ceilings of Talat Tarakçı House.

The ceilings of Talat Tarakçı House are constructed flat (Fig. 21, left and right) and dome-like (Fig. 21, middle). Dome-like ceiling structure in the middle of the vestibule on the top floor makes the vestibule more spacious. Iron sconce located in the middle of the dome-like ceiling features iron work, although not delicate.

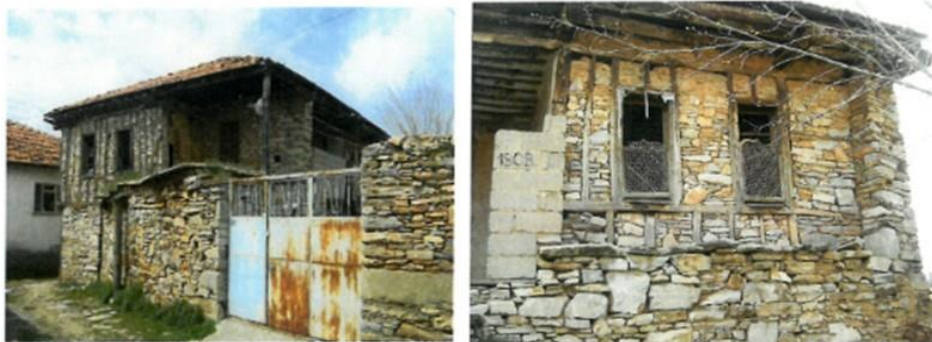
Figure 22. The general view of Mıstanlar’ House.

The construction is composed of stone walls and wooden studs (Fig. 22). The construction date is known as 1919. There are three rooms in this construction, two of which bearing doors with wood-based ornamentations.

The stairs of Mistanlar' House is made of stone slate (Fig. 22).

Eaves of Mistanlar' house are uncovered (Fig. 22).

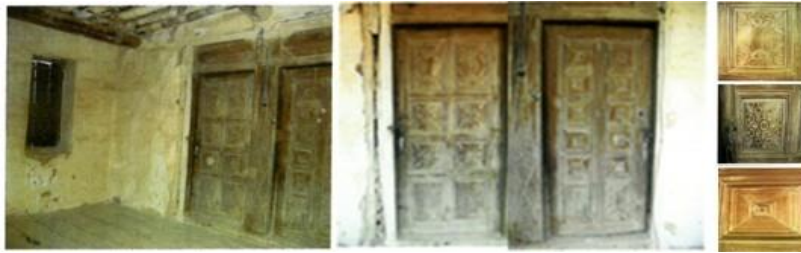
Figure 23. The doors of Mistanlar' House.

Solid wood inner door has raised panels fitted into the frames of Mistanlar' House. The tree of life motif was carved on the surface of the pillar sill between the two doors (Fig. 23, middle). Flower motif was carved on the surface of raised panels of the left door wing (Fig. 23, right middle and top). The raised panels of right door wing are constructed with 45° angle (Fig. 23, right bottom).

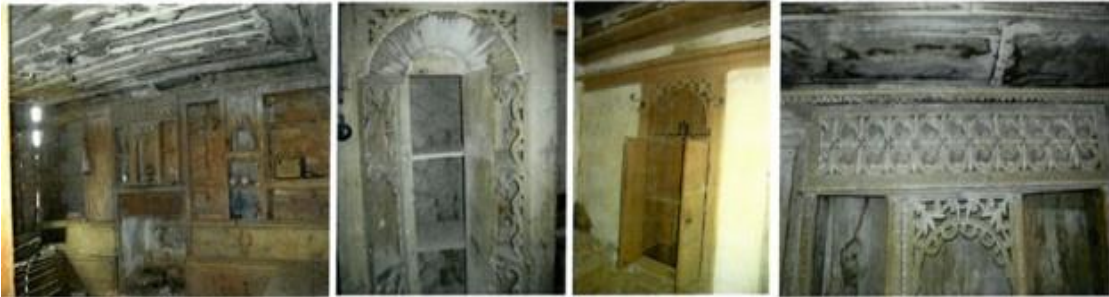
Figure 24. The closets of Mistanlar' House.

There are carvings on the wooden surfaces of Mistanlar' House closets carved with wood jigsaws (Fig. 24).

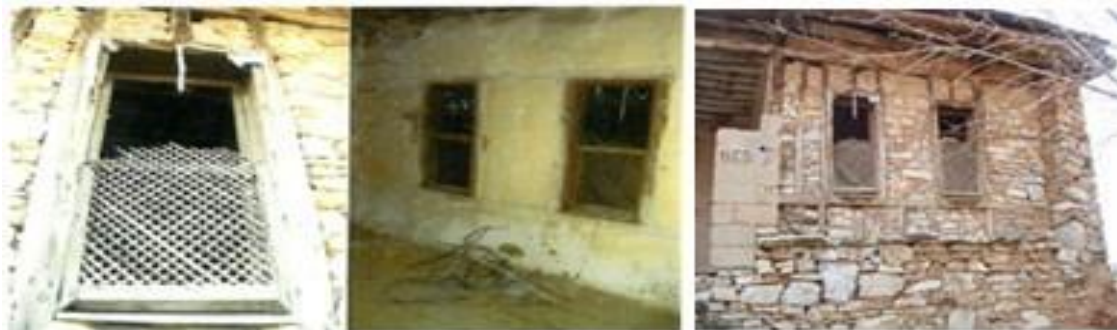
Figure 25. The windows of Mistanlar' House.

Lattice work shutters and sliding sash on the windows of Mistanlar' House (Fig. 25).

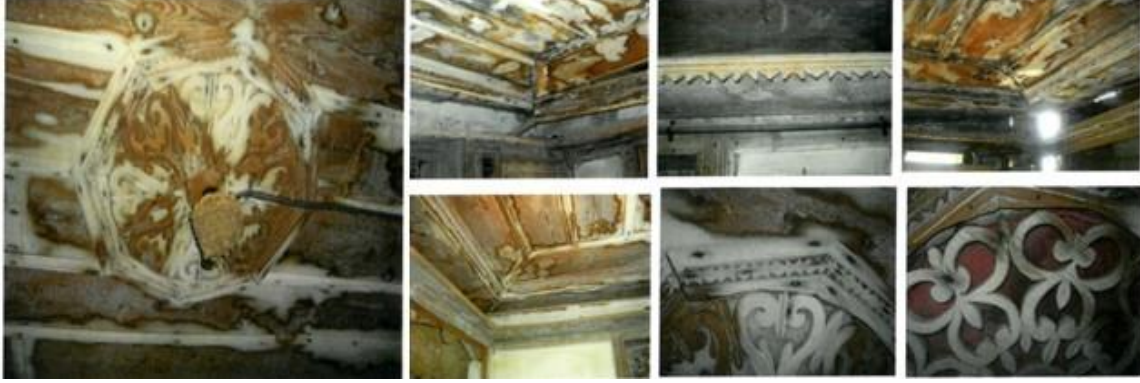
Figure 26. The ceilings of Mistanlar' House.

Carvings were applied with wood jigsaws in the construction of the ceilings' centers and edges of Mistanlar' House (Fig. 26).

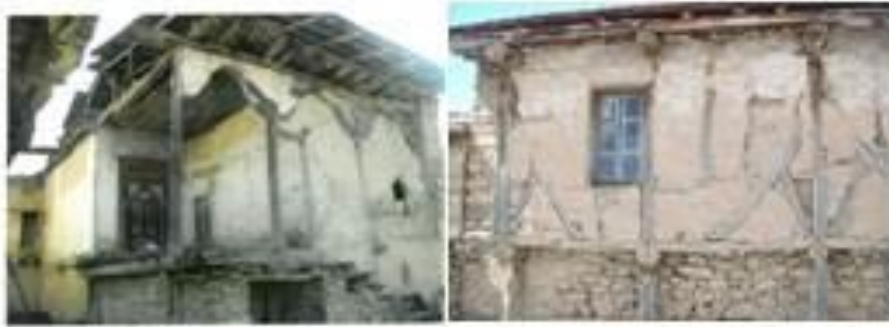
Figure 27. The general view of Saray House.

This house is in the Saray neighborhood of Orta village of Çal. The owner of the house is unknown and the house is not used. For this reason, the building was called "Ortaköy Saray House" in this study. Saray house was built on a transverse rectangular ground in east-west direction. Based on the architectural elements observed on the façade, originally the house had 2 rooms, which was later increased to 5 with add-on rooms. These add-on rooms are open to the sofa whose arches and central wooden columns connect to the roof (Fig. 27). The sofa is reached via slate stairs (Fig. 27). The construction date of the building can be seen within the circle formed by hand-carved adornments on the main door. "Maşallah Kane" inscription, written with the old letters in "sülüs" style, can be read within the circle (Fig. 28). Below it, "sene" inscription with "keşide" (a kind of calligraphic ornament) is seen. Between two "keşide"s, the construction date of the building, 1202 according to Hijri calendar (lunar calendar)/1788 according to Gregorian calendar, is barely seen. There are elements like wooden shelves, stove, and closet up to the lower level of windows in the lower room (Fig. 29). The ceiling of the room is made of wood and is embellished by the stained-ornamented ceiling rose framed in square by the adorned borders. The ceiling border is now detached and stolen. The ceiling is divided into small square zones around the ceiling rose (Fig. 31). The wooden ornamentations of this construction are seen on the entrance door, on the stove and on the walls of the room (Fig. 28). The entrance door of the house is made of wood. The ceiling of the construction is divided into small square zones by the nailing of laths. Various compositions formed again by the nailing of laths in rectangular patterns exist on the closets in the room. Hand-carved adornments have another important place as well (Fig. 29). These ornamentations are encountered on the outdoor of the house, ceilings and closet doors. The hand-carved adornments seen on the door arches and frames are hardly visible patterns of plant branches (Fig. 31).

The stairs of Saray house is made of slate stone (Fig. 27).

Eaves of Saray House are uncovered (Fig. 27). The eaves of the house may have been ripped.

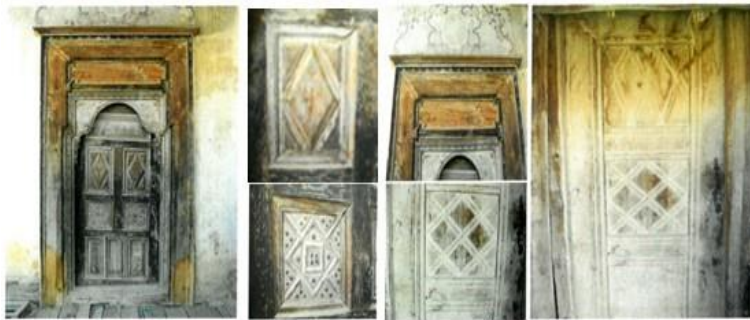
Figure 28. The doors of Saray House.

The doors of Saray house are made of solid wood raised panel and arch (Fig. 28). The surfaces of the doors are carved and decorated.

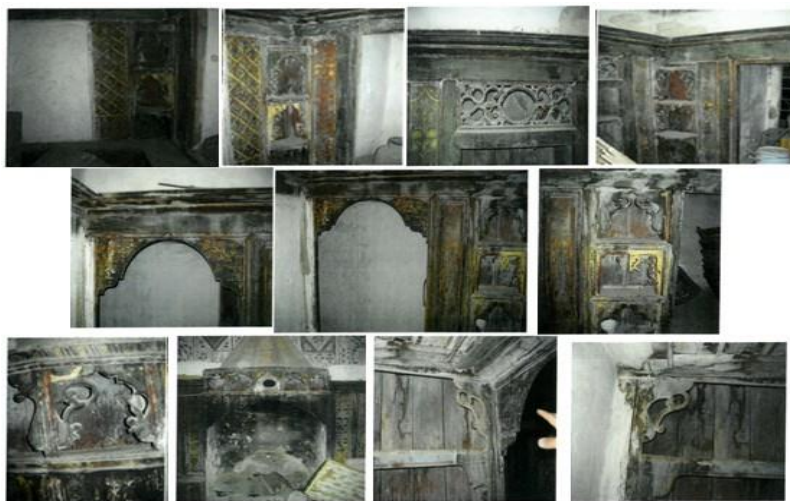
Figure 29. The closets of Saray House.

The surfaces of the closets are carved and decorated (Fig. 29).

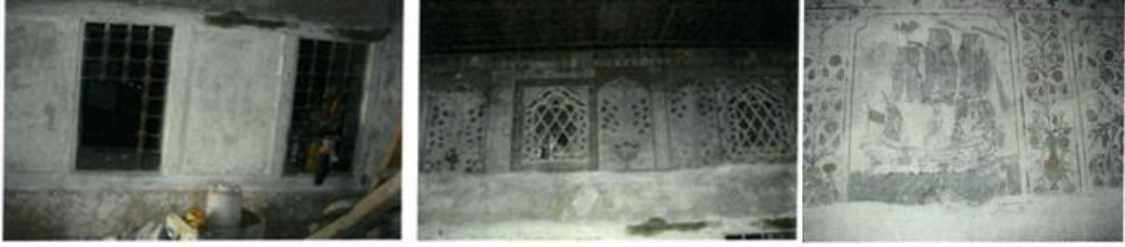
Figure 30. The windows of Saray House.

Guardrails with wooden covers (Fig. 30, left) and hand-carvings of the abat-jour (Fig. 30, mid and right) are seen.

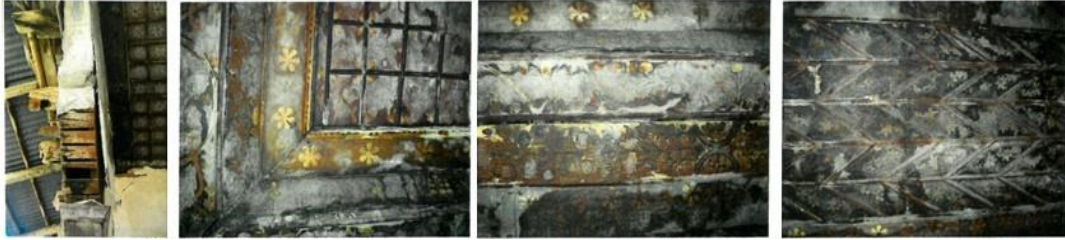
Figure 31. The ceilings of Saray House.

Hand-carved ceilings of Saray House are seen in Fig. 31.

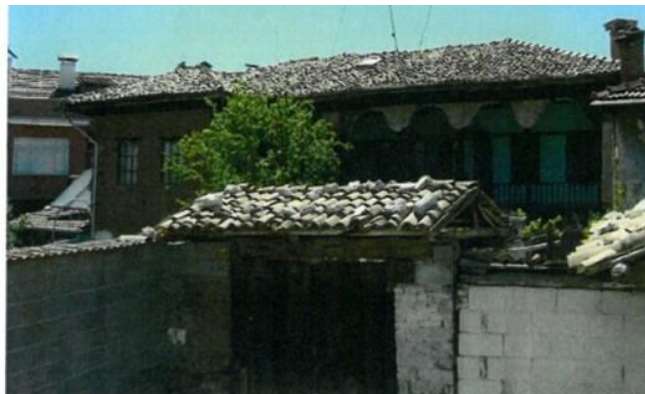
Figure 32. The general view of Şükrü Takım's House.

Third generation-relatives of Şükrü Takım reside now in this house which is claimed to be built in 1907. The knowledge related to the construction of it is insufficient. The house was built with an outer sofa and more than one row of rooms (Fig. 32).

Eaves were shaped in the form of covering with boards side by side. They are seen in the figure (Fig. 32).

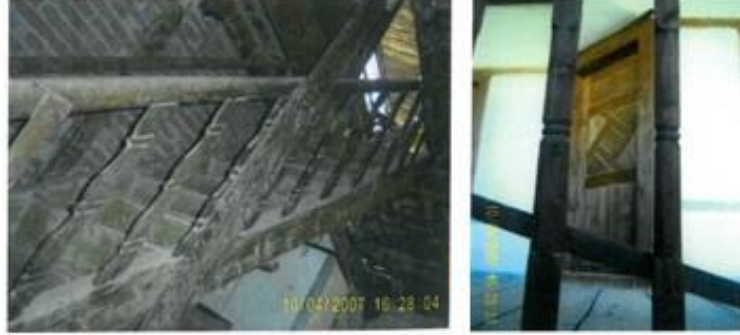
Figure 33. The stairs of Şükrü Takım's House.

The staircase made of pine wood was built to connect two storeys in the house of Şükrü Takım. The house has a straight-flight staircase. The balusters are adorned with laths (Fig. 33).

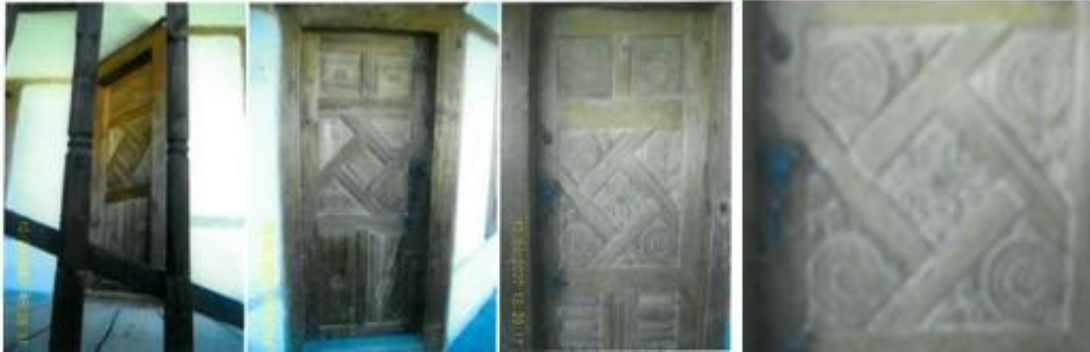
Figure 34. The doors of Şükrü Takım's House.

Solid wooden interior doors have raised panels fitted in to the frames of Şükrü Takım's House. The surface of the raised panels of the left door wing is flower carved. The raised mid panels of door wing are constructed with 45° angle (Fig. 34).

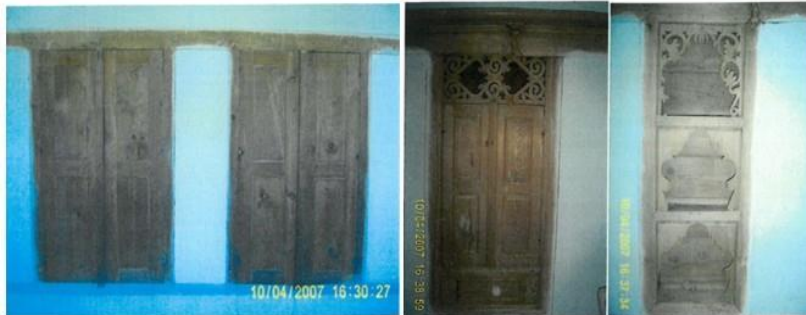
Figure 35. The general view of Şükrü Takım's House.

Closets have ledged and lined wings. This basic type of door/closet consists of lining boarding which is held together by ledges. Closets were produced as winged and unwinged. The racks of unwinged closets are arched (Fig. 35).

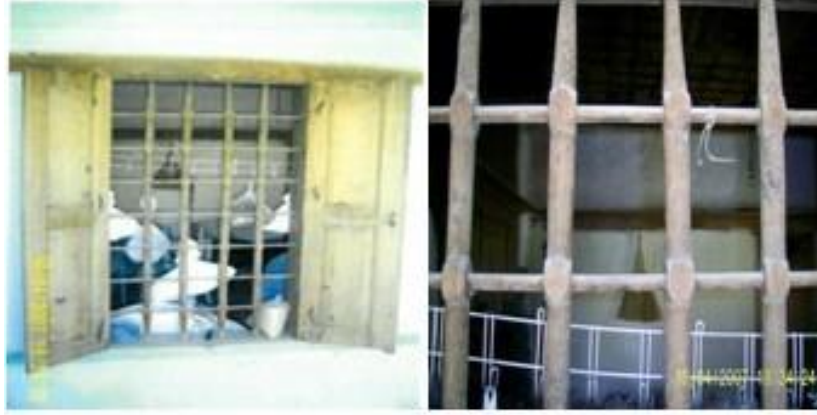
Figure 36. The windows of Şükrü Takım's House.

Window ornamentations of the house are made of wooden railings which are similar to iron counterparts (Fig. 36).

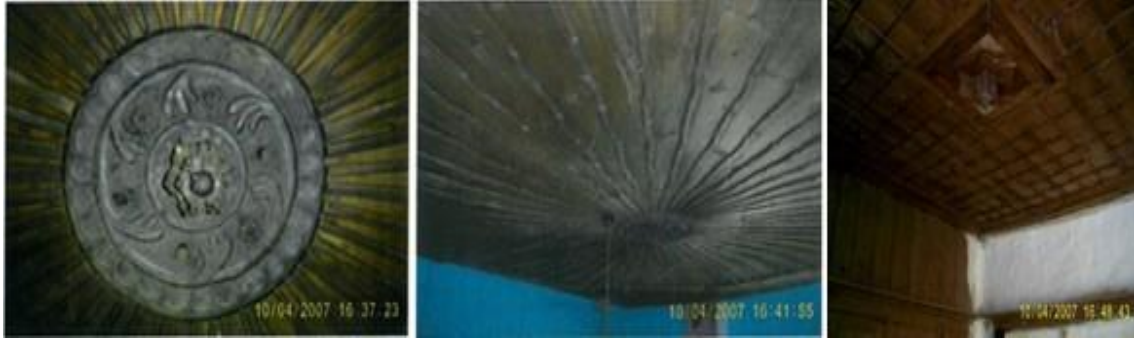
Figure 37. The ceilings of Şükrü Takım's House.

The ceiling of the house is curved and has a round core. Applied bars spread like sun beams from the center to the wall (Fig. 37).
