## Architect Kemalettin and Edirne Train Station Campus<sup>1</sup>

### Abstract

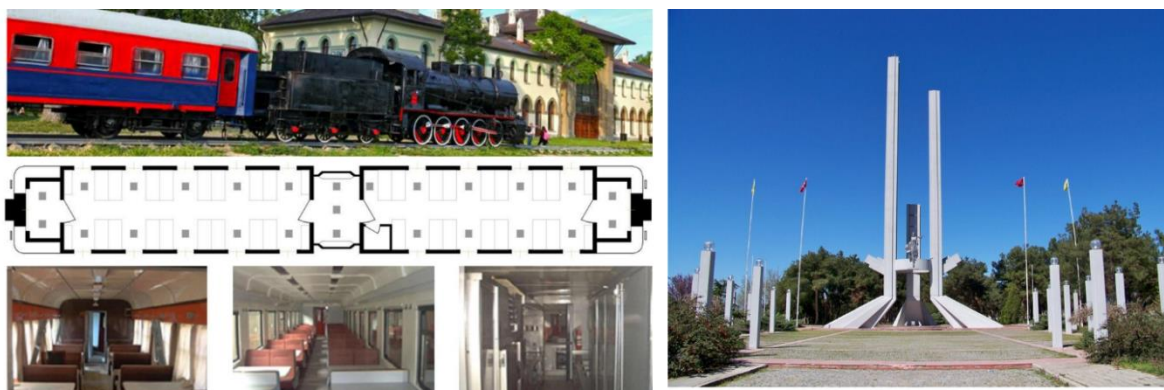
**Figure 9.** Train wagon and Lausanne Monument (Author's archive)

In 2002, an old train wagon was brought from Sakarya and placed in the old railway direction of the large station building. Its interior was designed as a restaurant (as shown in Figure 9 (Trakya Üniversitesi, 2002)). However, since it remains within the educational campus today, its restaurant function has been excluded from evaluation and only opened for nostalgic touristic purposes. The Lausanne Monument was built on March 29, 1998, and opened on July 19. It consists of three columns on which the figure of a young girl holds a dove and a document representing the agreement's text. The first column is 36.45 m long and symbolizes Anatolia; the second is 31.95 m long and symbolizes Thrace; the third is 17.45 m long and symbolizes Karaağaç, which was won in the Treaty of Lausanne. The concrete circle on the ground symbolizes unity. The monument is located in the westernmost part of the campus, at the level of the second entrance, which is not used today, creating a square in front of it.
