Removal of Two Canal Instruments from the Mesiobuccal Canal of a Mandibular Molar Tooth: A Case ReportTolga Han Edebal^{1*}

Case Report (HRU Int J Dent Oral Res 2024;4(2): 59-62)

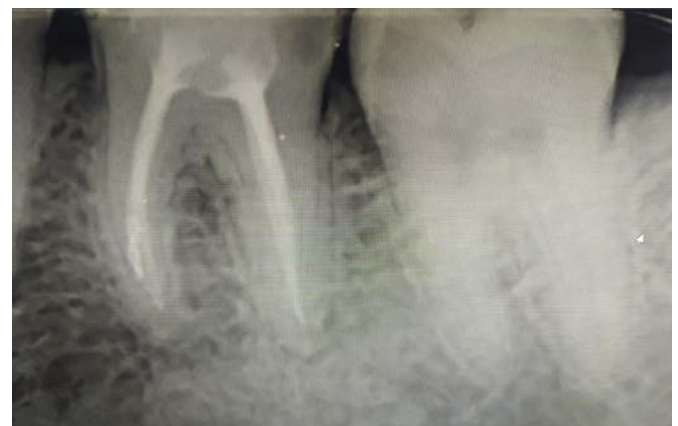
Figure 1: Initial periapical radiograph.

In the dental history obtained from a 30-year-old female patient without any systemic diseases who presented to our clinic, it was learned that she experiences pain on the lower left first molar tooth while biting. Informed consent was taken before any dental procedure conducted. Periapical radiography of the patient (Figure 1) showed that there were 2 broken instruments in the apical third of the mesiobuccal canal. During the first session, under the dental operating microscope, the old root canal filling was removed, and access to the broken instruments was achieved. Since the attempt to bypass the files was unsuccessful, a modified size 4 Gates Glidden drill (Figure 5) was used to create a platform up to the first broken instrument, and the broken piece was visually identified. The dentin was removed circularly from the periphery of the file using ultrasonic tips. Using

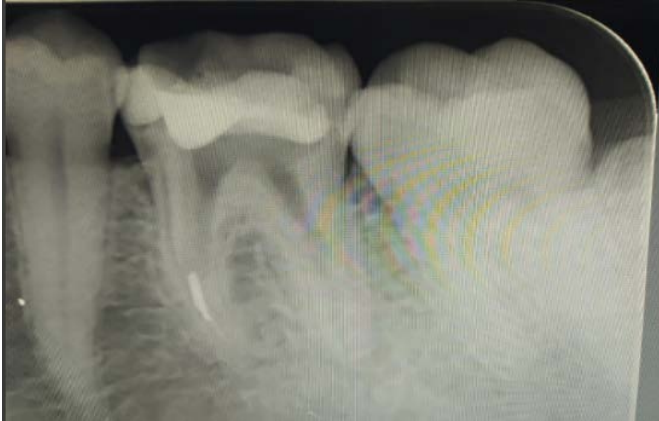
Figure 2: Periapical radiograph taken after the removal of the first broken instrument

With the help of irrigation, the first broken part was removed from the canal, and then periapical radiography was taken (Figure 2). Then the second broken piece was bypassed. During the preparation, the broken instrument found in the canal was removed. Subsequently, purulent exudate drainage was observed in the mesiobuccal canal. The root canals were irrigated with physiological serum, dried with microsuction and then checked with paper points. Since purulent exudate findings were encountered on the paper points used, the cavity was sealed using a loose cotton and temporary filling material (Figure 3). The patient was given an appointment for the second session two days later.

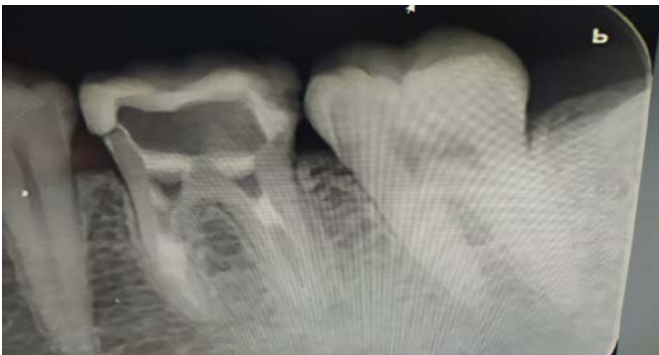
Figure 3: Radiograph taken after placement of $\text{Ca}(\text{OH})_2$

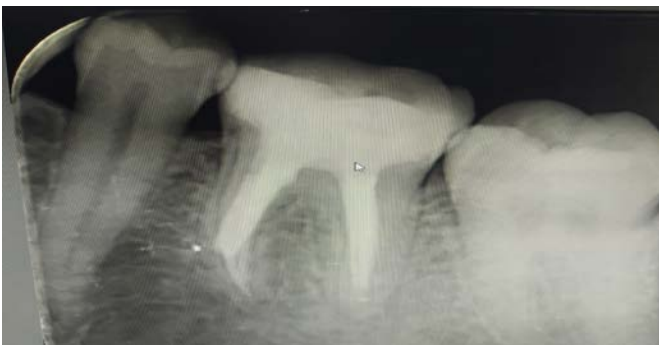
Figure 4: Periapical radiograph taken after root canal filling and coronal restoration

During the third session, it was found that the symptoms had completely resolved. After opening the cavity, Ca(OH)_2 was removed with the help of NaOCl and ultrasonic polymer tips. The canals were dried, and then filled with bioceramic root canal sealer (Dia-Root Biosealer, DiaDent Group International) and gutta-percha cones. At the most apical point of the created platform, it was cut and condensed. The remaining part of the canal was filled using thermoplastic gutta techniques (Figure 4).
