Düzce University Journal of Science & Technology

Research Article

Culture of Vineyard Roofs as Expression of Rural Architectural in Turkey: Nevşehir Göreme Examples

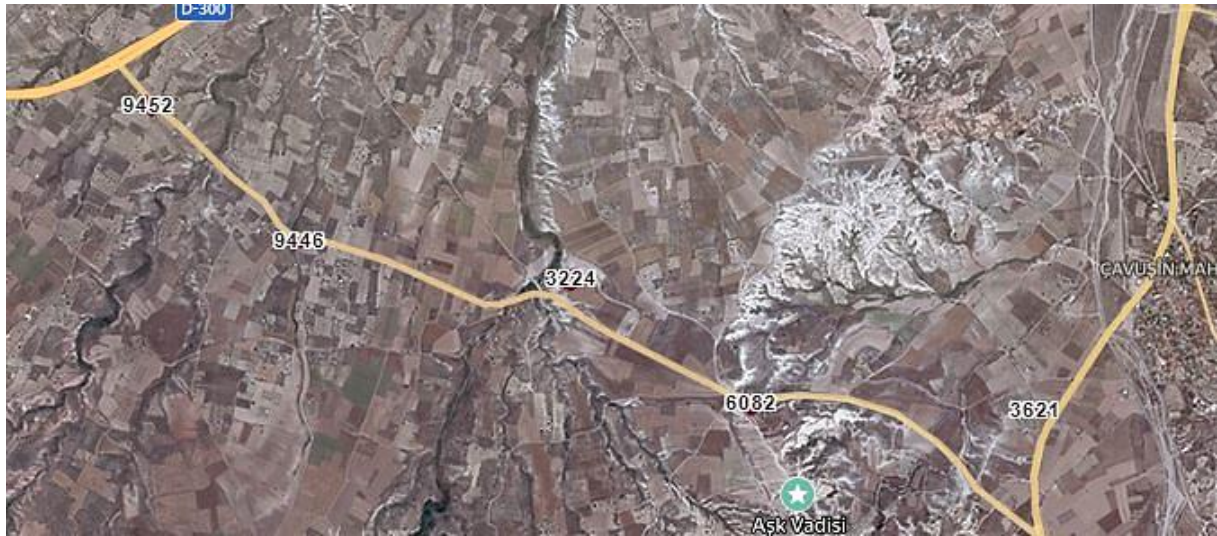
Figure 1. Vineyard roofs route (TKGM, 2024)

Although they have been subjected to deterioration or change under the influence of time, people or weather conditions, it is possible to observe vineyard roofs that have not lost their main characteristics in almost every rural district of Nevşehir. Since the existing inspectable/observable vineyard roofs are located on a meaningful route on the old vineyard road in Göreme Town; the cadastral status of their locations along the vineyard road has been taken into consideration. The vineyards included in the study are named with their parcel numbers.

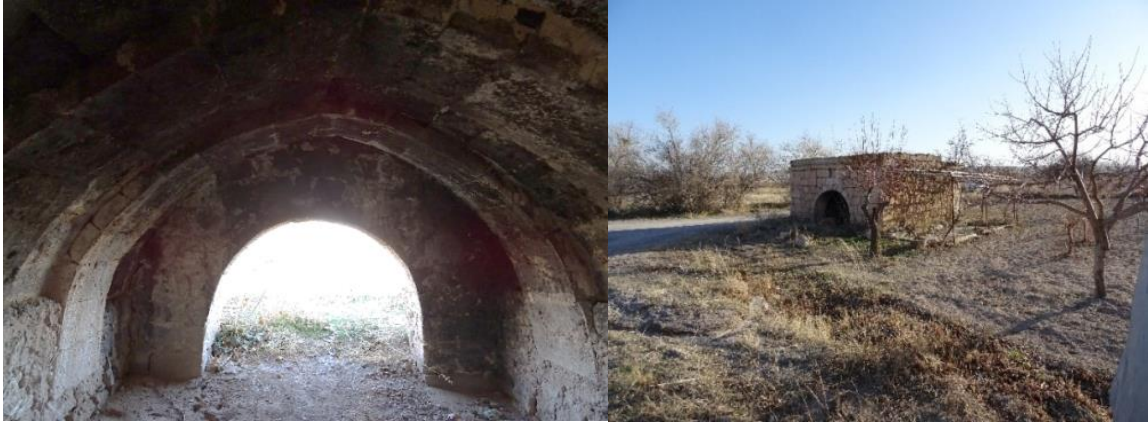
Photo 1. (a) Building no. 9452 - Appearance (Tokat, 2021) (b) Entrance (Tokat, 2021))

Structur number 9452 is located in Göreme Town, Demiyeni Locality. The iwan-shaped building is closed on three sides by windowless flat stone walls, and has a round-arched opening on the north side facing the road. In the building, which was built with yellow stone material specific to the region, ashlar stone was used in the corners of the facade and rows of arches, and roughhewn stone was used in other parts. The building has an interior space of approximately 3.45 meters wide and 4.86 meters deep, behind the 2.10 meter wide round arched entrance. Three rows of arches with an arch thickness of 71 cm, placed at intervals of 68 cm, form the interior.

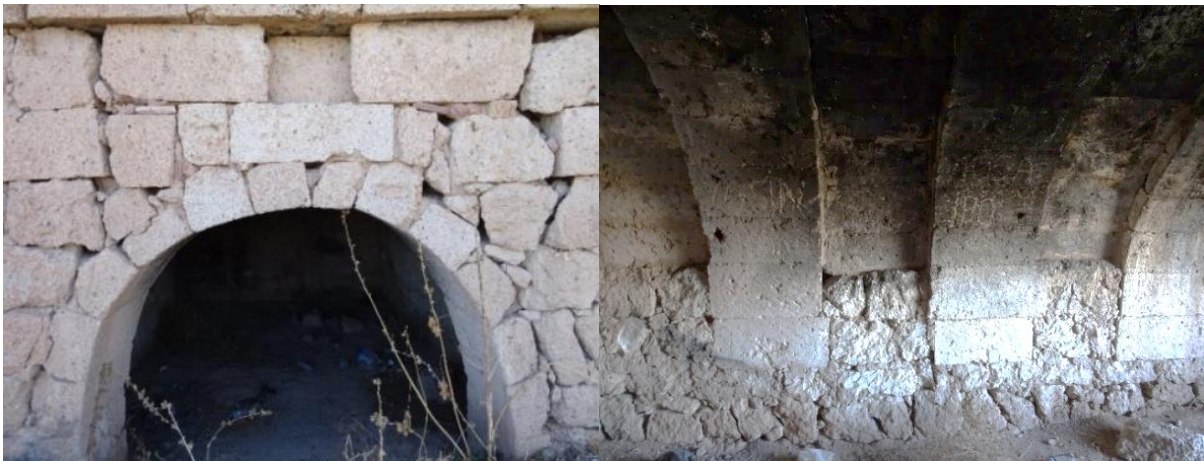
Photo 2. (a) Building no. 9452 - Entrance arch (Tokat, 2021) (b) Interior (Tokat, 2021)

There are a total of 4 arch spaces between the entrance and the iwan wall. In places corresponding to the arch spaces, there are niches formed due to the protrusions resulting from the ribbed structure of the arch rows. It is covered with a rib vault, emphasized by pointed arches, on the inside and a flat roof on the outside. There is an epitaphic space on the keystone axis of the second row of blocks above the round arch on the entrance façade. However, today this section is empty. Unlike the round arch on the portal, the arch forms inside are pointed arch.

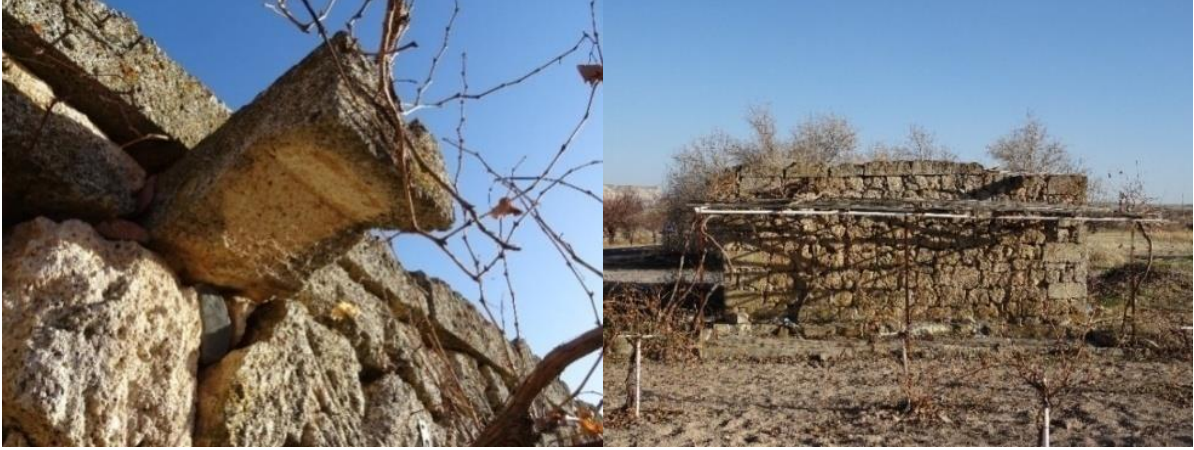
Photo 3.(a) Building no. 9452 - Western facade (Tokat, 2021) (b) Gargoyle detail (Tokat, 2021)

In addition, with the presence of an eaves molding along the entrance façade and the original gargoyles on the western facade, which have survived to the present day in good condition; it attracts attention as it is one of the rare examples among the vineyard roofs of the region and period.

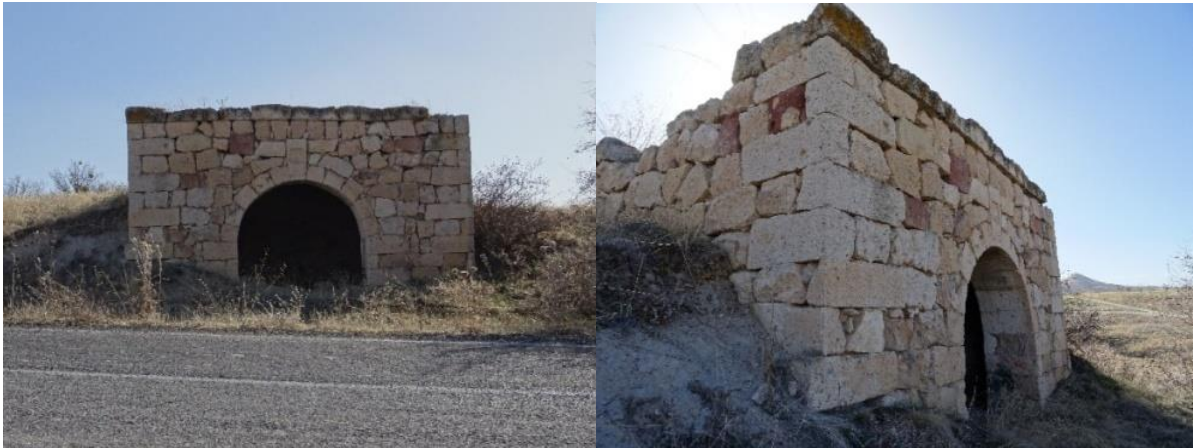
Photo 4.(a) Building no. 9446 - Northern facade (Tokat, 2021) (b) Northeastern facade (Tokat, 2021)

Although structure number 9446 is located at a point where the current border of Göreme and Uçhisar meet, unlike the other vineyard roofs in our research, it is located within the borders of Uçhisar Town, not in Göreme. However, it is still on the same route as the other vineyard roofs examined within the scope of this study, that is, it is in a suitable location for the vineyard route followed in Göreme Town. In addition, when the distances of the vineyard roofs are calculated, they are in harmony with the distances of the others. The building, which is closed with windowless stone walls from the east, west and south sides, has a round-arched opening on the north side facing the road. The vineyard roof, on a sloping land, leans on the slope from the south. In the building, which was built with yellow stone material specific to the region, ashlar cut stone was used in the corners of the facade and rows of arches, and roughhewn stone was used in other parts. In the building measuring 6 meters by 4.72 meters, the interior space, which is approximately 4.65 meters deep and 3.40 meters wide, is entered through the round arched entrance, which is 1.92 meters wide and 1.77 meters high. In the interior, there is a ribbed barrel vaulted upper cover consisting of three round arches. Arches thickness is 69 cm and arches spacing are 68 cm.

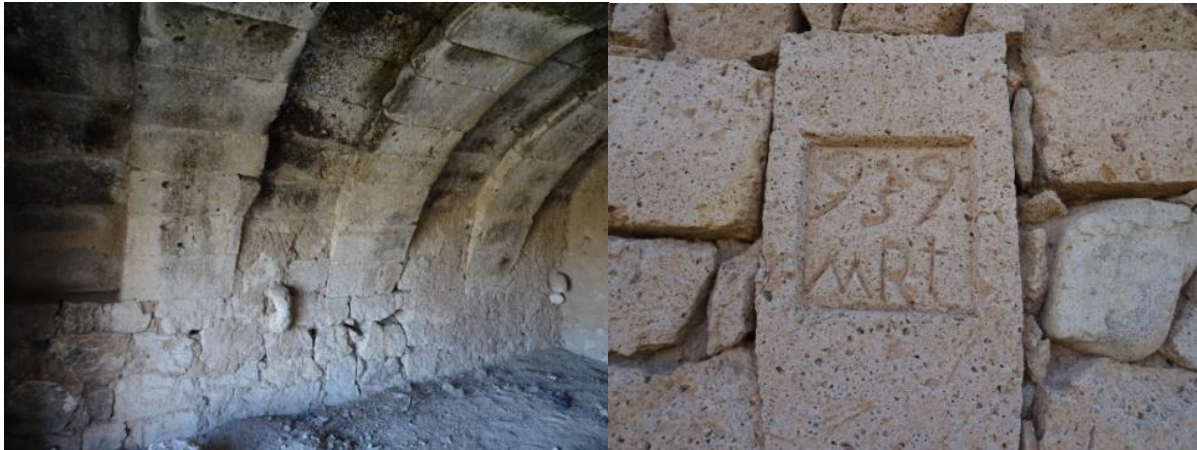
Photo 5.(a) Building no. 9446 - Interior (Tokat, 2021) (b) Building no. 9446 - Bookcase (Tokat, 2021)

There are niches in the left and right corners of the entrance. It is understood from the soot stains on the stone surface that the niches were used to place gas lamps used to illuminate the space. The 64 cm wide niches start with a depth of 24 cm and taper upwards. What draws attention in terms of unique elements in the structure is the presence of 4 "buckles" used to tie animals. Among the buckles

measuring 28 cm with a protrusion of 15 cm from the wall level, the one to the right of the entrance has a trace, but it has been completely destroyed. The buckles on the left and bottom right corner are intact, while the buckles on the left corner are partially intact due to the broken fastening area. With this, there is another stone buckle placed outside on the southeast façade to tie animals. The building is covered with flat drops from the outside. Another prominent issue about the vineyard roof is related to dating. The date "939 MRT", March 1939, was written by engraving on the keystone of the round arch on the entrance façade of the building.

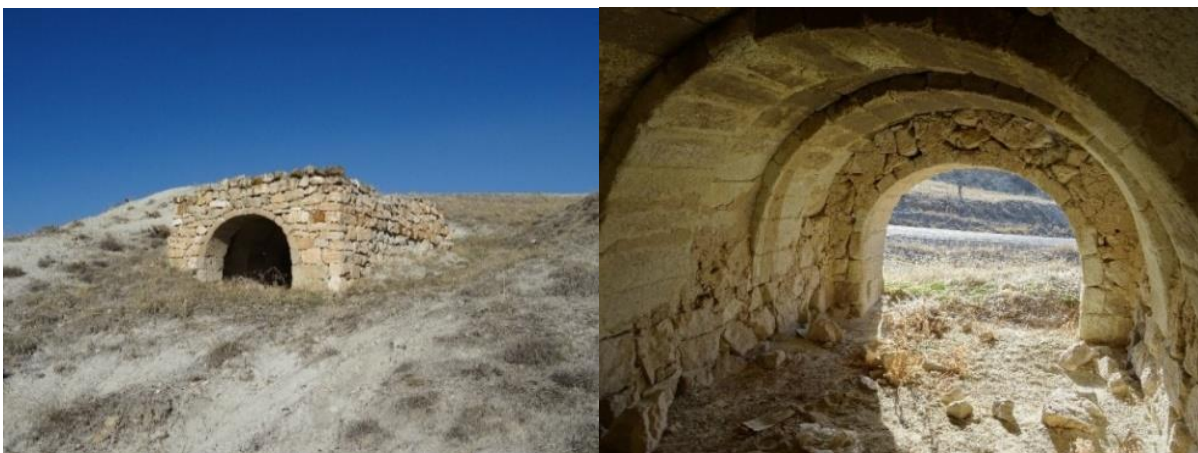
Photo 6.(a) Building no. 3224 -Front facade and entrance arch (Tokat,2021) (b) Building no. 3224 Interior (Tokat, 2021).

Building number 3224 is located in Tunus Location in Göreme Town. It is an iwan-shaped vineyard roof located on the old vineyard road. The building is closed with stone walls on three sides and there is a round arched opening on the north side facing the road. As seen in other examples, the structure was built with yellow stone material specific to the region; ashlar cut stone was used in the corners of the facade and in the rows of arches, and roughhewn stone was used in other parts. Behind the 2.24 meter wide round arched entrance is the iwan, which has an interior space of approximately 3.10 meters wide and 4.85 meters deep; it consists of 3 rows of arches with an arch thickness of 66 cm, placed at 72 cm intervals. The thickness of its walls is 60 cm. It was observed that the distance from the floor to the ceiling decreased to 1.73 meters due to the northern façade, which has an entrance arch to the building, being filled with soil over time. Like the round arch on the portal, the arch forms in the interior are also in the form of round arches.

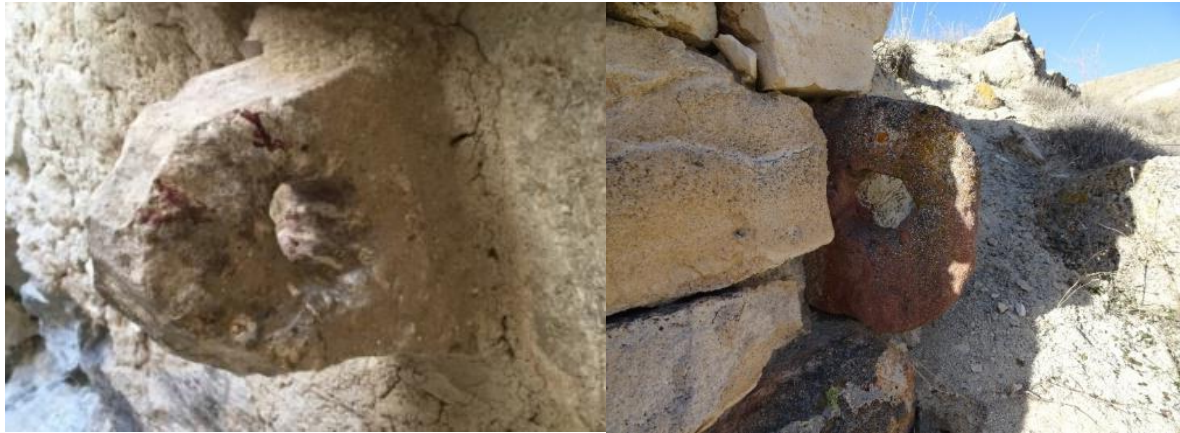
Photo 7. Building no. 3224 – Various buckles (Tokat, 2021).

There are a total of 4 arch gaps between the entrance and the iwan wall. Compared to similar structures, due to the rather dilapidated state of the vineyard roof in question and the fact that it was plastered with clay material, in the alignments corresponding to the arch gaps; niches formed as a result of protrusions resulting from the ribbed structure of the arch rows could be selected, but it was determined that they had lost their usable qualities. Another striking point in the building is the presence of a unique stone buckle on the west wall, which was added to the building mass for the purpose of tying animals.

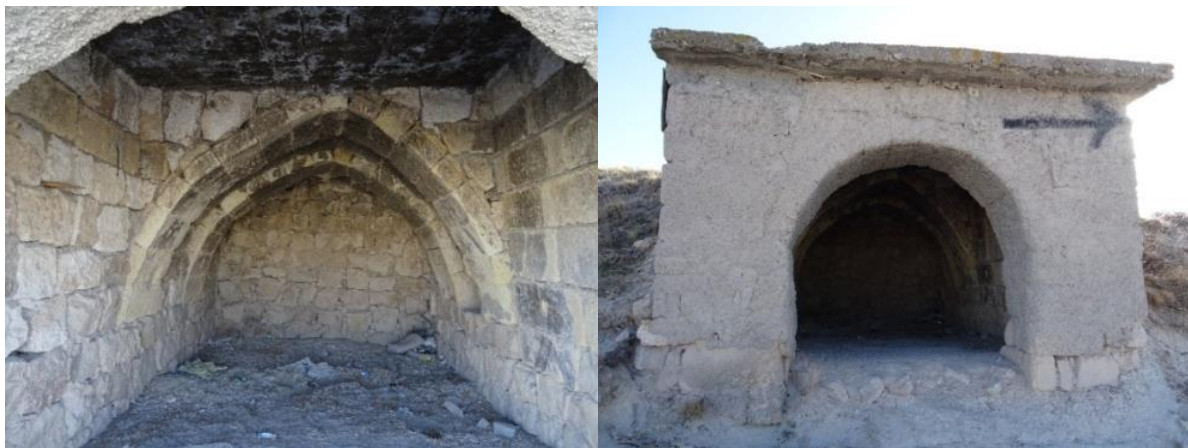
Photo 8.(a) Building no. 6082 -Front facade and entrance arch (Tokat,2021) **(b)** Building no. 6082 Interior (Tokat, 2021).

Building number 6082 is located in Yazıbağı District in Göreme Town. The vineyard roof, located on the old vineyard road, is closed by a stone wall on three sides and is in the form of an iwan with a round-arched opening on the north side facing the road. The vineyard roof, on a sloping land, leans on the slope from the south. In the building, which was built with yellow stone material specific to the region, ashlar stone was used in the corners of the facade and rows of arches, and roughhewn stone was used in other parts. What draws attention at first glance to the building is its clay-plaster exterior and the fact that it has survived to the present day in a better shape than its counterparts. However, a closer look reveals that after the collapse of the entrance section in an earlier period, stone blocks, apparently the original material of the building, were rebuilt using cement mortar between them and concrete was used on the ceiling. In its current form, the vineyard roof has a plan consisting of a rectangular space close to a square at the entrance and a pointed barrel vaulted space behind it, formed by two rows of arches.

In the approximately 5.10 meter deep and 6.64 meter wide interior, which is accessed through the 2.04 meter wide round arched entrance, the archless section covered with concrete measures 2.10x2.74 metres. In the arched section behind this, there are two rows of arches with an arch thickness of 69 cm, placed at 70 cm intervals. Considering the standard dimensions of the arches and arch intervals, it is highly likely that there was another 70 cm arch in the original state in the flat concrete-roofed entrance space. Unlike the round arch on the portal, the arch forms inside are pointed arches. Deformation has occurred in the structures and axes of the arches, and among the niches formed due to protrusions caused by the ribbed structure of the arch rows, only the niche on the right inner wall is clearly visible.

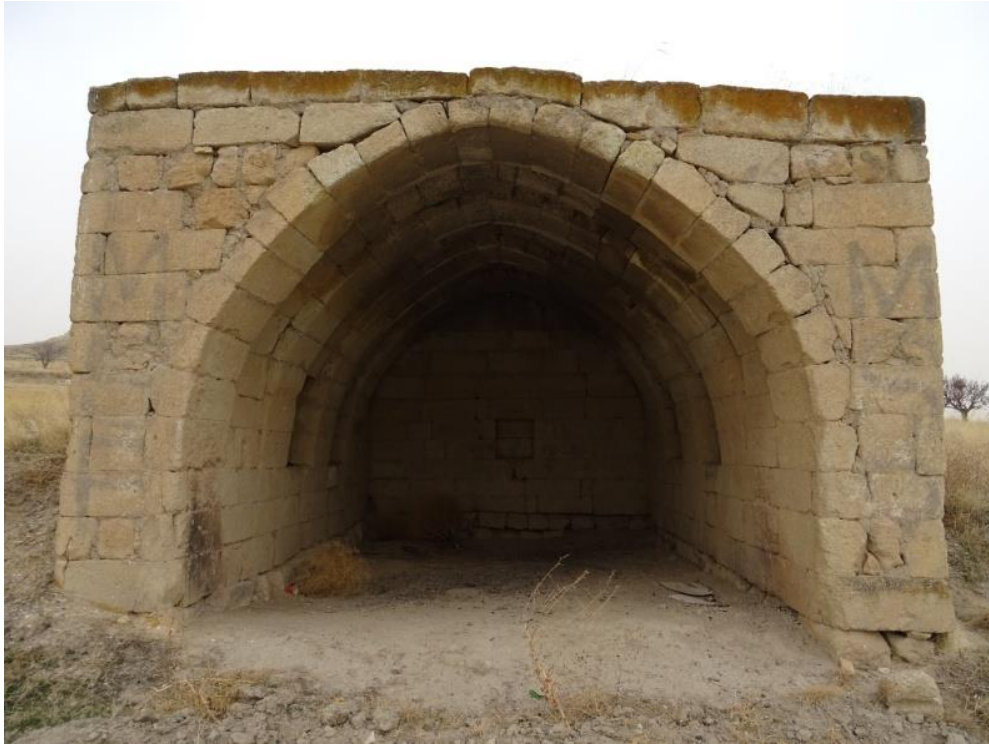
Photo9. Building no. 3621 -Front facade and entrance arch and interior (Tokat, 2021).

Building number 3621 is an iwan-shaped vineyard roof built with 1 row of rubble stone at the ground level and local natural yellow cut stone on the upper parts.

The immovable cultural heritage, which is closed with stone masonry on three sides, has a wide pointed arch opening on the east side facing the road. Located on a sloping land, the building is buried in the ground for approximately 4.5 meters from its outer western façade. Behind the wide pointed arched entrance, the iwan, which is approximately 5.70 meters deep, consists of 4 rows of arches with an arch thickness of 70 cm, placed at 73 cm intervals. There are a total of 4 niche openings in the interior, in the alignments between the arches on the north and south walls. Apart from these, there is a rectangular niche, almost square, measuring 60x53 cm and 21 cm deep, on the western wall in the interior. The building has a rib vault, emphasized by pointed arches, on the inside and a flat roof on the outside.

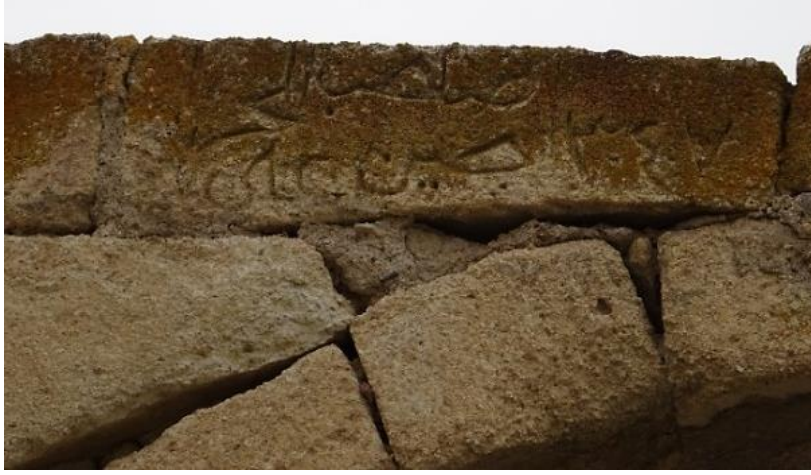
Photo9. Building no. 3621 - Inscription stone on the entrance arch (Tokat, 2021).

Among the stone blocks lined up on the entrance arch, it has read that "Sahibul Hayrat Hüseyin Ali - 1347" was written on the fourth stone from the right. The date 1347 written in the Rumi calendar in the inscription corresponds to the Gregorian year 1931. The expression "Sahibul Hayrat" is generally written on structures such as fountains, hospitals and mosques, as a set phrase in which works built for charity are written with the names of their owners. This phrase also; is another indication that the vineyard roofs built specifically for the region - especially those built on the roadside - were built for charitable purposes, to protect people and their animals from rain or sun, and to provide temporary shelter in necessary situations.
