# Investigation of the effect of using epoxy coatings on salt crystallization in ignimbrite (Nevşehir-Türkiye) stones

# Investigation of the Effect of Using Epoxy Coatings on Salt Crystallization in Ignimbrite (Nevsehir-Turkiye) Stones

Research Article / Araştırma Makalesi

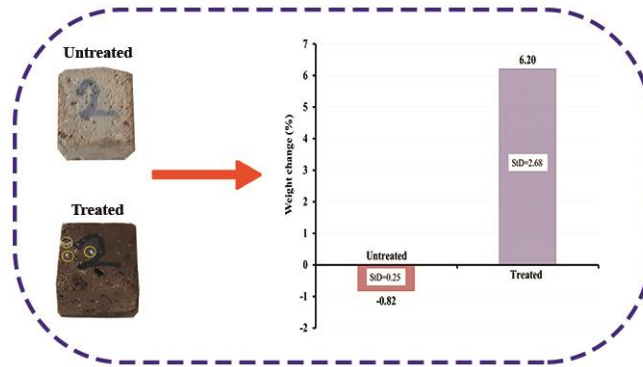
**Figure.** Dry weight change of untreated and epoxy coated (treated) ignimbrite samples at the end of the salt crystallization test

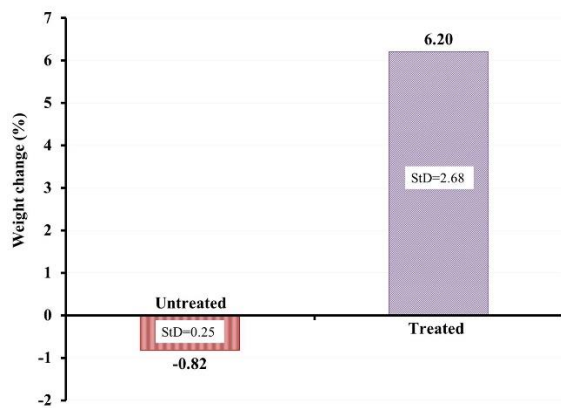
**Figure 6.** Dry weight change of untreated and epoxy coated (treated) ignimbrite samples at the end of the salt crystallization test (StD: standard deviation)

The change in dry weight loss due to salt crystallization of epoxy coated (treated) and untreated samples are given in Figure 6. According to the results given in Figure 6, the dry weight loss of untreated samples was 0.82%, while the samples subjected to epoxy coating showed an increase of 6.20%. Epoxy resin reduces the water absorption of the stones by filling the pores of the stones. Increasing the number of cycles applied to the samples increases the salt crystals in the pores, which causes the weight increase of the epoxy coated samples (Figure 7). However, in untreated samples, the salt solution entering the pores causes the internal pressure of the salt crystals to exceed the cohesion limit during evaporation, causing the stones to separate in the form of small crumbs. In this case, a weight decrease was observed in untreated samples. Similar results, in the research conducted by Çelik and Sert [36], were observed in the salt crystallization test of treated and untreated andesite

- According to the salt crystallization test results, determined that the dry weight loss of untreated ignimbrites was 0.82%, while the dry weight of epoxy coated ignimbrites increased by 6.20%.
- It was determined that the open porosity rate of untreated samples was 15.89%, and the open porosity rate of epoxy coated samples was 13.91%.

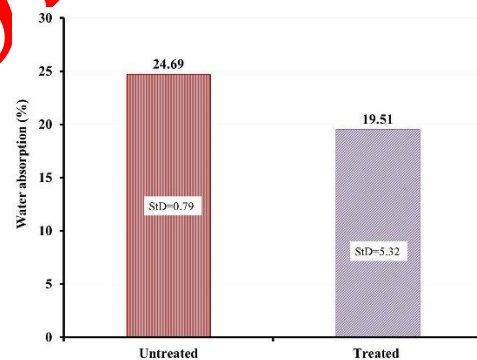
**Figure 10.** Change in water absorption (%) values of untreated and epoxy coated ignimbrite samples (StD: standard deviation)

The transport, crystallization and hydration of salts by the absorption of water formed by rain or moisture in the pores of the stones are the main reasons for the deterioration of historical buildings [38, 47]. Depending on the weather conditions, in environmental conditions where the temperature is below  $0^\circ\text{C}$ , water absorbed in the pores of the stones causes the volume of ice crystals to increase and reduces the strength of the stone [48]. For this reason, one of the important parameters investigating the resistance of stones against salt crystals is the determination of the water absorption amount of stones treated with polymer coating [37, 38]. Water absorption values of untreated and epoxy coated (treated) ignimbrite samples are given in Figure 10. According to the results given in Figure 10, it was determined that the water absorption value of untreated ignimbrite samples was 24.69% and the water absorption value of epoxy coated ignimbrite samples was 19.51%. This result, consistent with the results of open porosity values, shows that the water absorption of epoxy coated stones is reduced

compared to untreated stones. The decrease in the absorption of water in stones can be attributed to the fact that the epoxy coating creates a protective thin layer that prevents water entry into the pores of the stones.
