Düzce University Journal of Science & Technology

Investigation of The Architectural Features of Traditional Houses: Samsun-Havza Case

In this study, a total of 10 houses were examined, with five selected from each of the two neighborhoods, Bahçelievler and İlica, surrounding Havza district in Samsun province. The construction techniques,

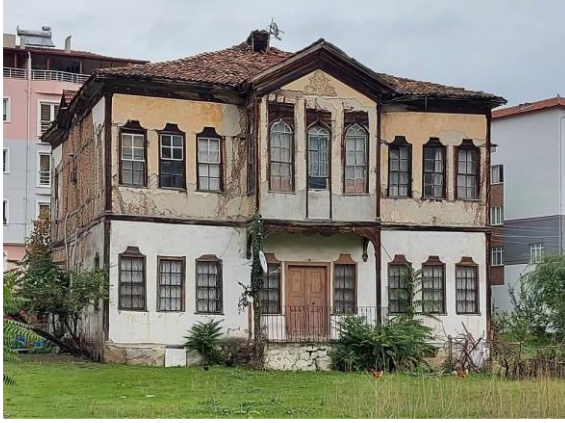
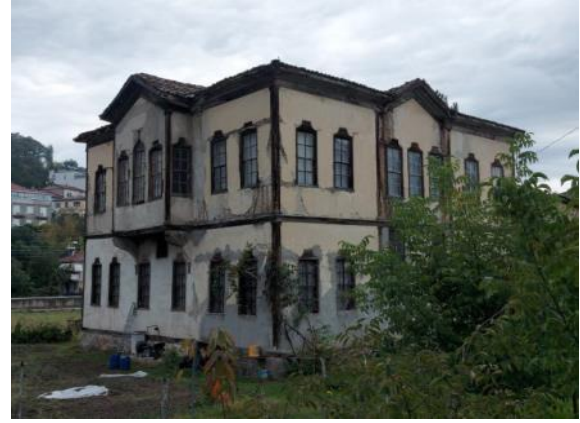
Figure 3. Ali Osman Ağa Mansion

The structure was built on a raised masonry stone base, with fired brick and adobe infill used between the wooden frame on the ground and first floors (Figure 3). Fired bricks were arranged in various patterns, such as herringbone and straight, creating an aesthetic and unique facade. The building has plaster that was applied while preserving the wooden skeleton frame, but over time, parts of the plaster have fallen off. The house has two external doors. The main entrance door is located approximately 80 cm above the ground, beneath the bay window of the structure. This entrance door is a wooden double-leaf door with an original design. The rear facade entrance door is also elevated from the ground and is a single-leaf wooden door. On both sides of the entrance door, there are symmetrical wooden sash windows. Wooden sash windows are repeated throughout most of the building. All windows in the building feature window head decorations. The windows in the bay window differ from the other windows of the building; they are more decorative and taller. The wall ornamentation above the bay window indicates that the structure was built with aesthetic concerns in mind. The windows of the building are symmetrical and aesthetic. The wooden sash window on the rear facade has been replaced with a single-leaf PVC window (Figure 4). The roof of the rectangular-shaped structure is a hip roof covered with traditional Turkish tiles.

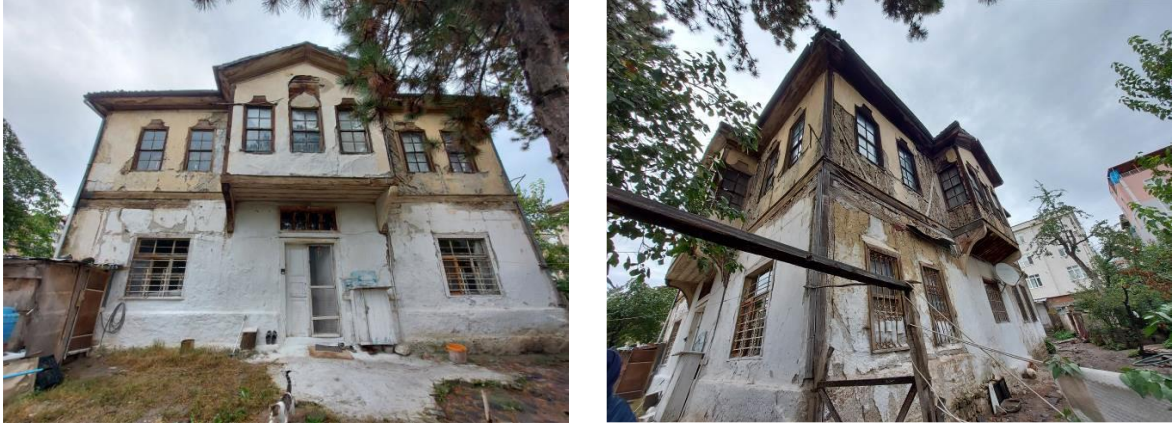
Figure 5. Talip Gürpınar House

The Talip Gürpınar House was built on a raised masonry stone base, with fired brick and adobe infill used between the wooden frame on the ground and first floors (Figure 5). The fired bricks and adobe were arranged in various patterns, such as herringbone and straight, creating a unique facade. The building features plaster applied while preserving the wooden skeleton frame; however, over time, some parts of the plaster have peeled off. The house has two external doors. The main entrance door is at ground level, located beneath a bay window. It is a double-leaf wooden door with a horizontal window above it. On the other side of the facade with the main entrance, there is a wooden double-leaf door beneath a wooden porch, which is believed to have been added later and is located 10 steps above the ground, covered with traditional Turkish tiles. The building has two bay windows. Beneath the bay window on the left side facade, there is a flat window. Throughout most of the building, wooden sash windows are repeated (Figure 6). On the ground floor, there are flat windows in addition to sash windows. The windows on the first floor feature window head decorations. The middle window decoration of the bay window above the entrance door differs from the other window decorations of the building; it is more decorative and taller. The area above the bay window was constructed using a wooden masonry method without the use of wall infill material. The windows of the building are symmetrical and aesthetic. The roof of the rectangular-shaped structure is a hip roof covered with traditional Turkish tiles.

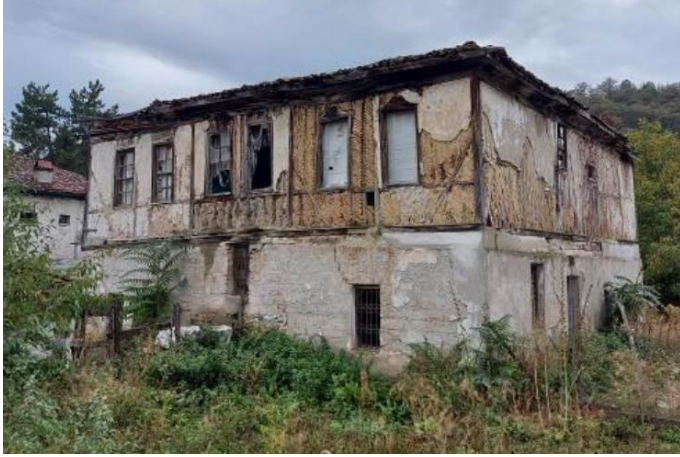
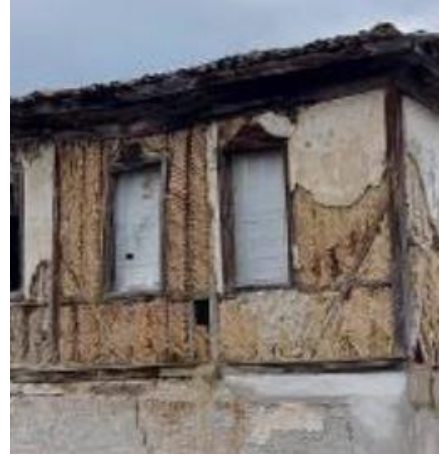
Figure 7. Mahmut House

The Mahmut House was constructed on a masonry stone foundation, with stone, adobe, and brick infill within a wooden frame on the ground floor and fired brick and adobe infill between the wooden framework on the first floor. The building has plaster applied while preserving the wooden skeleton frame; however, over time, some parts of the plaster have deteriorated. The house has one external door. The main entrance door is at ground level and located beneath a bay window. It is a double-leaf wooden door. On the rear facade of the entrance, the wooden frame structure is visible in the middle of the first floor; however, due to the considerable damage to the building, it is thought that the wooden framework system continues in the damaged area on the first floor.

Most of the windows in the building are repeated wooden sash windows. The window levels on the ground floor vary. The windows on the first floor are symmetrical and feature window head decorations, although these have been damaged over time. The middle window decoration in the bay window above the entrance door differs from the other window decorations of the building; it is more decorative and taller. Above the bay window, a triangular wooden masonry method was employed without the use of wall infill material. The roof of the rectangular-shaped structure is significantly damaged but is a hip roof. The roof is covered with traditional Turkish tiles.

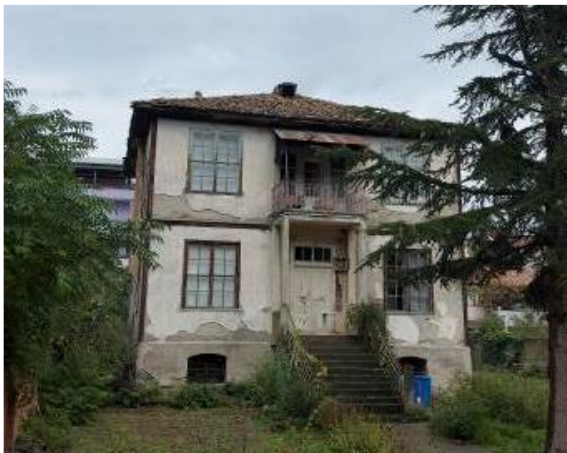
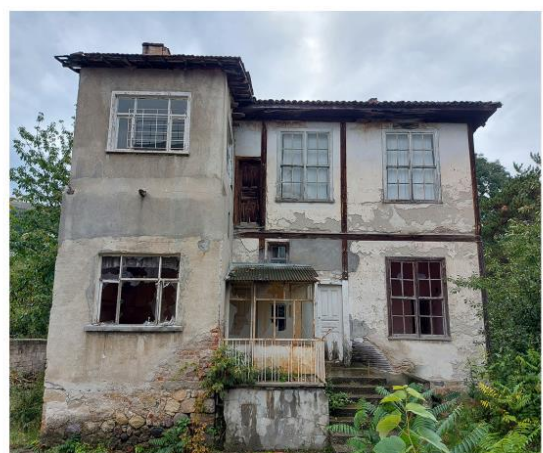
Figure 7. Sadoğulları House

The Sadoğulları House was built on a masonry stone foundation, with the ground and first floors constructed using the wooden "Bağdadi" method within a wooden framework. In the section believed to have been added later, the ground floor was built with solid brick masonry, while the first floor was constructed with fired brick infill within a wooden framework. The building features plaster applied while preserving the wooden skeleton frame, but over time, some of the plaster has deteriorated. The house has two external doors. The main entrance door is 12 steps above the ground, located under a balcony covered by a metal porch on the first floor. The entrance door is a double-leaf wooden door. There is also a single-leaf wooden door on the first floor that is exposed and cannot be accessed from outside. A horizontal window is located above the entrance door. On the front facade where the entrance is located, there are two symmetrical windows beneath the ground floor level, indicating the presence of a basement. Since entry into the building was not possible, the use of the basement area is unknown. On the rear facade of the entrance, there is a single-leaf entrance door located 7 steps above the ground. Next to the rear entrance door is a veranda under a metal porch accessible from the interior. Most of the windows in the building are paired wooden sash windows that repeat throughout. Due to numerous additions on the rear facade, this side does not appear symmetrical or decorative. In the section of the building that was added (where solid brick masonry is used on the ground floor and fired brick infill within a wooden framework is used on the first floor), the windows are flat. Generally, the windows of the building are symmetrical. The roof of the structure is a hip roof, covered with traditional Turkish tiles (Figure 7).

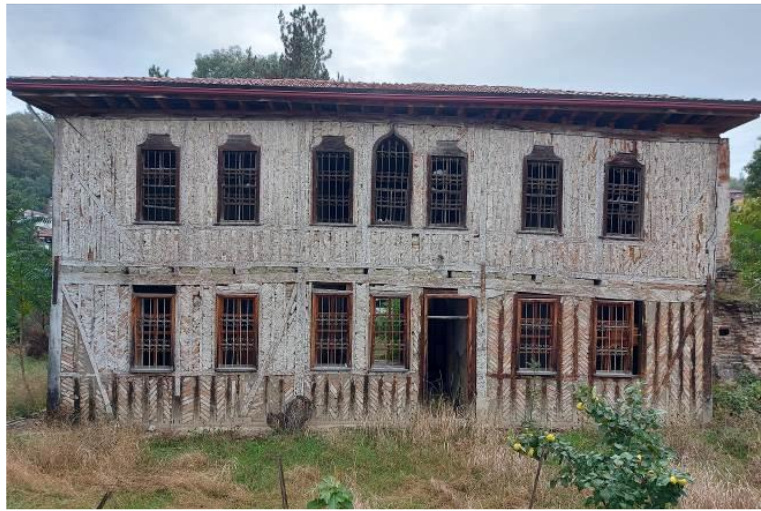
Figure 8. Çon House

The structure was built using fired brick and adobe as infill materials between the wooden frame on both the ground and first floors. The fired bricks were arranged in different patterns, such as herringbone and straight, to create an aesthetically pleasing and unique façade. The building has two entrances. Due to the recent commencement and subsequent suspension of restoration efforts, the doors are currently missing. Both entrance doors are at ground level. The entire building features repeating wooden sash windows that are symmetrical, with decorative elements above each window. The window above the main entrance door opening is taller and serves as a distinguishing feature of the entrance. On the side façade, there is an area thought to have been a bathhouse. Additionally, a modern brick extension has been added to the continuation of the side façade. The rectangular building has a hipped roof, covered with traditional Turkish tiles (Figure 8).

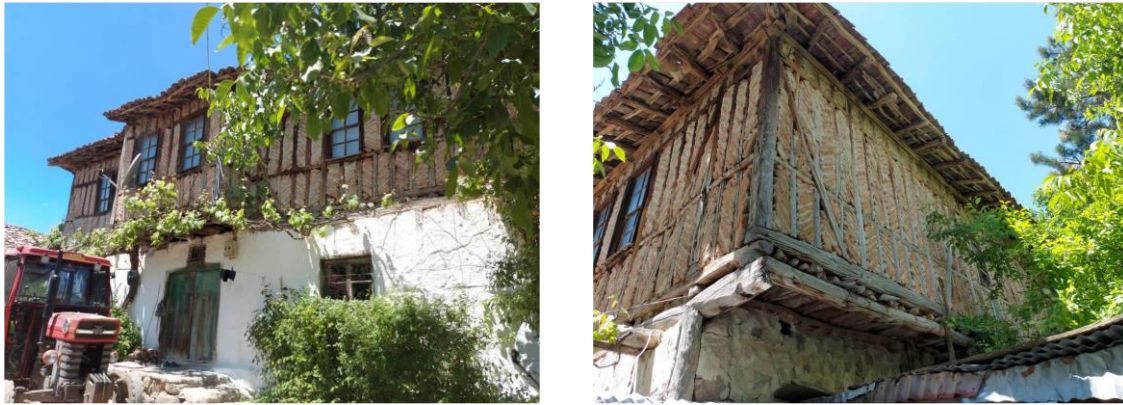
Figure 10. Ertuğ House

Ertuğ house was built with a rubble stone system on the ground floor and a timber frame filled with fire brick material on the first floor. On the ground floor front façade, a hybrid construction technique was employed by using fire brick material within a timber frame instead of the rubble stone system. The fire bricks were arranged in a herringbone pattern to create an aesthetic and unique façade. The front façade of the ground floor is plastered. On the left side of the building, the ground floor beams have been extended to form a cantilevered projection on the first floor. The house has one external door. The main entrance door is three steps above the ground level and is located under the bay window. The entrance door is a double-leaf wooden door, with a square window above it. On the ground floor front façade, there is a flat wooden window. On the first floor, the wooden sash windows are aligned and symmetrical. The roof of the rectangular-shaped building is a hipped roof. The roofing material used is Turkish-style tiles (Figure 10).

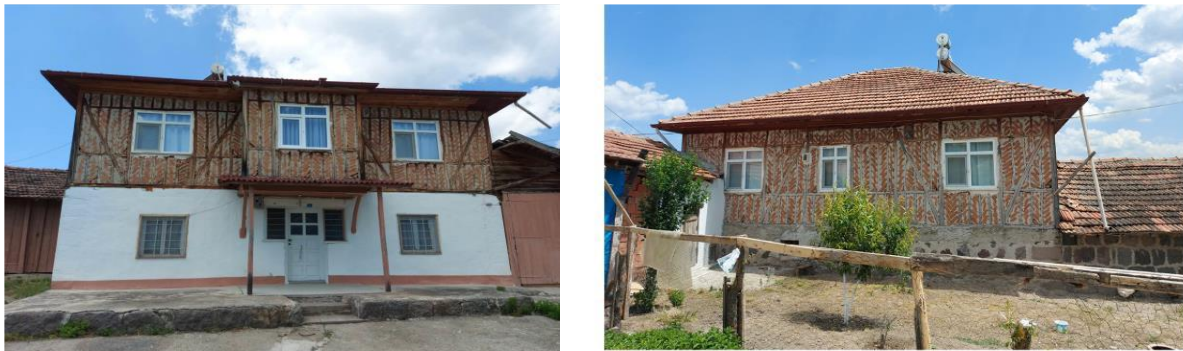
Figure 11. Ateş House

Ateş house was constructed with a rubble stone system on the ground floor and a timber frame filled with fire brick material on the first floor. The fire bricks were arranged in a herringbone pattern, creating an aesthetic and unique façade. The front façade of the ground floor is plastered. The house has a single external door. The veranda is elevated three steps above ground level, while the main entrance door is at the same level as the ground. It is located beneath the bay window, which is supported by brackets. Above the entrance door, there is a sheet metal canopy elevated by wooden posts, which is inconsistent with the original structure. The entrance door is a single-leaf wooden door, with single-leaf wooden windows on either side. A flat wooden window is used on the front façade of the ground floor. The windows on the first floor have been replaced with PVC windows, which are inconsistent with the original structure. The rectangular-shaped building has a hipped roof, and the roofing material used is Marseille tiles (Figure 11).

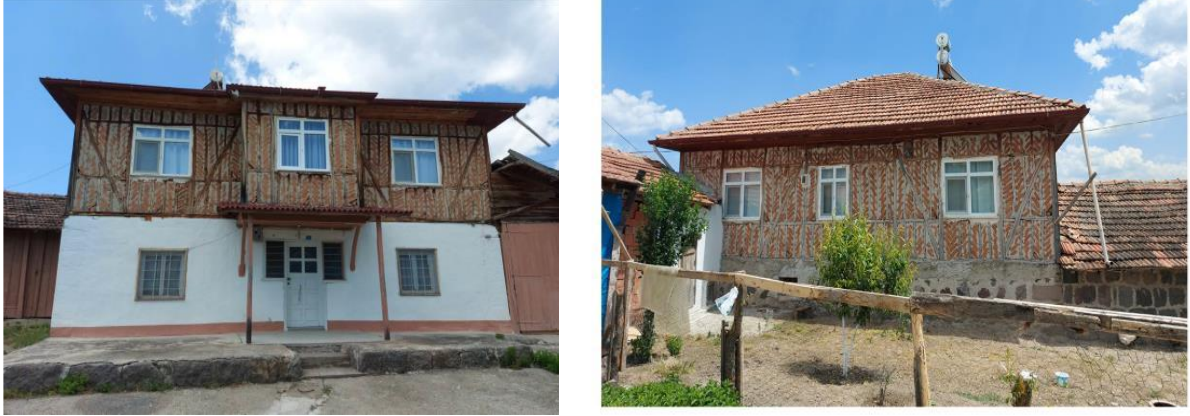
Figure 12. Temiz House

Temiz house was constructed with a rubble stone system on the ground floor and a timber frame filled with fire brick material on the first floor. A hybrid construction technique was chosen for the front façade of the ground floor, using fire brick infill within a timber frame instead of the rubble stone system. The fire bricks were arranged in a herringbone pattern, resulting in an aesthetic and unique façade. The front façade of the ground floor is plastered. The house has a single external door. The main entrance door is three steps above the ground level and is located beneath the bay window. The entrance door is a double-leaf wooden door, with a small rectangular window beside it. Flat wooden windows were used on both the ground floor and the first floor. The windows are aligned and symmetrical. The rectangular-shaped building has a hipped roof, covered with traditional Turkish tiles (Figure 12).

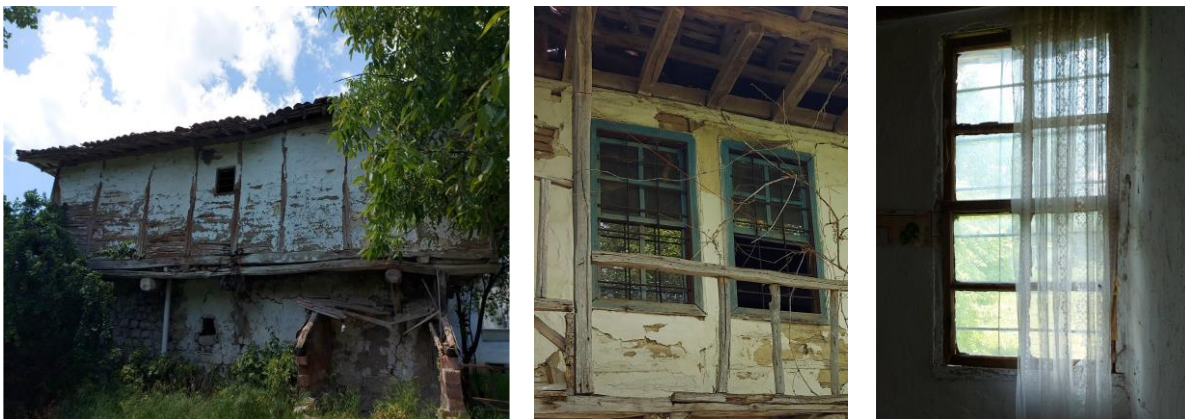
The building features a masonry stone system on the ground floor, while the first floor is constructed using a timber frame filled with wooden masonry materials. The entire structure is covered with plaster, though over time, some sections have deteriorated and peeled off. The house has three exterior doors. In addition to the main entrance, there are two single-leaf wooden doors on the first floor, opening onto a balcony made of wooden projections. The main entrance door is at ground level and is a double-leaf wooden door. The first floor features wooden sash windows. The roof, which is rectangular in shape, is a hipped roof covered with traditional Turkish tiles (Figure 13).

Figure 13. Koçoğlu house left side facade and guillotine window

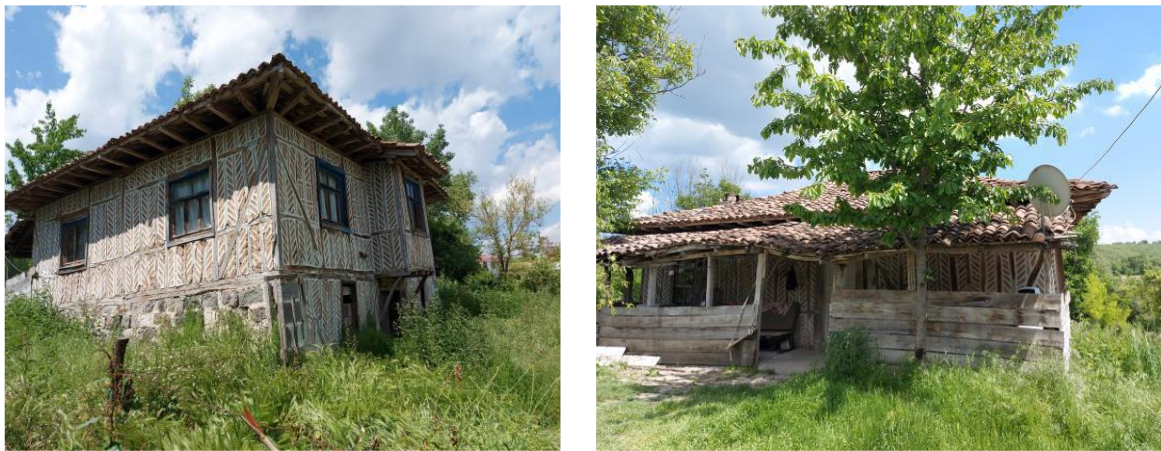
Figure 14. Sarıtaş house

The building was constructed with a masonry stone system on the ground floor and a timber frame filled with fire bricks on the first floor. On the front façade of the ground floor, instead of the masonry stone system, a hybrid construction technique using fire bricks within a timber frame was preferred. The fire bricks were arranged in a herringbone pattern, creating an aesthetically unique façade. The building lacks plaster. There are two exterior doors. Due to the sloped terrain, the structure appears as two stories from the front façade and as a single story from the rear façade, with ground-level entrances on both sides. The main entrance door, a double-leaf wooden door, is located beneath a cantilevered bay window supported by brackets. The rear entrance is a single-leaf wooden door. A veranda, supported by wooden posts, was created under the alaturka tile roof at the rear, just below the roofline. In some parts of the building, damage was repaired with bricks, which are inconsistent with the original structure. Wooden casement windows are used on both the ground and first floors, aligned symmetrically. The roof of the rectangular building is a hipped roof, covered with traditional Turkish tiles (Figure 14).
