# Recommendations for the Restoration and Conservation of Early Christian Period Rock-Cut Settlements in the Reservoir Area of Karakurt Dam (Kars, Türkiye)

Oktay DUMANKAYA – İrfan TUĞCU – Mesut YILMAZ

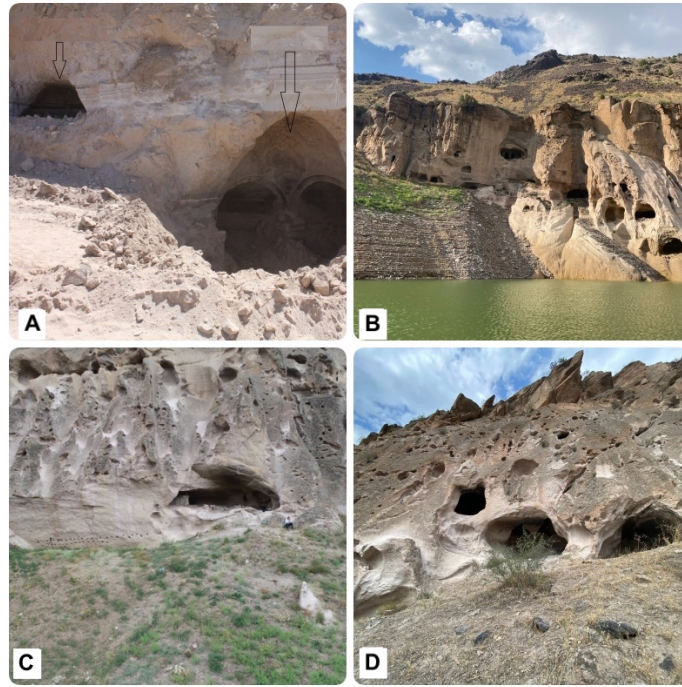
The rock settlements and the Akkoç Church near the Karakurt Dam were also carved into volcanic tuff (Fig. 3). Located on slopes with inclinations between 60° and 90°, these rock-carved settlements provided strategic advantages for defense against potential threats. In addition to independent rock-cut rooms, interconnected spaces with staircases were also present. Rooms closer to the ground level were used as stables, while higher and larger rooms served as shelters, residences, tombs, or storage spaces (Fig. 4). Over the centuries, the structural integrity of these early Christian rock-cut settlements and religious structures has been preserved. However, following the filling of the dam reservoir, it has been determined that the structures are now exposed to the effects of water fluctuations and wave movements. Archaeological research conducted during the summer, when the water level recedes, has revealed collapses and erosion on the surfaces of some of the rock settlements that emerge above the water (Figs. 5-6).

Fig.3. A) Akkoz Church B) Rock-cut settlements-I  
C) Rock-cut settlements-III D) Rock-cut settlements-II

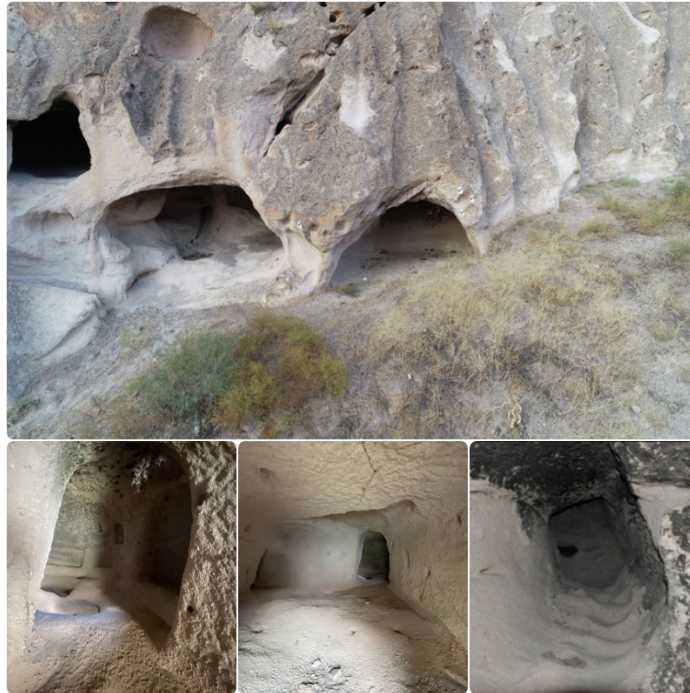
Fig.4. General views of the rock-cut settlement-II.

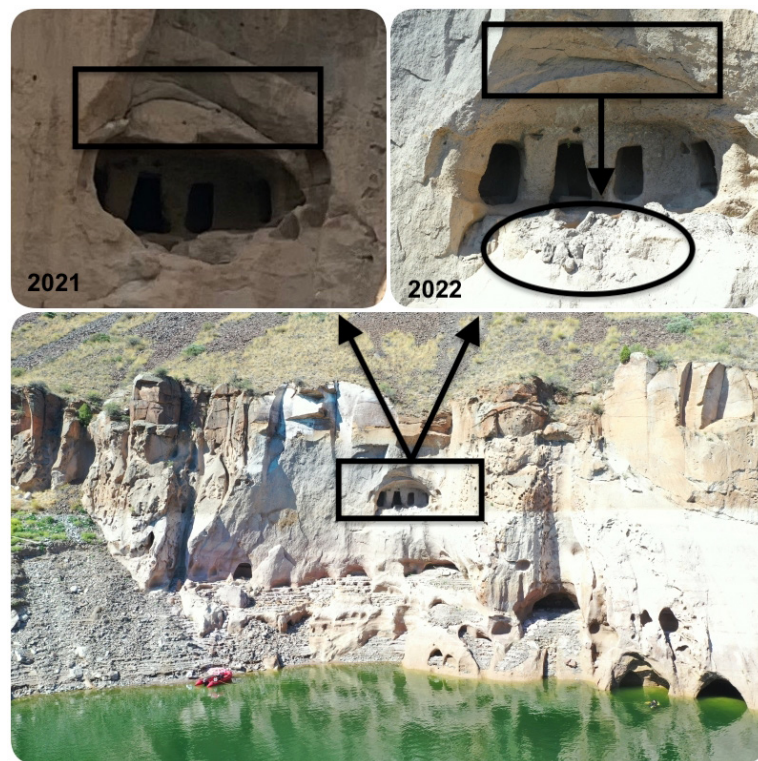
However, following the impoundment of the dam, these cultural assets have begun to deteriorate physically due to wave action and water-level fluctuations. Observations made during low water periods revealed signs of erosion, collapses, and surface cracking on the rock faces. Underwater surveys further

Fig.5. Details of the damage occurred in the rock-cut settlement-III over the years.

- Before starting the filling process, the spaces should be cleared of mud layers, accumulated soil, and detached fragments from the surface.

- Cracks and voids within the rock mass should be filled and reinforced with non-salty mortar injections. If necessary, alternative reinforcement methods and materials can be considered. Prior to implementation, the strength and suitability of cement-based and lime-based materials should be tested. The most appropriate material for reinforcement should be selected.

\*After cleaning the caves, 2-inch injection pipes, as shown in the detailed drawings, should be installed and secured within each cave.

\*Subsequently, the rock-cut rooms should be filled with rubble stones of varying sizes that match the lithological properties of the bedrock, and the entrances to the spaces should be sealed with mortar-based stone walls. Using rubble stones that match the lithology of the bedrock will ensure a consistent environment, preventing further fragmentation and degradation of the internal structure.

\*Once the filling of the rock-cut rooms and the sealing of the entrances are completed, mortar injections should be carried out through the 2-inch injection pipes that were previously installed (Fig.10).

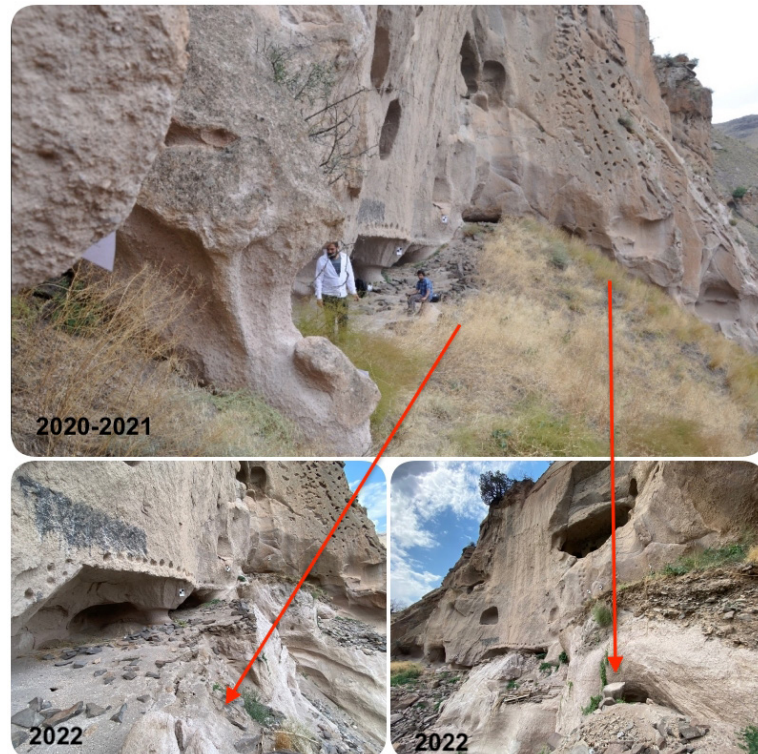
separations have developed over time, resulting in collapses caused by accumulated stress. Observations also indicated that, in addition to superficial soil erosion, localized collapses and mass soil movements have occurred on the slopes where the rock settlements are located. Based on these findings, it is recommended that damaged areas be filled in a manner that maintains the structural integrity of the surrounding rock, particularly in areas where continuous erosion and cracking have weakened the rock-cut settlement. This approach will ensure that the walls of these spaces retain their stability.

Fig.6. Details of the mass soil slide that occurred in the rock-cut settlement-III.

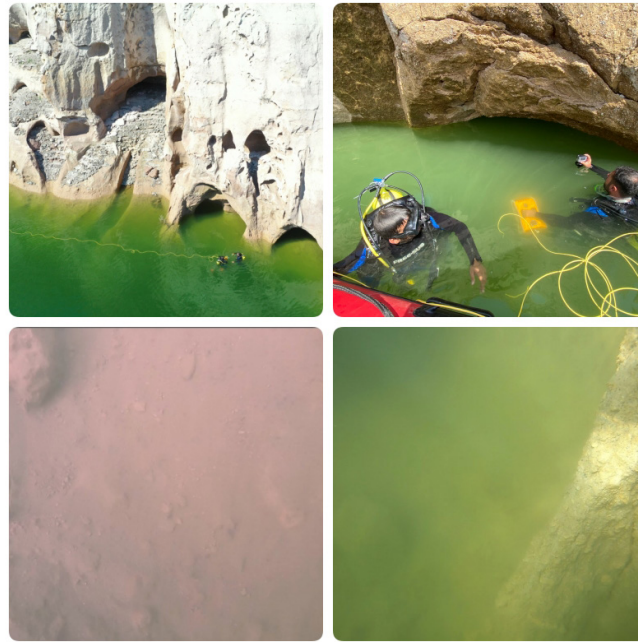
Underwater archaeological researches have also identified layers of mud deposited by the reservoir on the floors of the rock settlements, as well as erosion and surface cracks on the structures (Fig. 7).

Fig.7. Details of the damage that occurred in the submerged rock-cut settlement-IV.

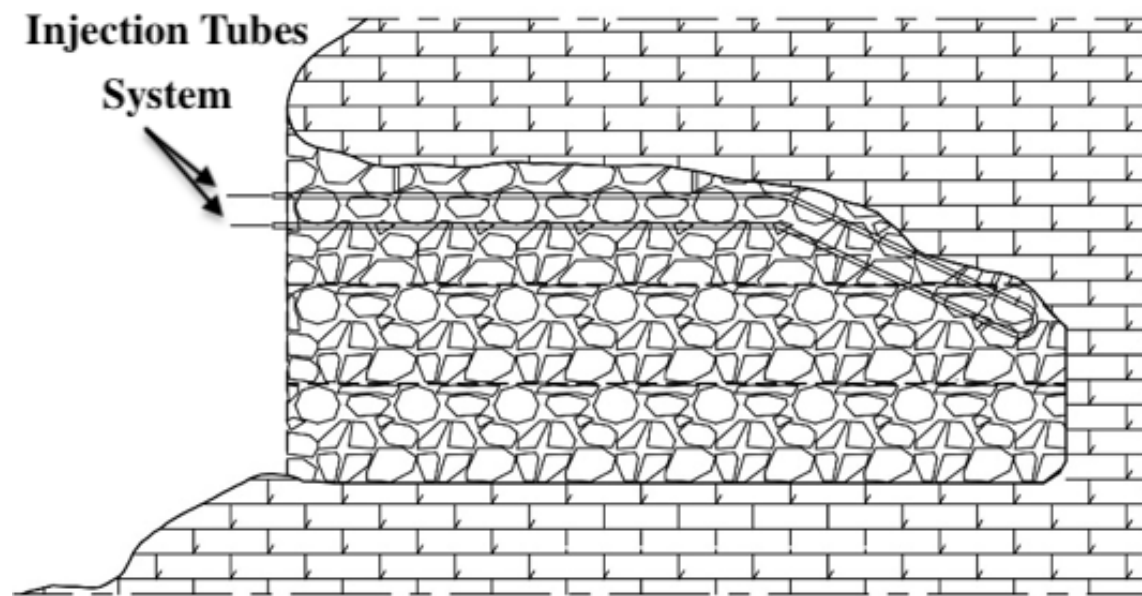
Fig.10. Details of the injection tubes system.

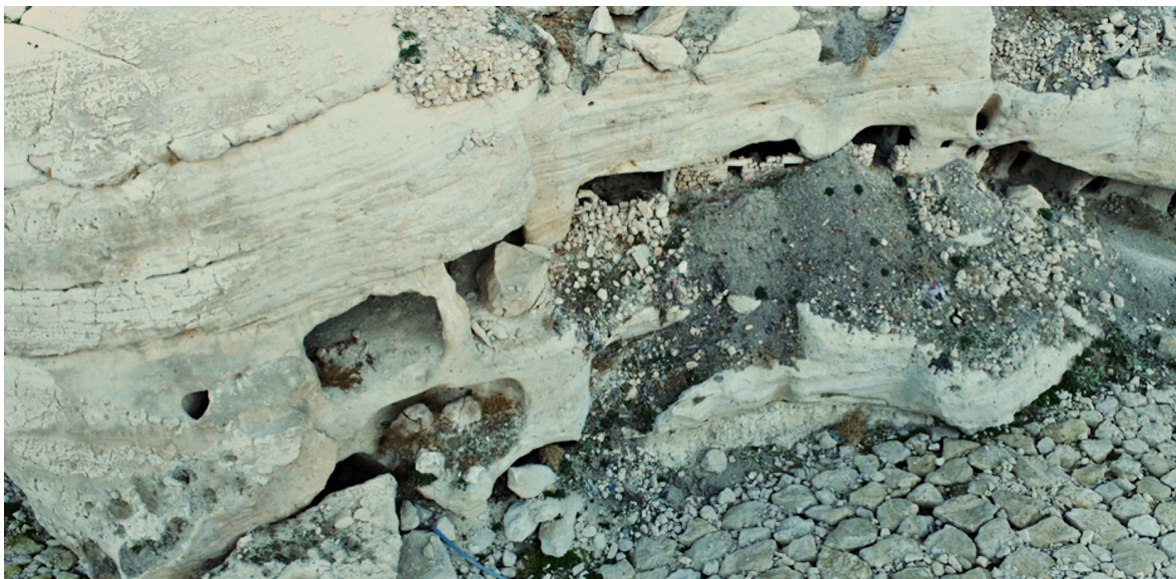
The first of these similar practices was successfully implemented in the Ilisu Dam archaeological site, in the Upper City of Hasankeyf, along the Tigris Valley, and in the surrounding areas. In these regions, approximately 225 rock-cut rooms were identified and preserved (Fig. 11-12). The rock formations in the Karakurt rock-cut settlements of the Aras Valley,<sup>28</sup> composed of volcanic tuff, claystone, and limestone, share similar characteristics with the thick

Fig.11. View of the rock-cut settlements of the Ilisu Dam.

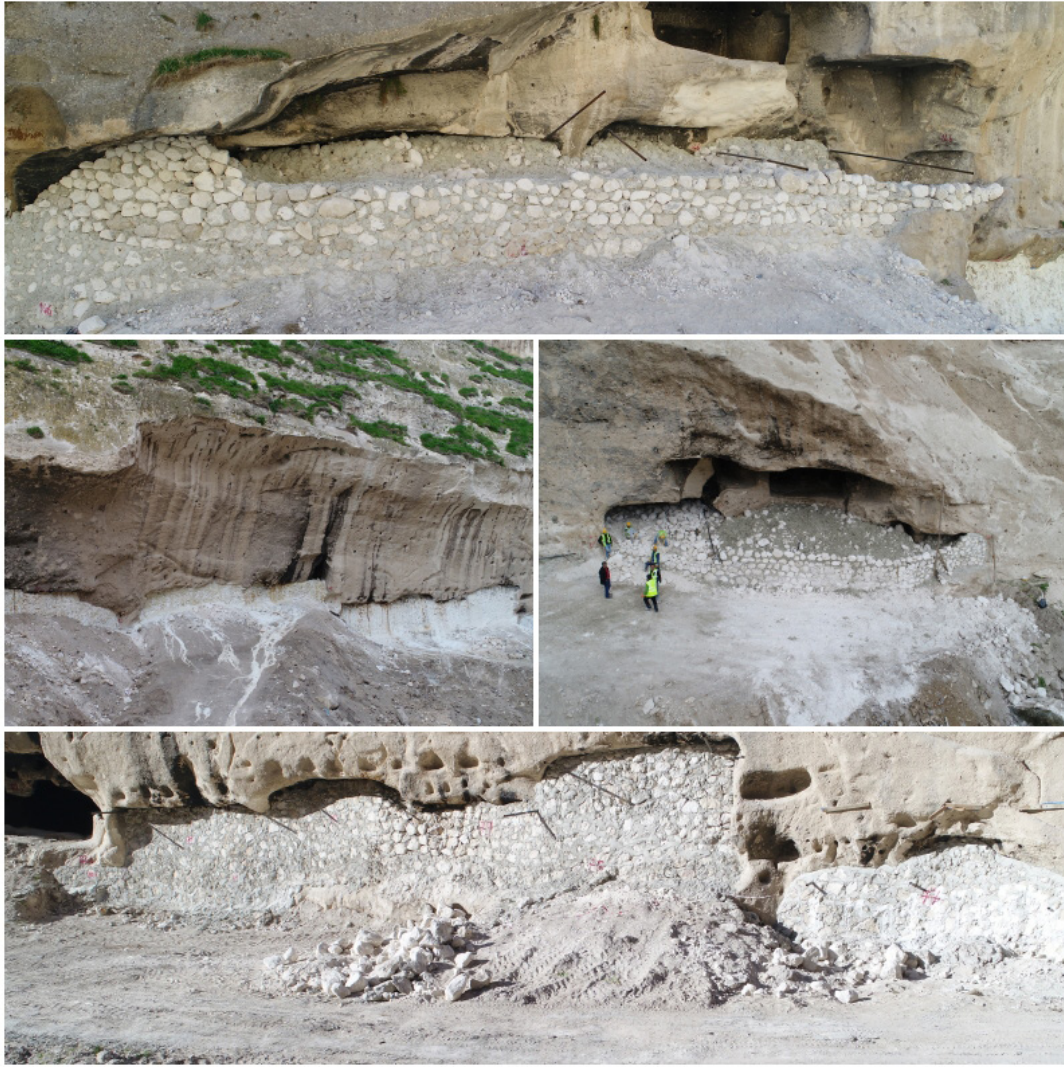
Fig.12. View of the rock-cut settlements of the Ilisu Dam.
