# Evaluations of the Byzantine Period Data Obtained from the Archaeological Excavations of the Tuzla Değirmenaltı Monastery in Istanbul

Rahmi ASAL<sup>1</sup>  
Yusuf ÇURKU<sup>2</sup>  
Yusuf TOKGÖZ<sup>3</sup>  
Tolga KÖROĞLU<sup>4</sup>

**Cite this article:** Asal, R., Curku, Y.,  
Tokgöz, Y. & Köroğlu, T. (2025).  
Evaluations of the Byzantine Period Data  
Obtained from the Archaeological  
Excavations of the Tuzla Değirmenaltı  
Monastery in Istanbul. *Anatolian  
Archaeology*, 5, 35-59.

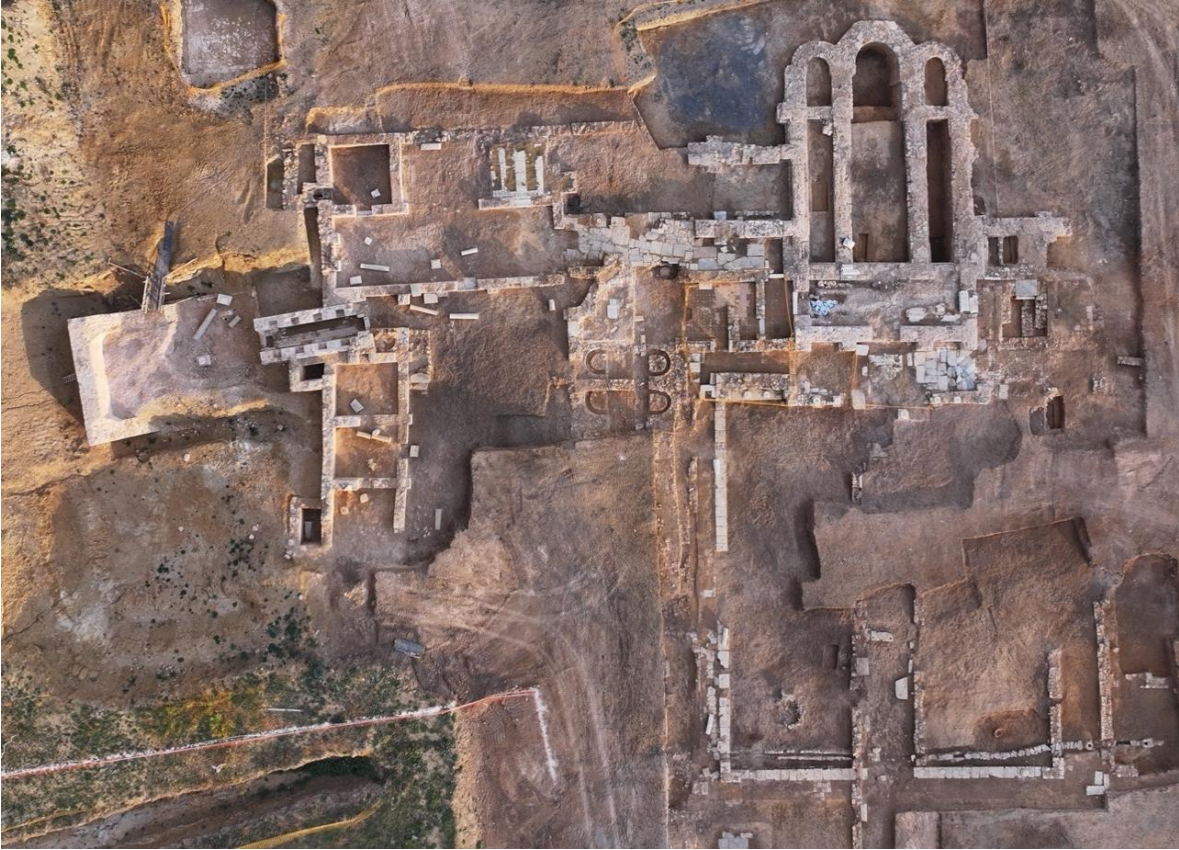
**Figure 1:** Aerial view of the excavation site (iAM<sup>32</sup> archive).

To the west of the church, there is a square-plan atrium (**Fig. 1**). Excavations are still ongoing in the atrium, where the *stoa* sections to the north and west have been uncovered at the floor level. The *stoa* features a series of columns, and the walking areas are paved with bricks arranged in three rows,

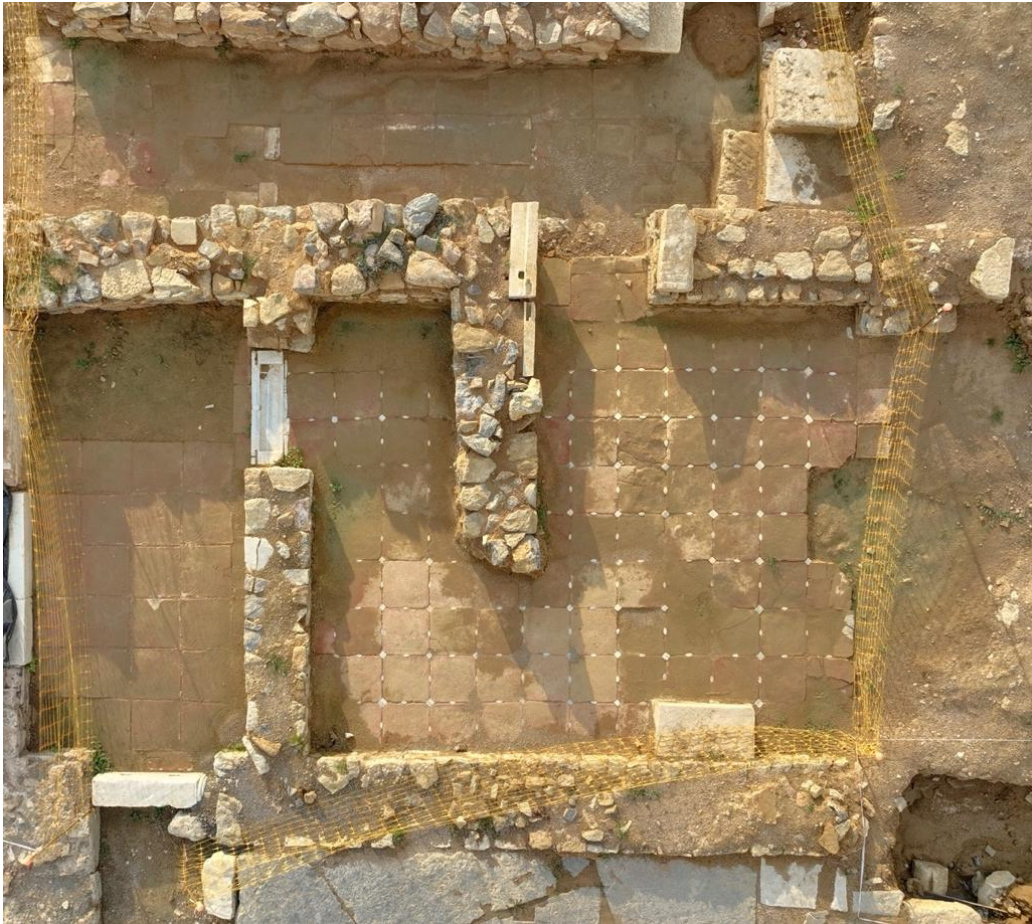
**Figure 3:** Brick pavement decorated with opus sectile fragments (IAM archive).

The interior of the main space is paved with bricks measuring 0.45 x 0.45 meters. The gaps between the brick flooring are decorated with small geometric patterns resembling *opus sectile*. The unique combination of brick and marble in this flooring is significant, as there are no other known examples from Byzantine excavations (**Fig. 3-4**). In the western part of the main space, there is another entrance measuring 1.10 meters in width. Adjacent to this entrance is a wall, 2.70 meters long, that divides the main space in the west-east direction and is understood to have been constructed in a later period. This space is presumed to serve as a transition area from the church to the refectory.

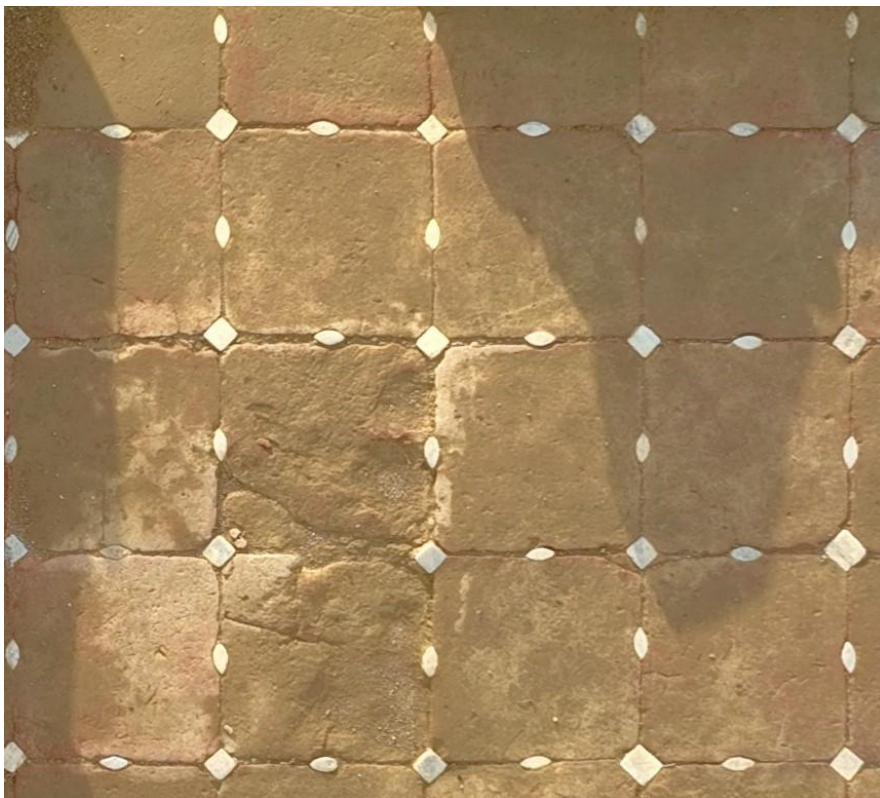
**Figure 4:** Detail view of the brick pavement decorated with opus sectile fragments (IAM archive)

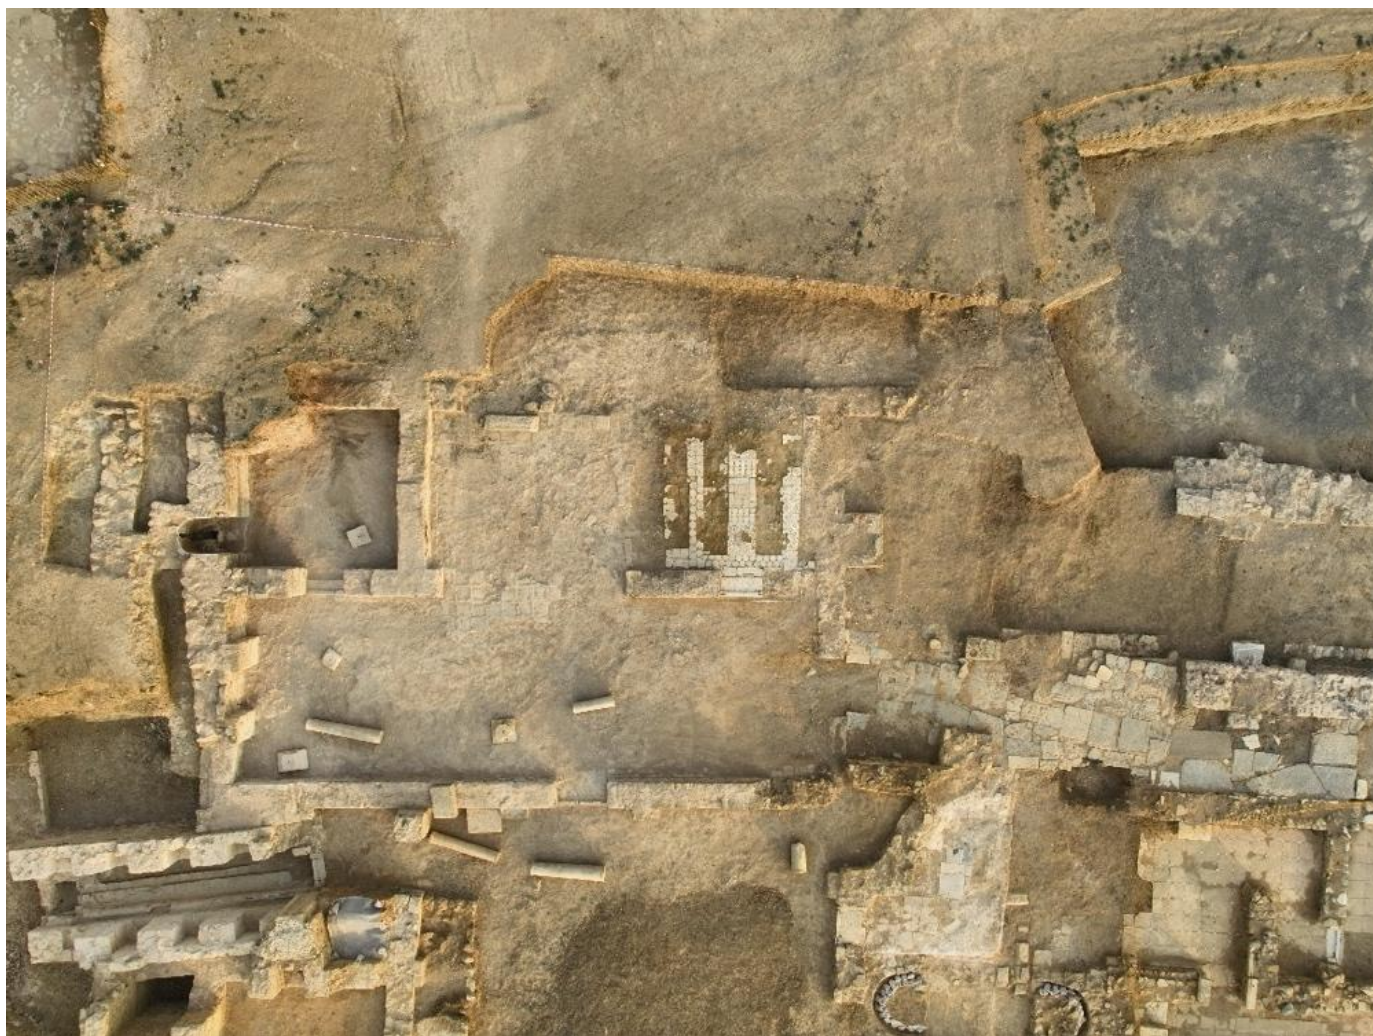
**Figure 9:** Aerial view of the building to the north of the church (IAM archive).

Large structures have been identified in the excavations to the north of the church, which have been coded as "Structure A" due to the ambiguity of their function (**Fig. 9**). The dimensions of the structure are 16.70 x 10.20 meters two separate symmetrical spaces have been created at the eastern corners of the structure, transforming its internal layout into an inverted T-shape. Both of these spaces measure 4.50 x 4.30 meters each of these spaces has two entrances located to the west and south of the northeastern corner, with the southern entrance having been later closed off. A notable feature of this space is the presence of a toilet (**Fig. 10-12**).

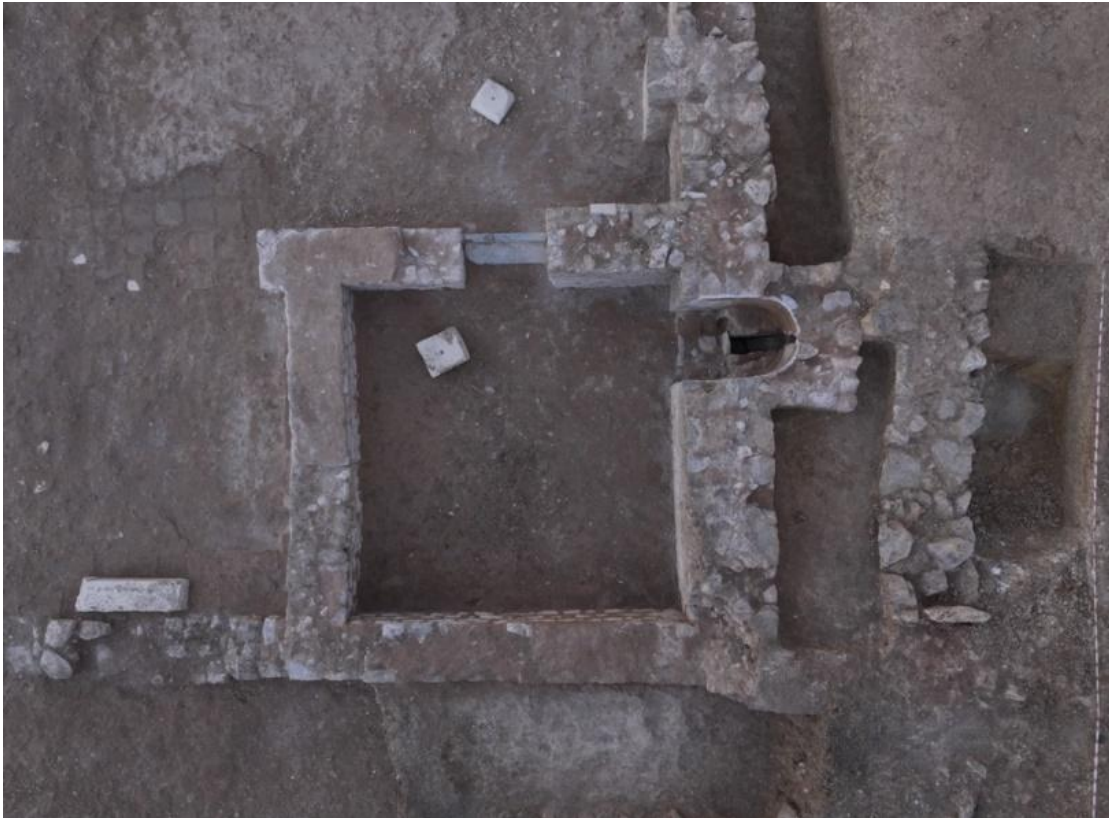
**Figure 10:** The space with the toilet in the niche (IAM archive).

The toilet is situated within a niche that is 1.40 meters deep and 1.00 meters wide, opened on the northeastern wall. The toilet floor is raised by a step of 0.15 meters relative to the room's floor. The seating plane of the toilet is also elevated approximately 0.45 meters above this floor. A row of pipes has been identified at the back wall of the toilet, indicating that sanitation was maintained through these pipes. This section of the wall, through which the pipe line

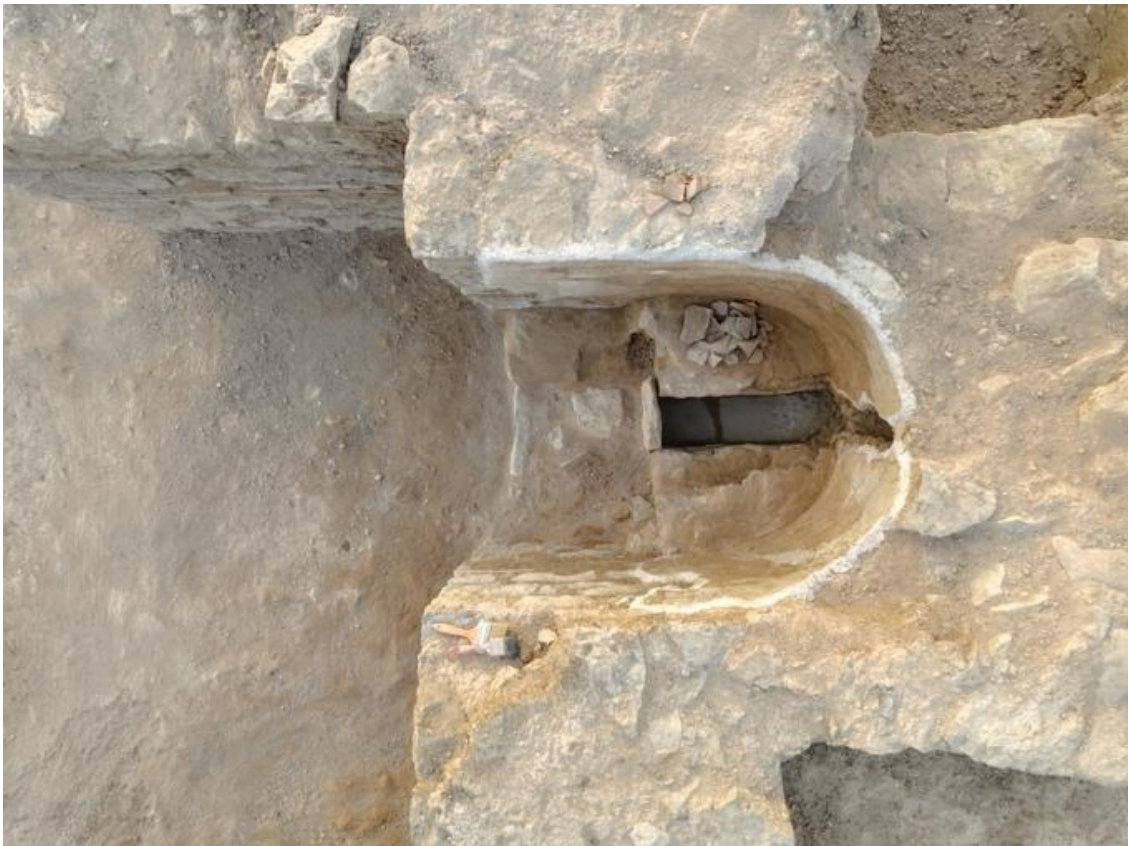
**Figure 11:** Toilet in the niche (IAM archive).

passes, has survived to the present day due to repairs made during its period. Only a small portion of the pipe series has been preserved in the opening of the wall. Inside the toilet, stones have been placed at a slope towards the sewer to facilitate better water flow. The method of channeling water through the walls to supply the toilet is significant in understanding the water infrastructure during the Byzantine period.

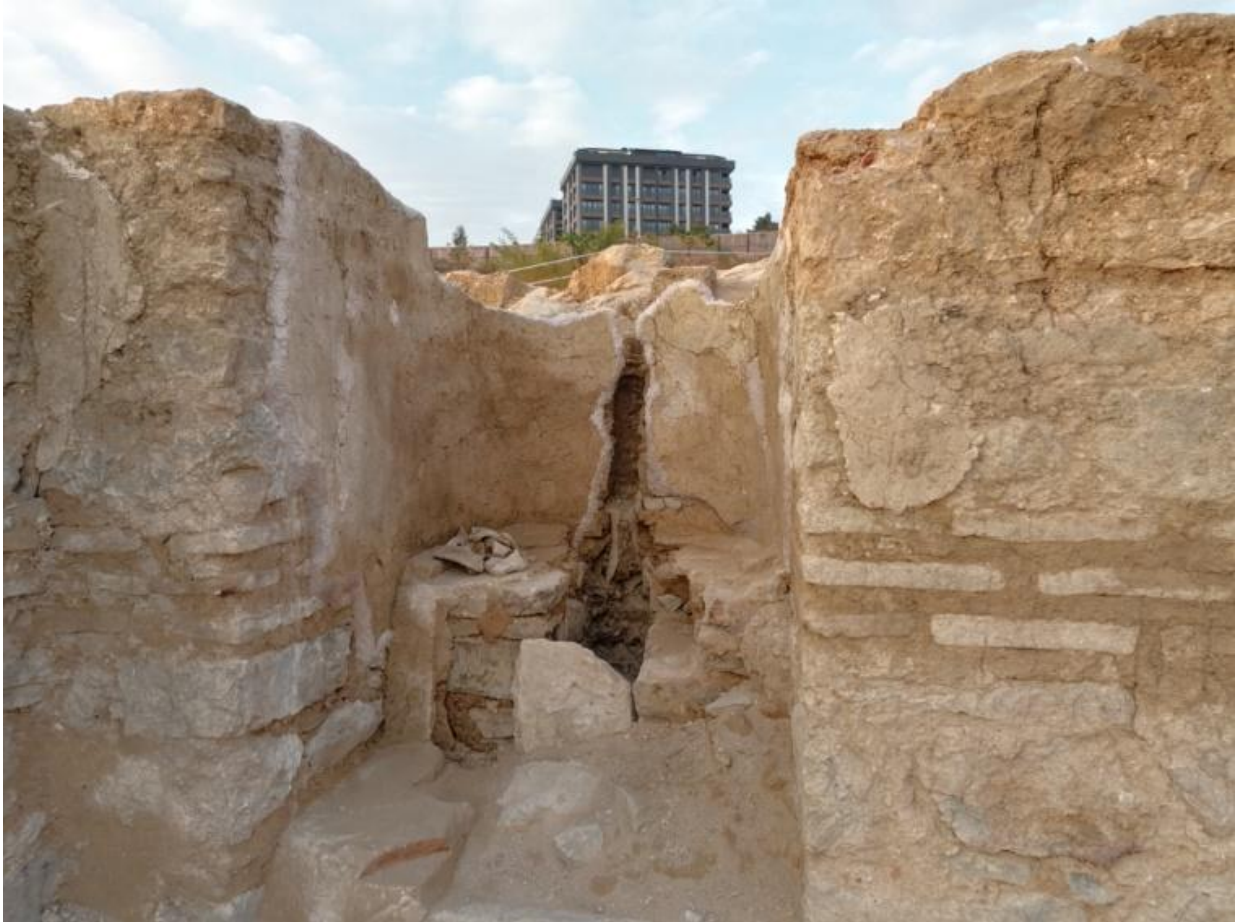
**Figure 12:** Toilet in the niche (IAM archive).

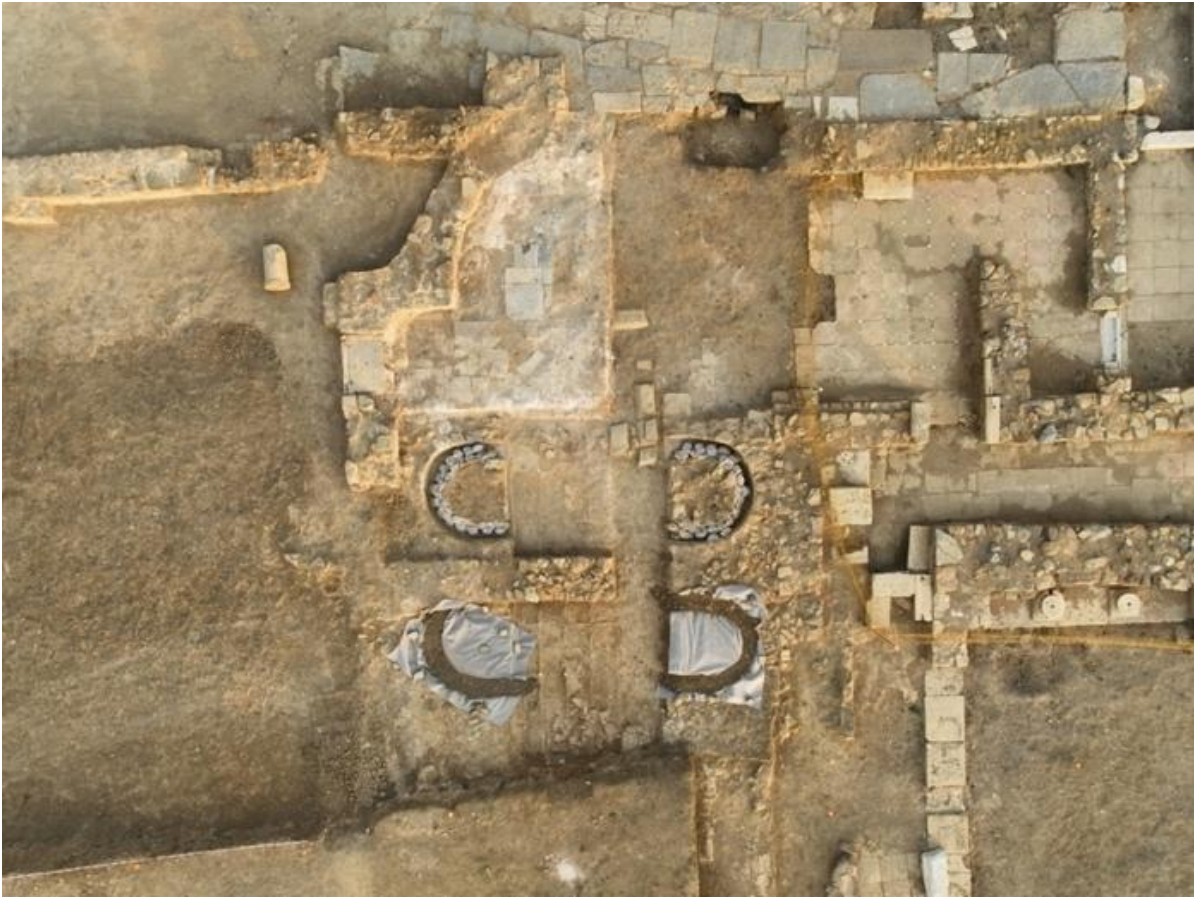
**Figure 14:** Aerial view of the refectory (IAM archive).

The refectory unit of the monastery has been identified in the excavations to the north of the church (**Fig. 14-15**). A significant portion of this structure, which is still under excavation, has been uncovered. The single-nave structure measures 25.00 x 9.00 meters and extends in an east-west direction. An apse measuring 6.00 meters in width is situated at the short eastern end. The southern half of the apse is completely collapsed. From the surviving section, it can be inferred that the floor of the apse is approximately 0.25

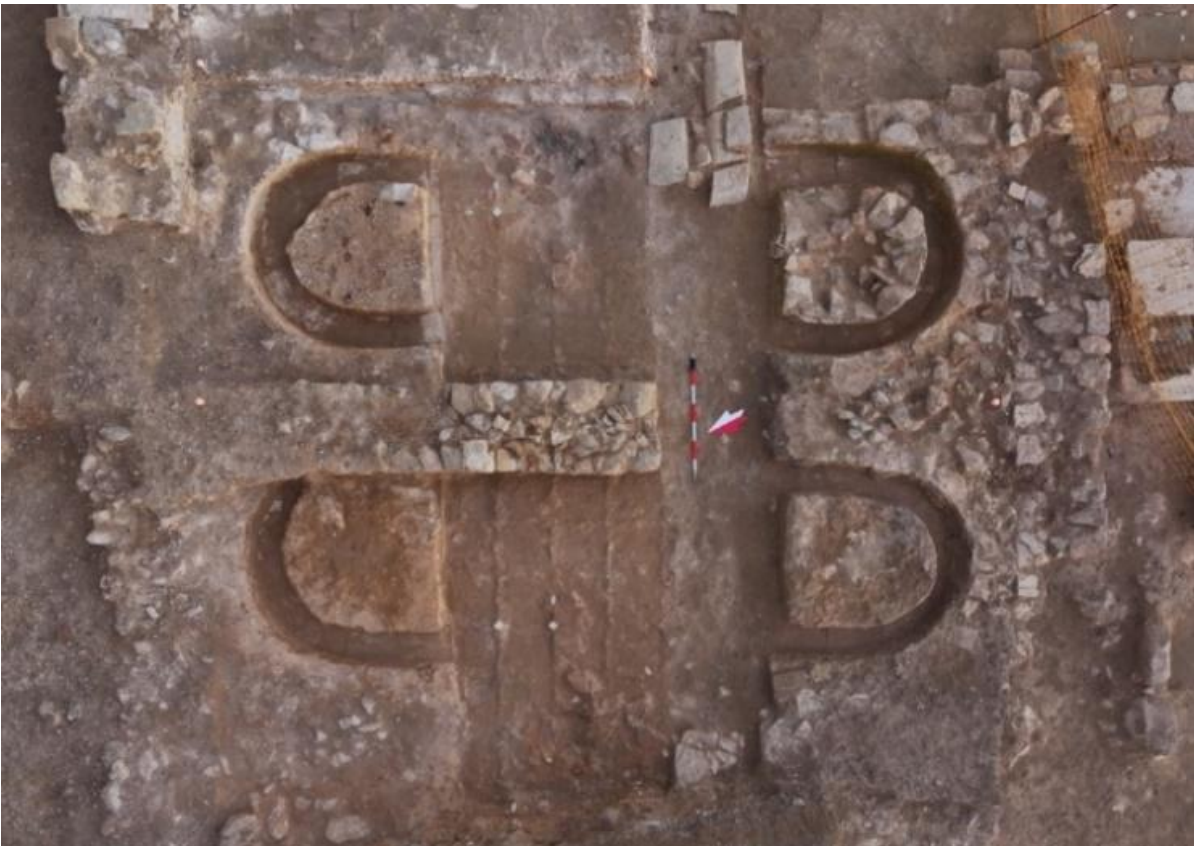
**Figure 15:** Detail view of the refectory (IAM archive).

meters higher than the floor of the other sections of the structure. Four dining tables, symmetrically arranged along the walls, have been identified at the base level within the structure. These tables are made of stone laid on a brick floor and constructed in a "horseshoe" form. Each table measures 1.20 x 1.20 meters and is surrounded by an approximate 0.30 meters gap.

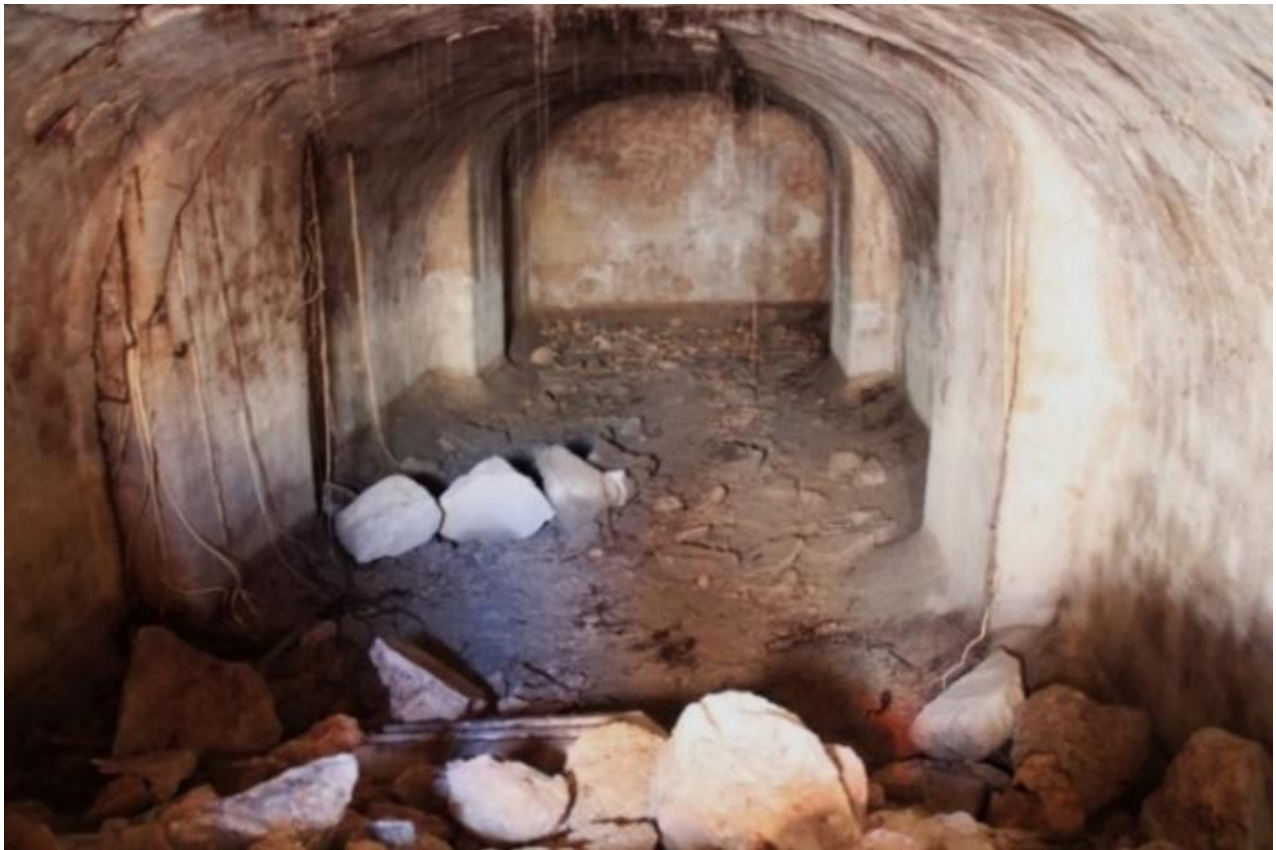
**Figure 17:** View of the cryptanalysis before the works (IAM archive).

It is known that tombs were created at the base of the narthex in monastery churches for the burial of deceased clergy<sup>19</sup>. Following the identification of damage at the northern end of the vault in the church's inner narthex within the excavation site, deepening work was conducted in the damaged area, leading to the discovery of the crypt (Fig. 17). The external dimensions of the crypt are 11.45 x 3.15 meters, with a height of approximately 2.00 meters. The interior of

the crypt is plastered, and its long walls are supported by internal piers. Evidence of subsequent damage is indicated by marble window frames, column bases, broken brick fragments, and rubble in the form of a mass with horasan mortar found to the north of the crypt.

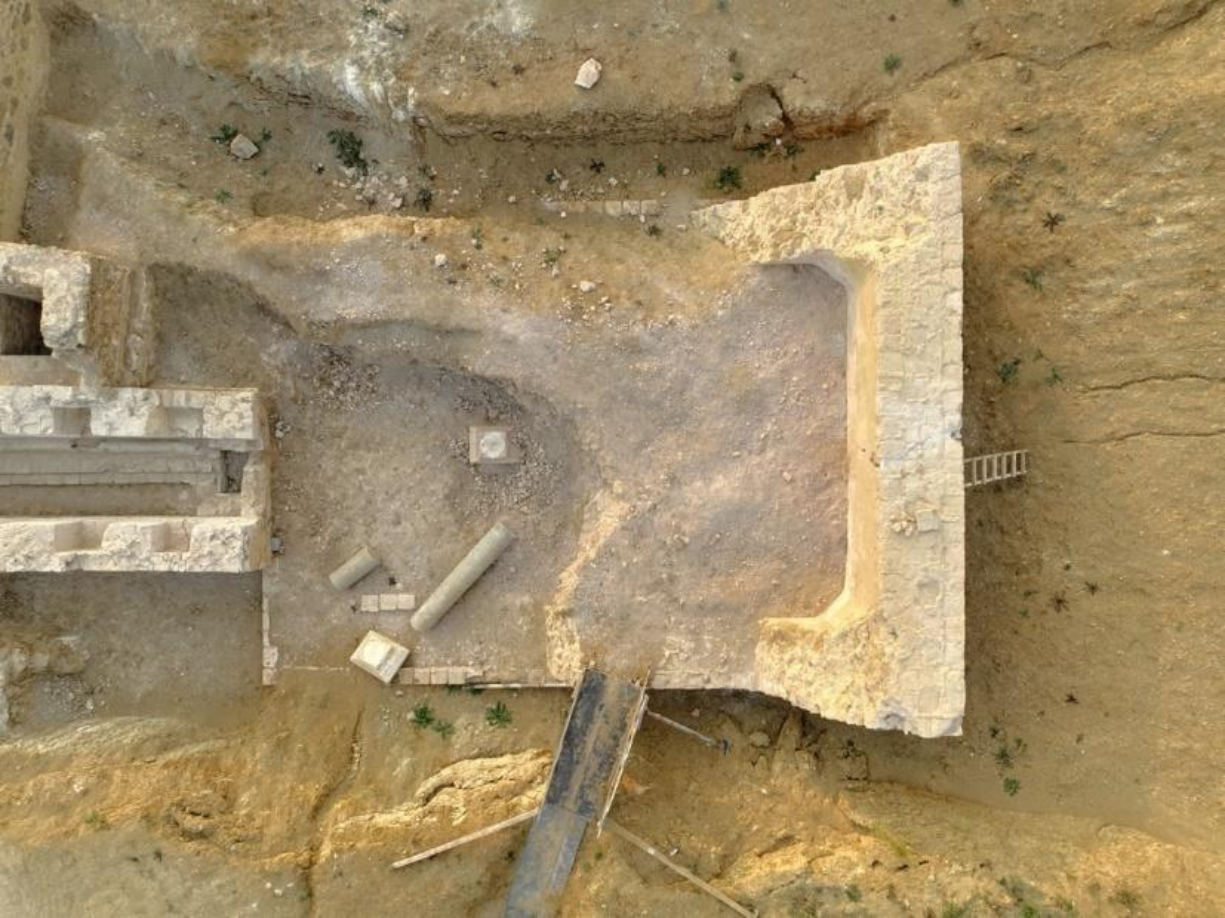
**Figure 24:** Aerial view of the cistern structure (IAM archive).

In the northern part of the excavation site, remains of a cistern measuring 9.00 x 12.60 meters were discovered (**Fig. 24-26**). The structure is located closest to the workshop (Figure 26). This north-south oriented rectangular structure has suffered damage in earlier periods. The northern wall of the structure has survived in good condition, while the other walls have been found to have collapsed down to the foundation level. The walls, approximately 1.30 meters thick, are constructed using the alternating masonry technique, with five rows of brick laid following the stone pattern. The plaster on the walls within the cistern has a thickness of approximately 0.04 meters which varies in places. Debris associated with the structure has been found inside, including a granite column measuring 3.55 meters in length and two Ionic impost capitals obtained during cleaning operations. Excavation and restoration work on the structure is ongoing.

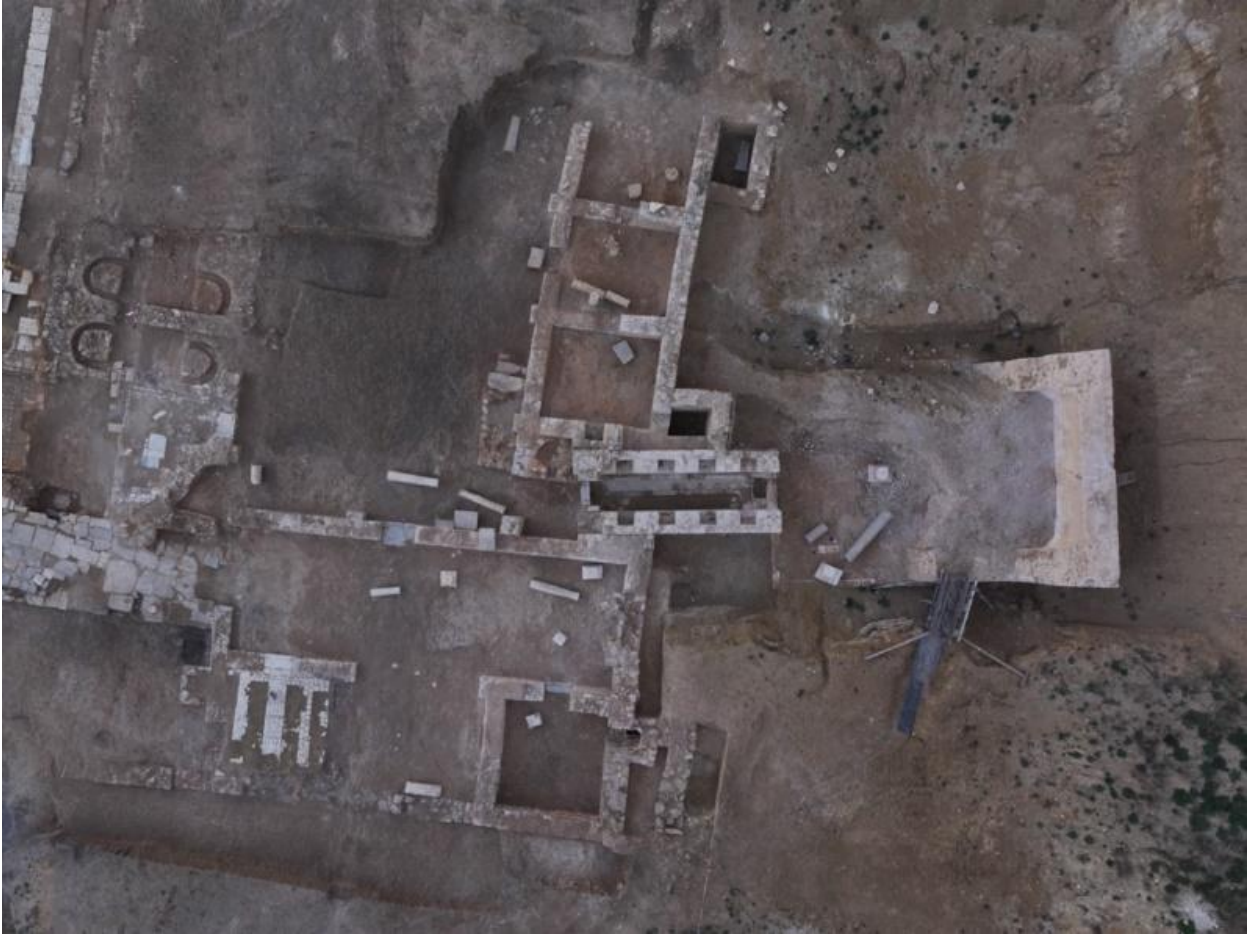
**Figure 26:** Aerial view of the cistern and workshop (IAM archive).

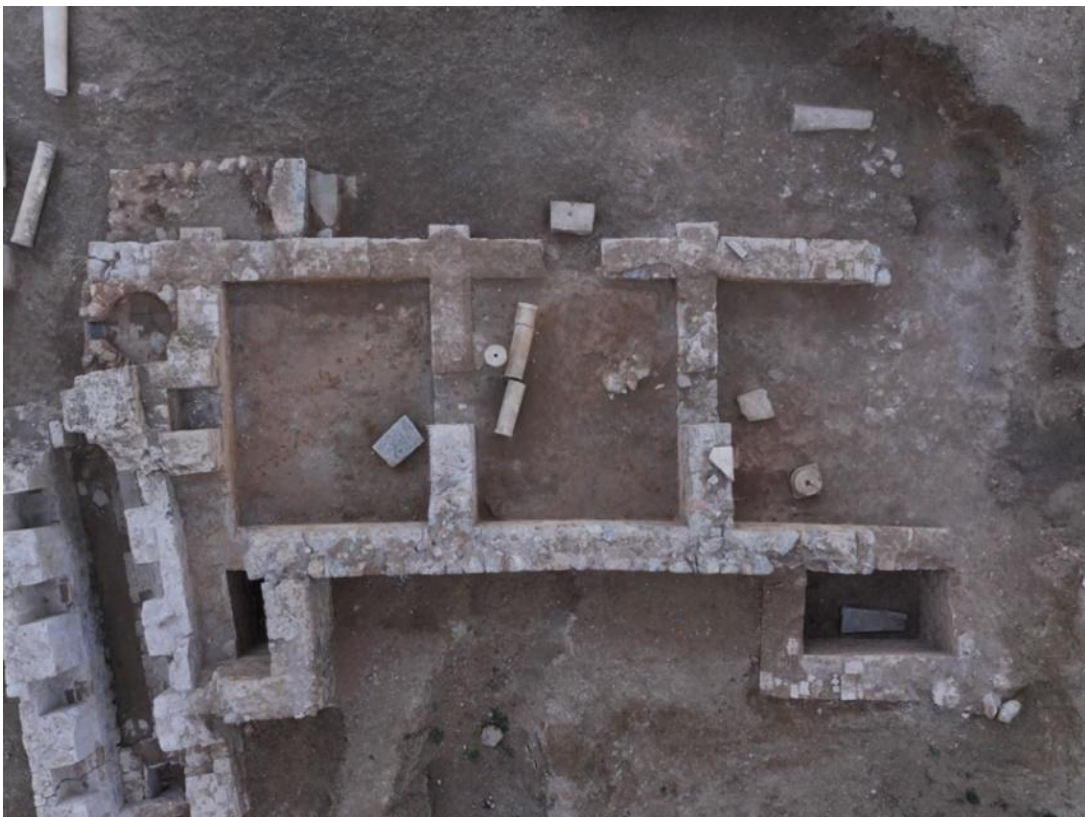
**Figure 27:** Aerial view of the workshop (IAM archive).

During the excavations at Tuzla Değirmenaltı Monastery, remnants of a structure believed to be a workshop have been uncovered to the south and southwest of the cistern (**Fig. 27-28**). Excavation work to the south of the cistern revealed a rectangular structure measuring 7.50 meters in length and 1.65 meters in width. On either side of the structure are symmetrical niches, each measuring 0.72 meters in width and 0.54 meters in depth. Although the upper part of this structure is collapsed, it is understood that the niches were covered with arches. The wall surface of the niches is covered with white plaster. There are two levels of brick courses at the base of the transition area. At the northern end of this brick course, there is a collection pool measuring 0.80 x 0.85 meters and 1.00 meters in depth. Additionally, a series of pipes runs along the north-south axis at the base of the structure. At the southern end of the passage with niches on either side, there is an entrance section flanked by columns. The eastern column of this section is collapsed, while the western one has survived to the present day. A marble door threshold measuring 1.00 meters in width and 0.38 meters in height has also been preserved.

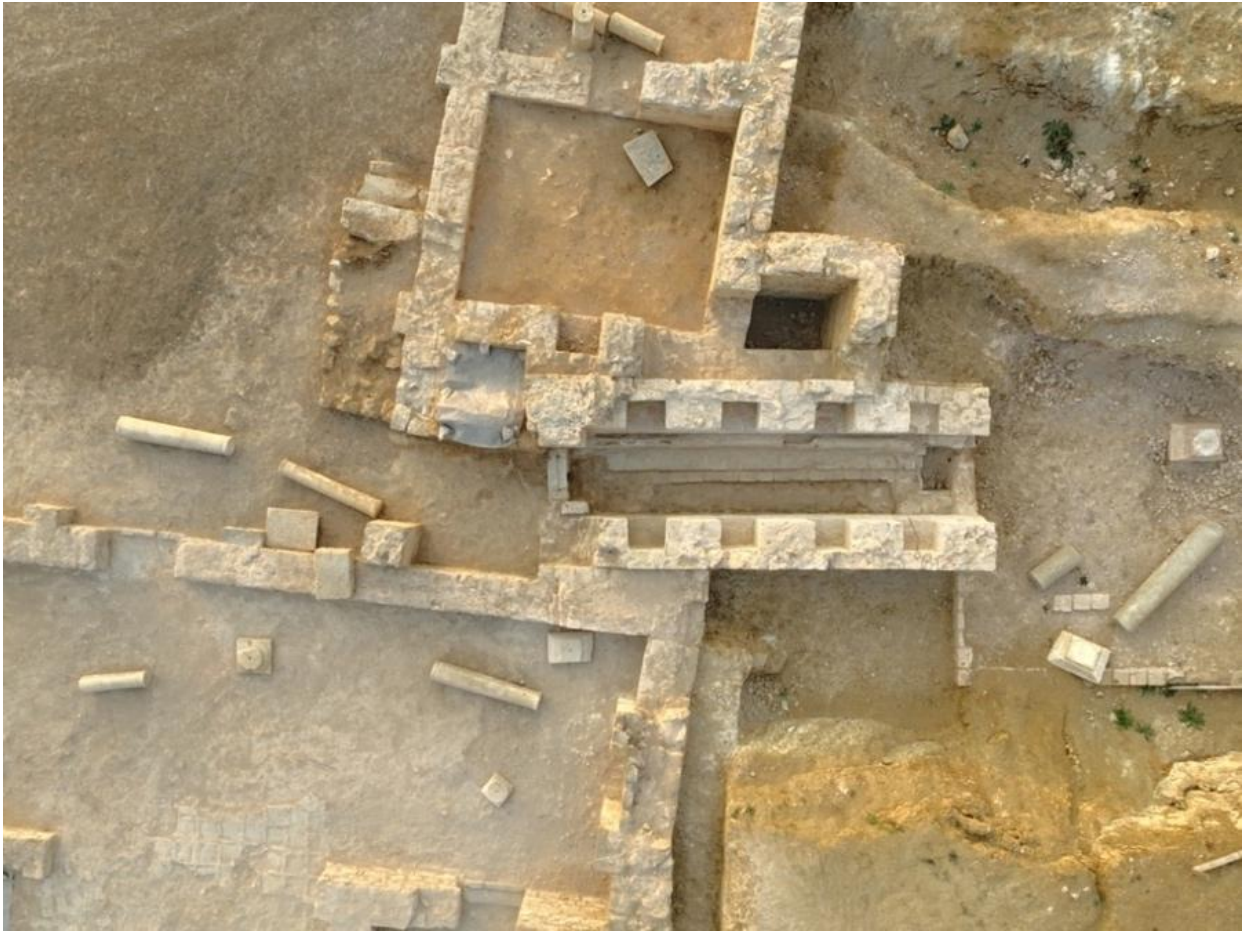
**Figure 28:** Aerial view of the workshop (IAM archive).

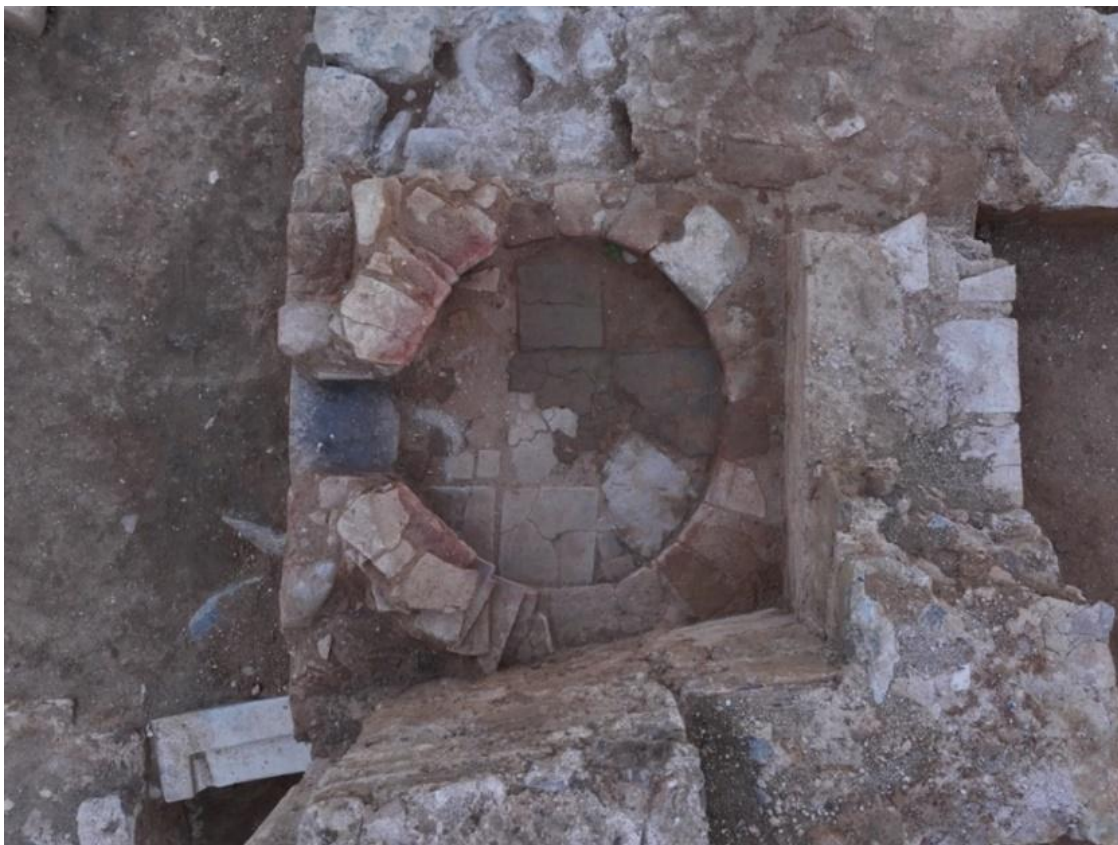
**Figure 29:** Oven in the workshop (IAM archive).

During the excavations, a round-shaped oven has been documented adjacent to the pier to the east of space a (**Fig. 29**). The body of the oven is supported on three sides (north, south, west), and the eastern part of the oven contains five rows of bricks that have survived, which is important for understanding the covering of the upper structure with a dome. In the center of these bricks, there is an opening measuring 0.40 meters in width used for cooking.

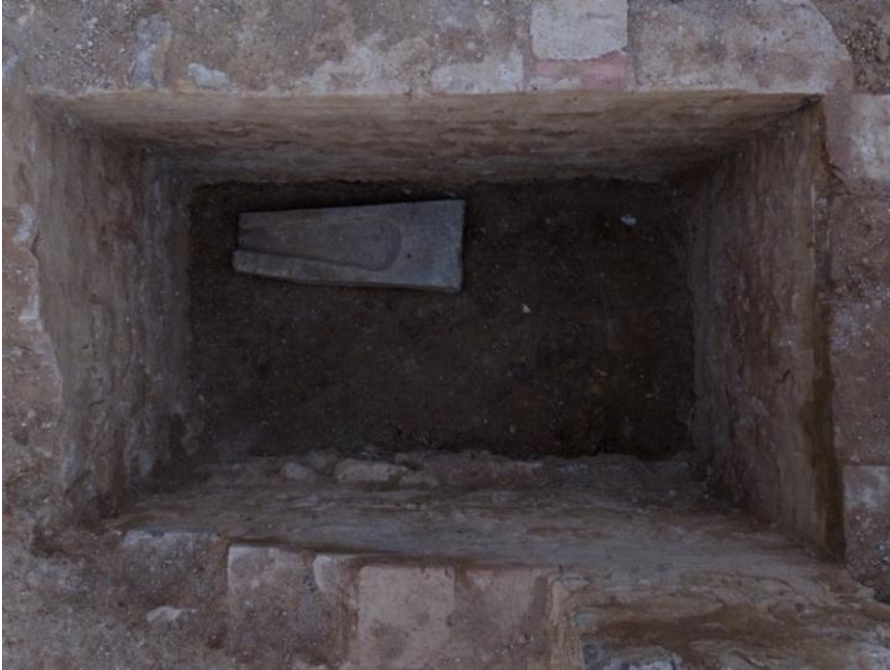
**Figure 30:** Crushing trough in the workshop building (IAM archive).

indeed a workshop (**Fig. 30-33**). The function of this structure will become clearer after the completion of excavation work. Additionally, during the excavations in this area, a fragment of a statue head and a pit coin dating to the Byzantine Period have been recovered (**Fig. 34**).

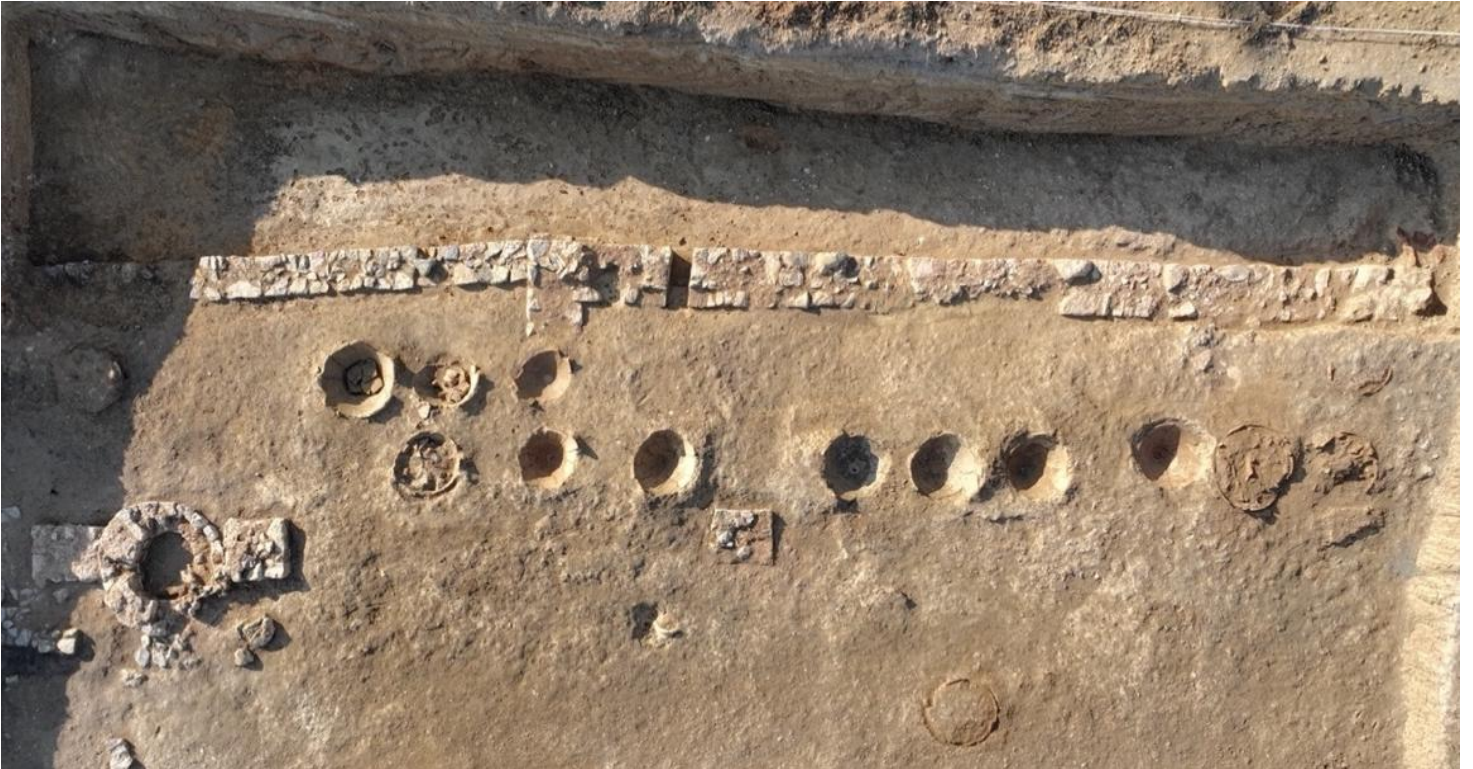
Figure 35: Aerial view of the storage (IAM archive).

In the excavations conducted to the west of the church on the excavation site, the storage space of the monastery has been identified (**Fig. 35**). Within this space, a wall composed of regular stone courses laid in a horasan mortar pattern has been uncovered, extending along a south-north axis. The wall measures approximately 20.00 meters in length, 0.50 meters in width, and 0.50 meters in height. Immediately to the east of this wall, nineteen pithoi have been discovered, arranged in two rows. Soil samples have been taken from within the pithoi for analysis. The pithoi have been numbered, and documentation and restoration processes have commenced. Repair traces from the period have been observed on pithos number eight (**Fig. 36**). South of the storage space, a tower-like structure composed of stone courses bonded with horasan mortar has been identified at the foundation level. This structure is supported by two pillars measuring 1.00 x 1.00 meters at both the northern and southern ends. The wall thickness of the remains is 0.60 meters, and the internal diameter measures 1.20 meters. The function of this structural remnant has yet to be defined.

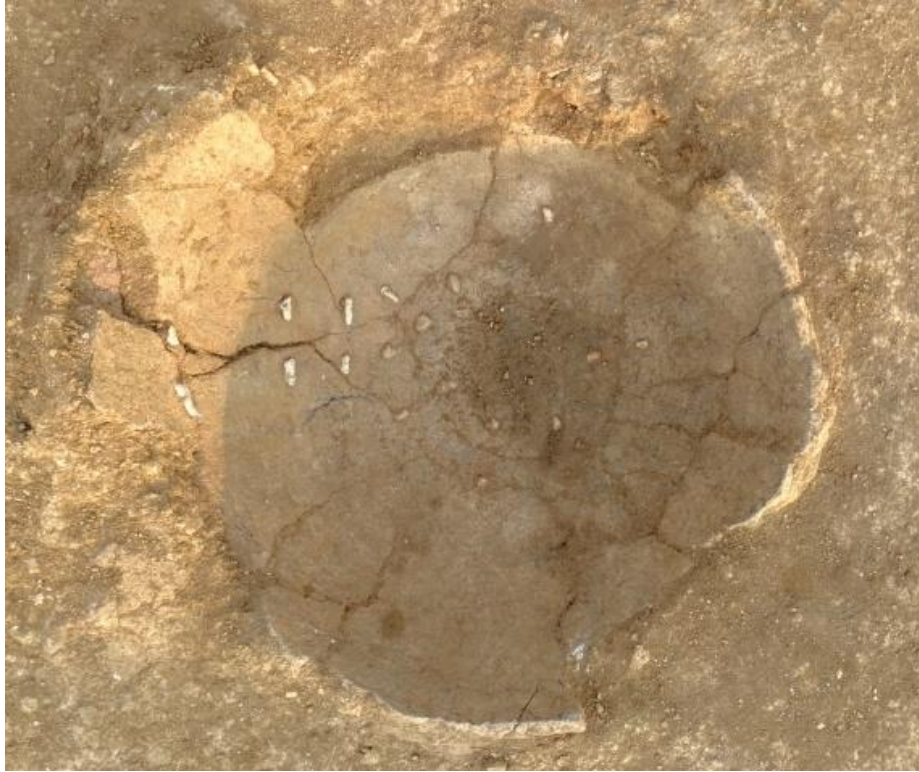
**Figure 36:** Period repair marks on pithos number eight (IAM archive).
