# ADAPTIVE REUSE OF INDUSTRIAL HERITAGE: ESKİŞEHİR HALLER YOUTH CENTER

## YENİDEN İŞLEVLENDİRİLEN ENDÜSTRİ MİRASI: ESKİŞEHİR HALLER GENÇLİK MERKEZİ

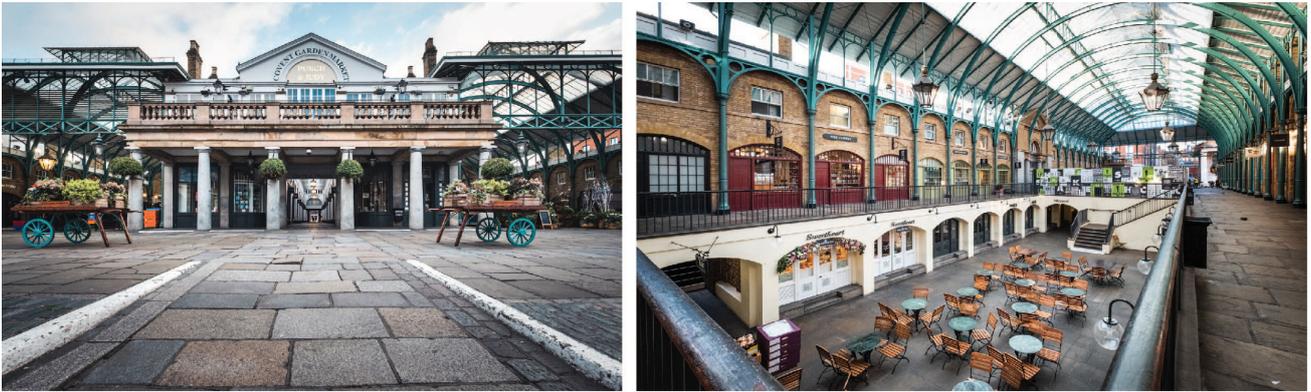
**Figure 2**

Façade and Interior Images of Covent Garden Building / *Covent Garden Binası Cephe ve İç Mekan Görşelleri* (Sherwin, 2019)

One of the examined examples in this context is Covent Garden in London. After the Great Fire of London in 1666, the city underwent a major reconstruction process. Covent Garden was designed in 1828 by architect Charles Fowler in a Neoclassical style and opened in 1830 as a fruit and vegetable market (Covent Garden Market, 2025). In the 1970s, the building was planned to be demolished; however, due to public opposition, it was preserved and underwent restoration. Following a five-year process, it was repurposed in 1980 for commercial and cultural uses (Fig. 2). Today, it continues to serve as a multifunctional public space housing restaurants, theaters, and various commercial enterprises, contributing actively to urban life.

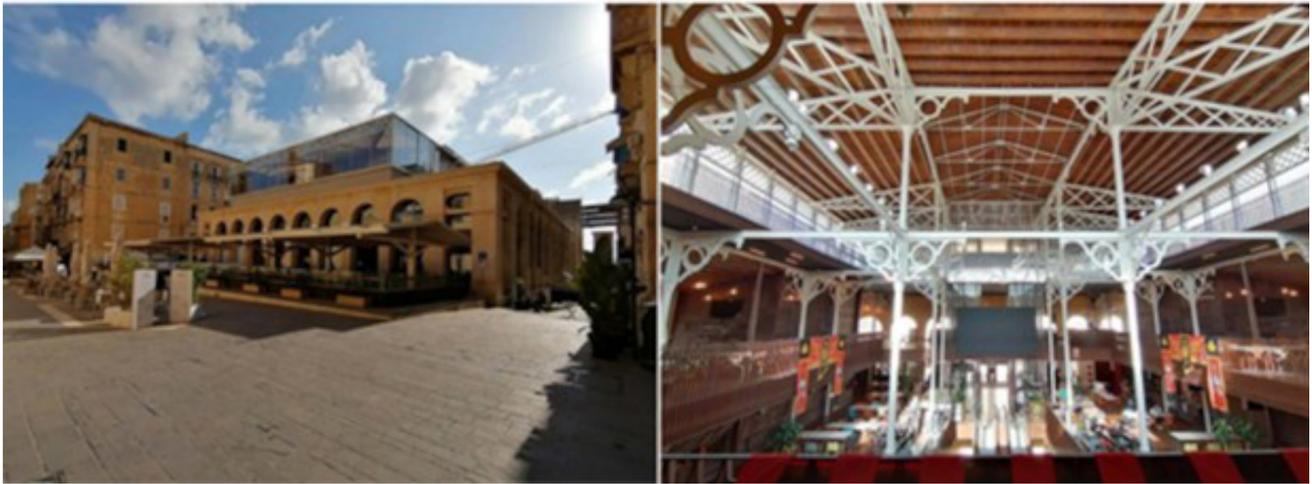
**Figure 3**

Valletta Market Hall Façade and Interior Images / *Valletta Hal Binası Cephe ve İç Mekan Görşelleri* (Bianco, 2023)

Another notable example is the Valletta Market Hall in Malta's capital, Valletta. Built between 1859 and 1861 using local limestone and cast iron, it suffered damage during World War II air raids. A comprehensive restoration process was carried out between 2016 and 2017, and the hall was reopened in 2018, coinciding with Valletta's designation as the European Capital of Culture (Bianco & Busuttil, 2022, p. 67). Today, it consists of three levels—a basement, a ground floor, and an upper floor—housing an organic produce market below, a local food market at street level, and cultural events on the upper floor. The basement houses organic food markets, the ground floor serves as a local food market, and the upper floor is designated for cultural and social events (Fig. 3).

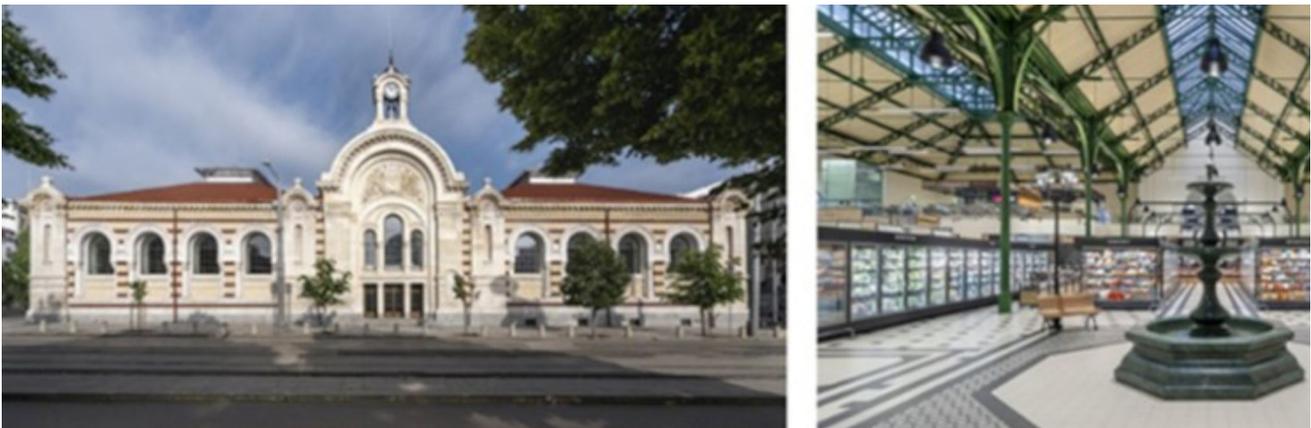
**Figure 4**

Sofia Central Market Hall Façade and Interior Images / *Sofya Merkez Hal Binası Cephe ve İç Mekan Görşelleri* (Hiese, 2024)

Sofia Central Market Hall represents another significant example of adaptive reuse. Sofia, the capital of Bulgaria, is one of Europe's oldest settlements. Built in 1911, the structure features a combination of Neo-Renaissance, Neo-Byzantine, and Neo-Baroque architectural styles, with a steel framework designed by Gustave Eiffel (Hiese, 2024, p. 201). The restoration process was completed between 2016 and 2017, and the building was repurposed as a commercial and cultural complex, incorporating food markets, restaurants, retail stores, and event spaces. During the renovation, remnants of Roman-era structures were preserved and displayed in the basement level, giving the building an additional museum function. The original clock tower was restored, and the central fountain was reconstructed in accordance with its historical design (Fig. 4).

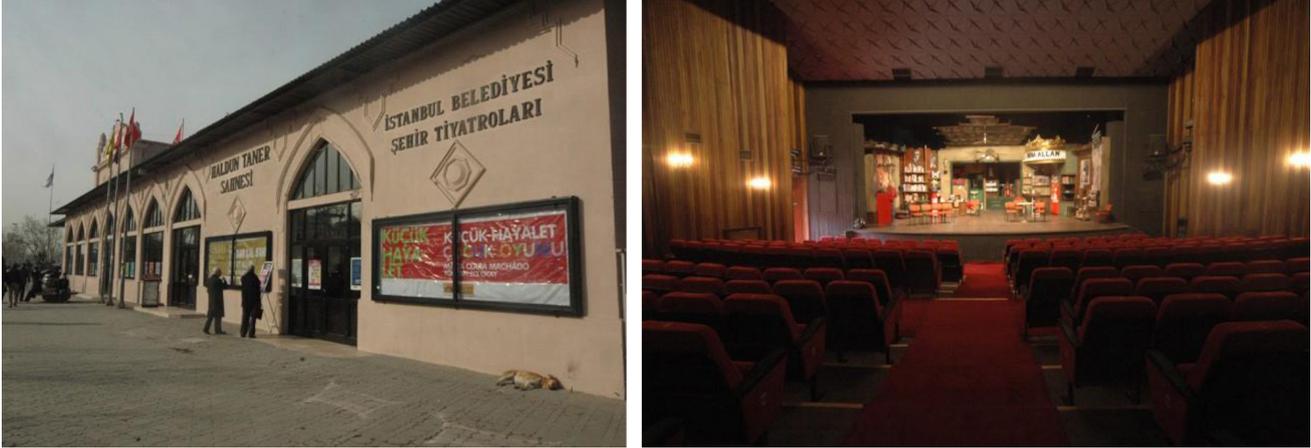
**Figure 5**

Kadıköy Market Hall Façade and Interior Images / *Kadıköy Hal Binası Cephe ve İç Mekan Görselleri* (İstanbul Büyükşehir Belediyesi, t.y.)

In Türkiye, Kadıköy Market Hall serves as a key example of adaptive reuse. Designed in 1927 by Italian architect Umberto Ferrari, the structure initially accommodated fishmongers, butchers, and greengrocers. However, after the market was relocated to Ataşehir in 1973, the building lost its function (Alemdar & Özkan Özbek, 2021, p. 145). In 1986, the structure was assigned to İstanbul University, and in 1989, it was converted into Haldun Taner Theatre, giving it a cultural function (Fig. 5).

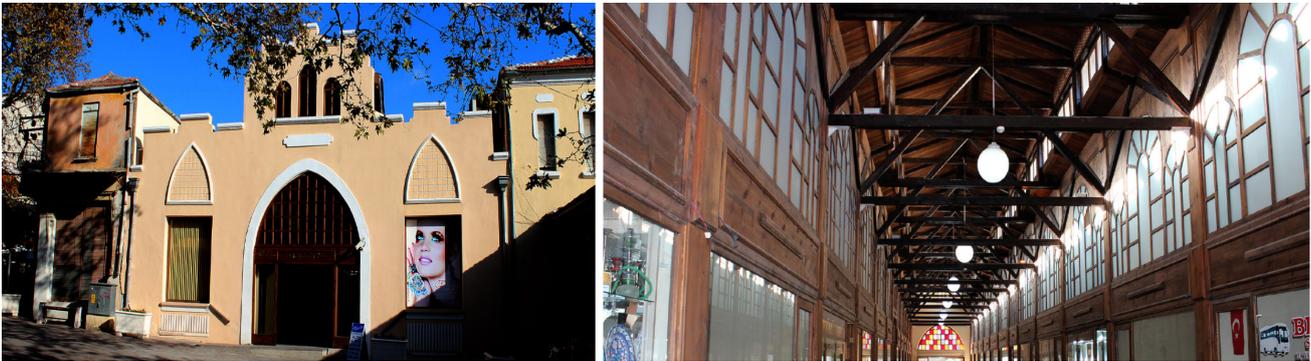
**Figure 6**

Bergama Covered Market Façade and Interior Images / *Bergama Kapalı Pazarı Cephe ve İç Mekan Görselleri* (Bergama Alan Başkanlığı, 2023)

Another example examined in this study is Bergama Meat and Vegetable Market, located in Bergama, İzmir, Türkiye. Originally built in 1930, the structure was repurposed as an indoor market in 2010 (Gökçen et al., 2022, p. 173). Constructed using rubble stone, the building follows a rectangular plan and features a wooden truss roof system. Today, it functions as a covered market area, housing retail stalls and commercial spaces (Fig. 6).

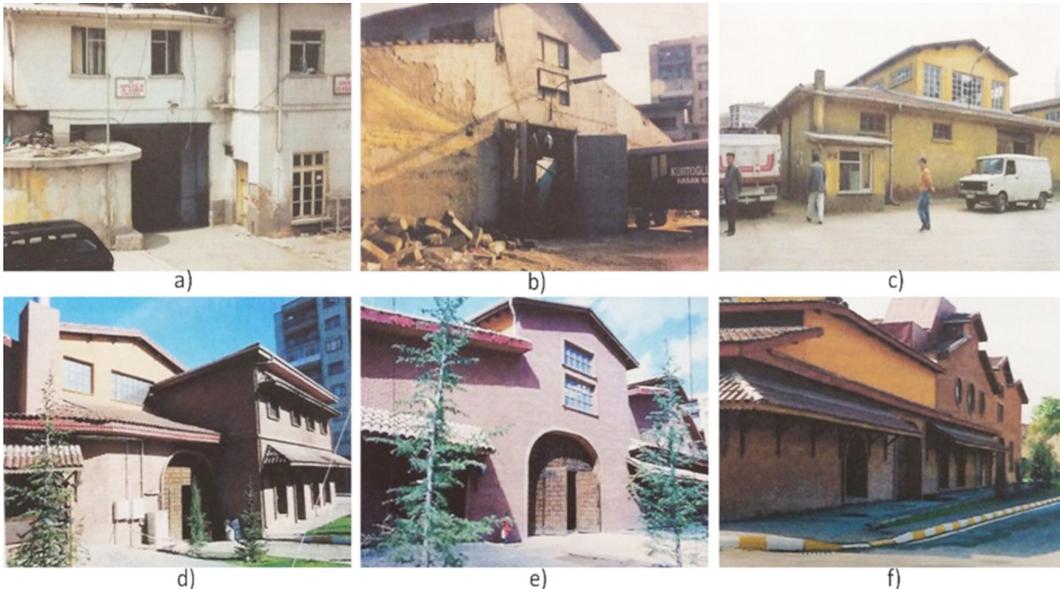
**Figure 8**

Before Restoration: a) Front Facade, b) Front Facade, Second Entrance, c) Rear Facade. After Restoration: d) Front Facade, e) Front Facade, Second Entrance, f) Rear Facade / *Restorasyon Öncesi: a) Ön Cephe, b) Ön Cephe, 2. Giriş, c) Arka Cephe. Restorasyon Sonrası: d) Ön Cephe, e) Ön Cephe, 2. Giriş, f) Arka Cephe* (E.K.V.K.K. Arşivi, 2024).

The two-story building features a reinforced concrete structural system with brick infill walls. Its roofing system consists of a wooden framework covered with traditional Turkish tiles (E.K.V.K.K. Archive). Constructed in the 1930s, the Haller Building functioned as a market hall until 1998. However, after the relocation of the marketplace to a new site in 1990, the structure was abandoned and gradually deteriorated (Fig. 8a, 8b, 8c).

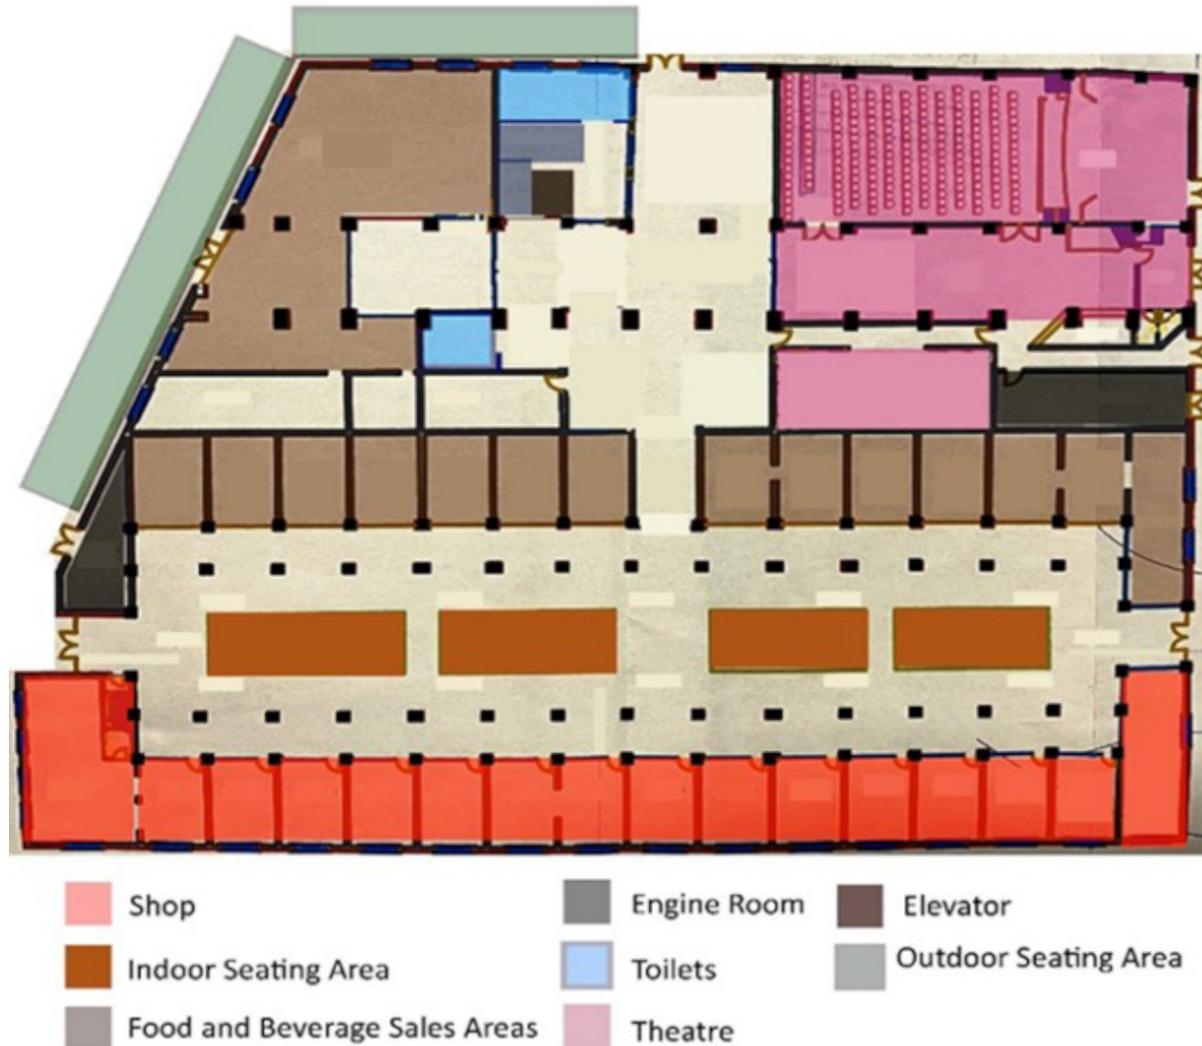
**Figure 9**

Haller Youth Center Ground Floor Schematic Layout Plan / *Haller Gençlik Merkezi Zemin Kat Şematik Yerleşim Planı*  
(E.K.V.K.K. Arşiv Belgeleri Kullanılarak Yazar Tarafından Oluşturuldu)

As part of the adaptive reuse efforts undertaken by Eskişehir Metropolitan Municipality, the Haller Youth Center has been transformed into a cultural and entertainment complex, incorporating cafés, bars, souvenir shops, a theater stage, exhibition halls, and a bookstore. This transformation aimed to create a meeting point that bridges the city center with Anadolu University, facilitating social and cultural interactions. Furthermore, this project is considered a pioneering initiative that has inspired the adaptive reuse of other historic buildings in the area (Koç, 2018, p. 124). The schematic ground floor plan of the Haller Youth Center is shown in Figure 9. The ground floor accommodates retail shops, dining areas, seating spaces, a theater hall, restrooms, and a mechanical room, catering to visitors' needs.

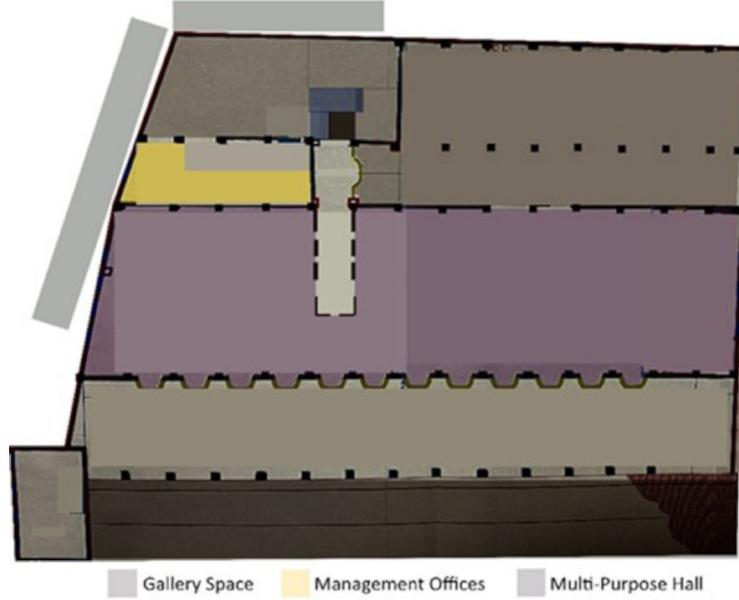
**Figure 10**

Haller Youth Center First Floor Schematic Layout Plan / *Haller Gençlik Merkezi Birinci Kat Şematik Yerleşim Planı* (E.K.V.K.K. arşiv belgeleri kullanılarak yazar tarafından oluşturuldu)

The first floor of the Youth Center houses seminar rooms, study areas, and a library, providing spaces for students and visitors to engage in academic activities, conduct research, and attend seminars (Fig. 10).

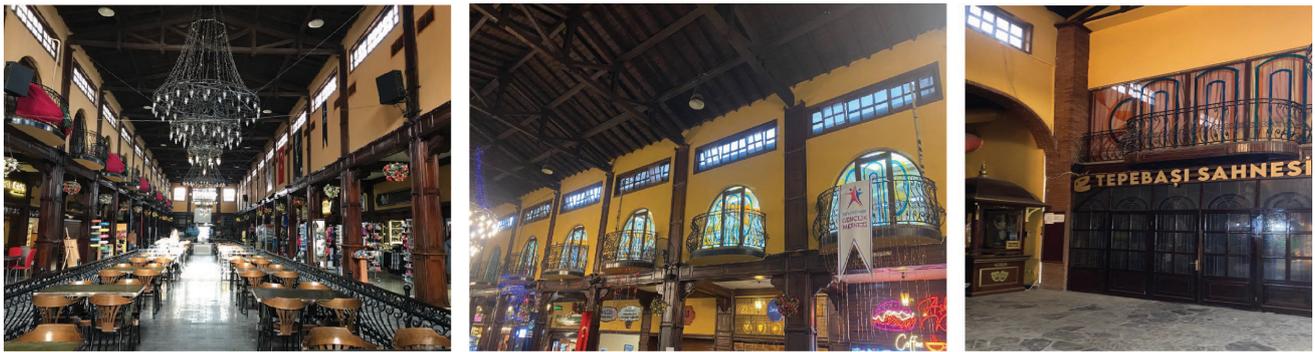
**Figure 12**

Ground Floor Interior Images After Restoration / *Restorasyon Sonrası Zemin Kat İç Mekan Görselferi*

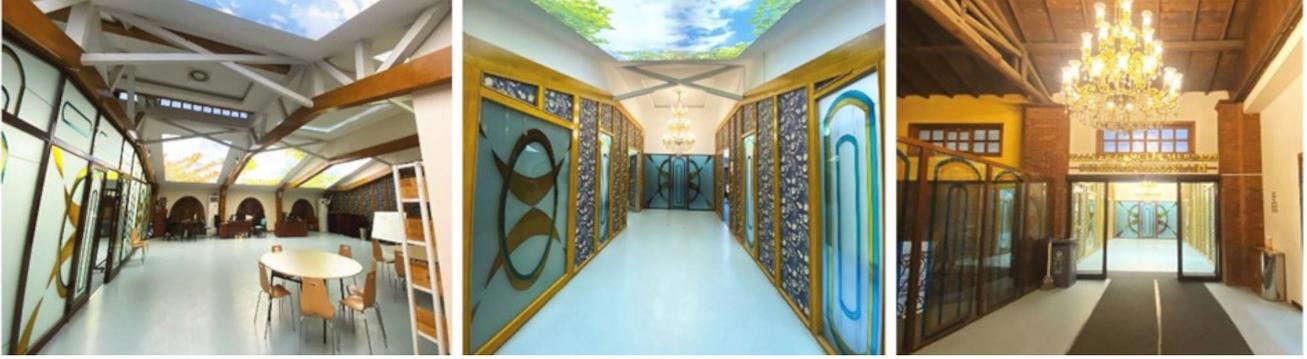
**Figure 13**First Floor Interior Partitions / *Birinci Kat İç Mekan Bölmeleri*

It has been observed that the interior spatial fabric of the building has largely been preserved. However, various food and beverage venues and commercial units within the youth center have adopted their own decorative approaches (advertisements, posters, menus, etc.), which hinders the perception of the building's original architectural qualities and sometimes creates an atmosphere inconsistent with its historic character. On the first floor, seminar rooms, a library, administrative offices, and study areas are located. To accommodate the needs of the new function, partition walls have been added on this floor, and horizontal and vertical circulation elements have been increased. Designed primarily for educational and administrative purposes, the upper floor has lower circulation density compared to the ground floor. Additionally, spatial and volumetric interventions on this floor have enabled the separation of spaces based on function and include structural additions that support the organizational requirements of the new function (Fig. 13).

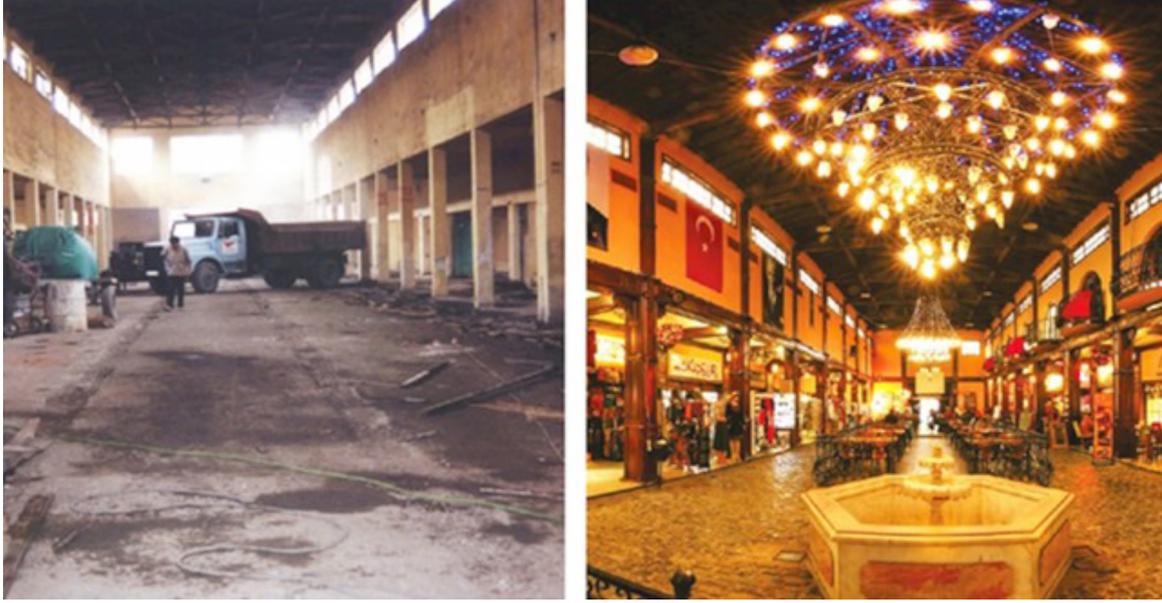
**Figure 14**

Haller Youth Center Interior Images Before and After Restoration / *Haller Gençlik Merkezi Restorasyon Öncesi ve Sonrası İç Mekan GörSELLERİ* (Eskişehir.net, 2024)

When historic buildings are repurposed for new functions, it is essential to reinforce their structural integrity and meticulously carry out necessary repairs. This process requires detailed research and analysis of the load-bearing system and structural elements, ensuring that interventions are implemented based on scientific data. Research findings indicate that the most appropriate approach to architectural conservation is to preserve the original structural and load-bearing system characteristics while conducting necessary reinforcement work (Yalaz & Yaldız, 2020, p. 78). A comprehensive study and examination of the Haller Youth Center's structural system have been conducted, and as a result, the building's load-bearing system has been reinforced with a reinforced concrete and steel frame system. As part of the adaptive reuse efforts, it has been determined that the original load-bearing system has been preserved and strengthened (E.K.V.K.K. Archive). These interventions have been carefully designed to align with the new function of the building, ensuring that modifications are carried out without causing damage to the historic structure. In terms of interior spatial organization, interventions have been designed to preserve the aesthetic and structural integrity of the original building. Notably, the interior columns have been clad with wooden materials, maintaining harmony with the architectural composition. Additionally, necessary repair and renovation work has been conducted on window frames and doors. The original stone flooring, which was a characteristic feature of the former marketplace, has been restored and preserved to maintain the authenticity of the space (Yükselir, 2022, p. 102). The roofing system of the building has also been preserved in its original form, with necessary repairs carried out to adapt it to modern conditions. In the interior, wooden structural roof elements have been exposed, reflecting the distinctive architectural features of the historic building (Fig. 14). This approach enhances the experience of the historic identity of the repurposed building, allowing users to engage with its original character in a tangible way.

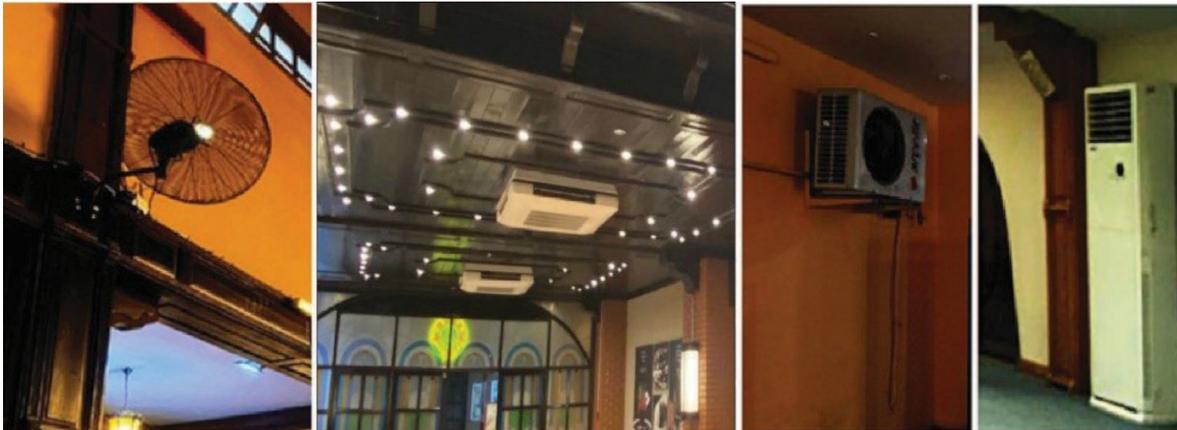
**Figure 15**

Examples of Indoor Climate Control / *İç Mekan İklimlendirme Örnekleri*

Technical equipment interventions in repurposed buildings encompass modifications and enhancements made to align the existing structure with its new functional requirements. These interventions not only involve the architectural aspects of the building but also include necessary improvements to its infrastructure. The adaptation of historically significant buildings to contemporary standards is a critical phase in the adaptive reuse process. In this context, it is essential to upgrade the technical systems of buildings in accordance with modern conditions while ensuring necessary maintenance and repairs are conducted (Kocabıyık, 2014, p. 64). The infrastructure and mechanical systems of the Eskişehir Haller Building have been modernized in line with its new function. Electrical installations, lighting, heating, cooling, ventilation, and plumbing systems have been redesigned to meet contemporary comfort standards and revised according to current regulations (Fig. 15, 16). These interventions have been carried out while preserving the historical fabric of the building and ensuring that its original structural characteristics remain intact.

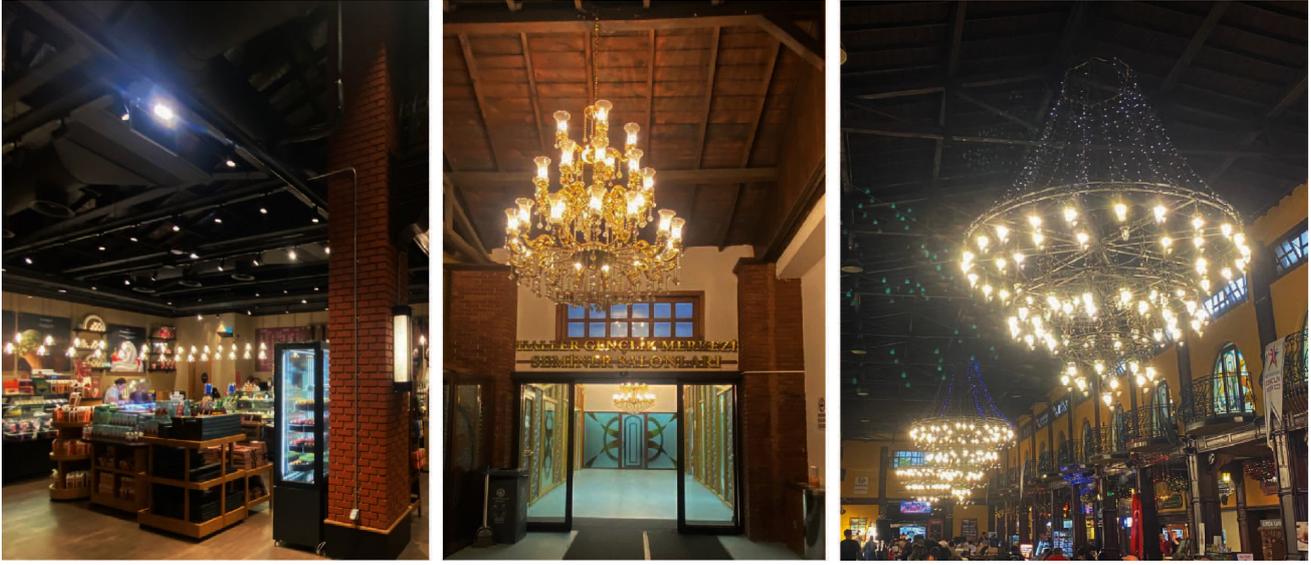
**Figure 16**Examples of Indoor Lighting/ *İç Mekan Aydınlatma Örnekleri*

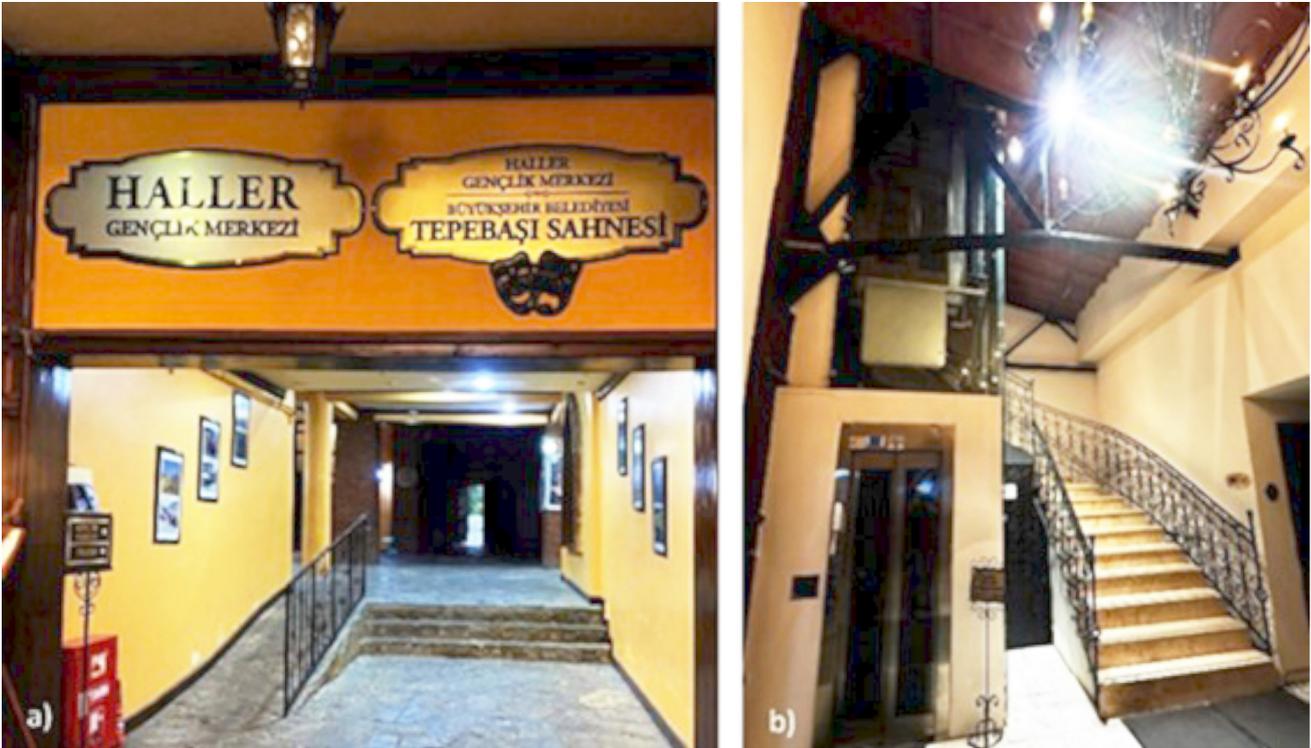
**Figure 17**Haller Youth Center (a) Ramp and Staircase, (b) Elevator and Staircase Example / *Haller Gençlik Merkezi (a) Rampa ve Merdiven, (b) Asansör ve Merdiven Örnekleri*

Moreover, improvements in vertical circulation elements have been implemented, including the integration of elevators, staircases, and ramp extensions into the building (Fig. 17). These modifications have been made to enhance accessibility, particularly for individuals with physical disabilities, thereby increasing user diversity and supporting the social and functional sustainability of the building.

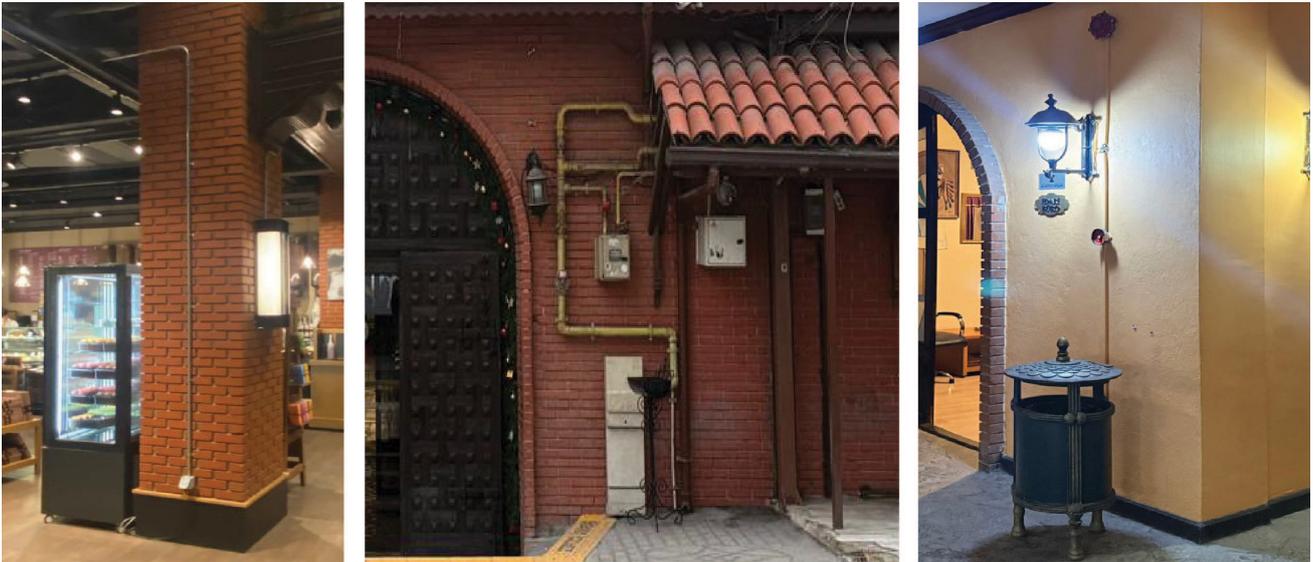
**Figure 18**

Wall Surface Application Examples / *Duvar Yüzeyi Uygulama Örnekleri*

Within this scope, electrical, heating, and ventilation systems inside the building have been modernized in compliance with relevant regulations, and routine inspections of these systems are conducted regularly. Fire escape areas have been designated, and additional emergency exit staircases have been planned as part of the adaptive reuse process. Furthermore, emergency exit signage has been integrated into these areas in accordance with the standards established by the Turkish Standards Institute (TSE). Fire alarm and warning systems have been installed along fire escape routes, ensuring their visibility and accessibility. Additionally, fire cabinets and portable fire extinguishers have been placed at appropriate locations within the interior spaces of the building. In parallel, structural reinforcement and repair work has been carried out in accordance with earthquake regulations. Originally constructed as a masonry structure, the Haller building has been reinforced using reinforced concrete and steel frame systems, thereby increasing its earthquake resistance in accordance with current regulations. Technical repairs and additions have been executed without compromising the building's original fabric, with interventions applied externally on plastered surfaces (Fig. 18).

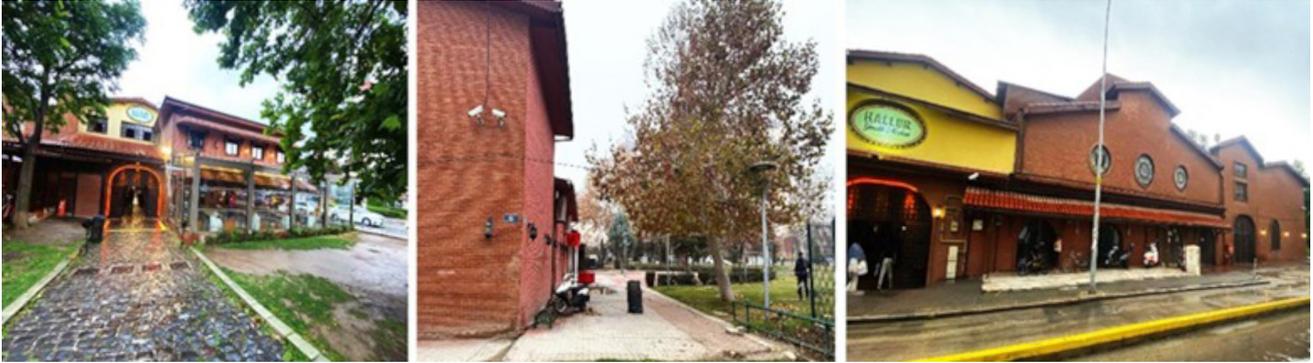
**Figure 19**

Interventions in the Surrounding Area / *Yakın Çevrede Yapılan Müdahaleler*

As shown in Figure 19, various urban design interventions were carried out in the immediate surroundings of the building following its adaptive reuse. These interventions include the arrangement of lighting elements, bicycle and automobile parking spaces, and urban furniture, all of which contribute to the integration of the historic structure with its environment. These changes have not only improved the user experience but also facilitated the harmony of the building with the existing urban landscape, ensuring a holistic spatial integration.
