Water-Oriented Design Strategies and Rising Damp Mitigation in Anatolian Seljuk Period Architecture: Konya Ince Minareli Madrasa Review

stone masonry, porosity, rising damp, water and moisture control

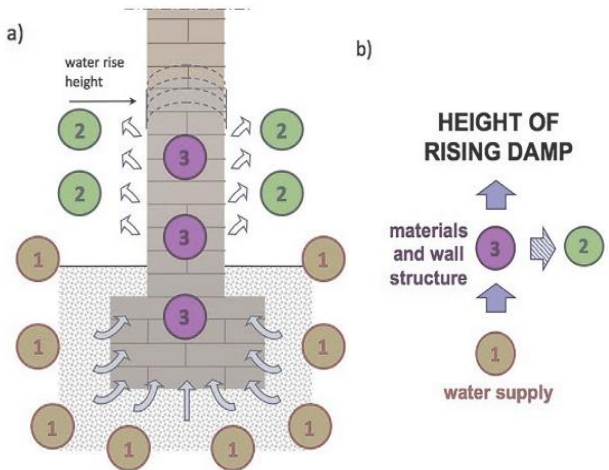
Figure 6. Capillary rise phenomenon in masonry:

(a) representation of moisture movement due to capillary action; (b) conceptual diagram illustrating the equilibrium height of rising damp [43]

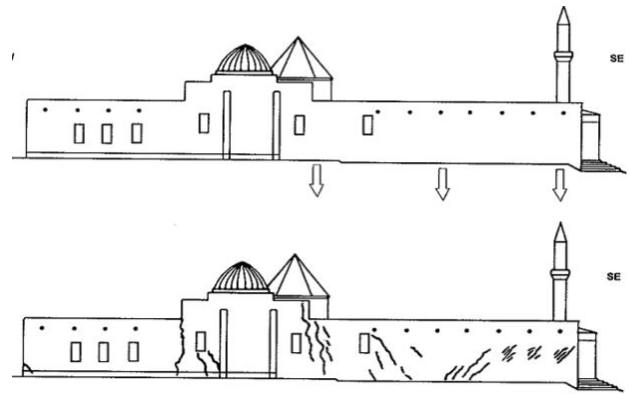
Figure 7. Settlement mechanism and resulting crack pattern at Konya Alaeddin Mosque [59]

Field studies on historic masonry structures further demonstrate that inadequate subsoil conditions and moisture-related weakening can lead to differential settlements between structural elements, resulting in severe cracking and structural deformation. For example, in the case of the Konya Alaeddin Mosque, long-term moisture exposure and subsoil instability were identified as primary causes of differential settlement in columns and walls, ultimately leading to significant structural damage [59], (Figure 7).

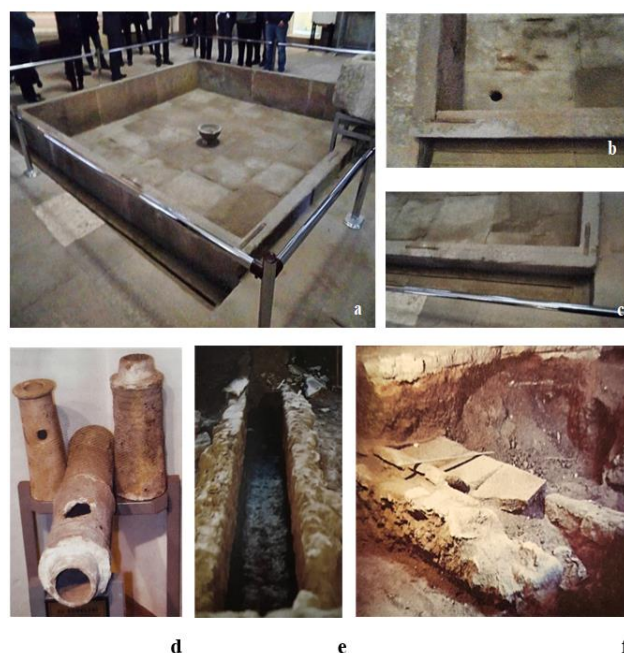
Figure 9. The pool, water channel, and drainage hole of Ince Minareli Madrasa (Author,2026), d- Terracotta pipes of the subsurface canal network of the Ince Minareli Madrasa [29], e,f- open canal [30]

The functionality of this system is supported by subsurface infrastructure. During the restoration work of Ince Minareli Madrasa conducted in 2001, excavations revealed the original water conveyance system of the pool [8]. Beneath the *eyvan* floor, an approximately 30 cm-wide channel [23] supplying water to the pool was identified. Further investigations demonstrated that an open channel connected to the pool and terracotta pipe systems were used for both water supply and discharge. These pipes consist of modular cylindrical segments with diameters between 13-17 cm and lengths of 39-42 cm, connected through a sleeve-like joint system [29]. At a larger scale, the presence of a cistern adjoining the southern foundation wall indicates that the building incorporated a combined system of water collection, storage and drainage. Measuring approximately 10.60 × 3.80 meters and covered with a pointed barrel vault, this structure reflects an integrated substructural water management strategy [34]. No direct documentation confirms the presence of a well in the immediate vicinity of the Ince Minareli Madrasa. However, architectural elements such as niches near the entrance support suggest possible fountain installations [38]. This configuration clearly demonstrates a deliberately engineered hydraulic network (Figure 9).

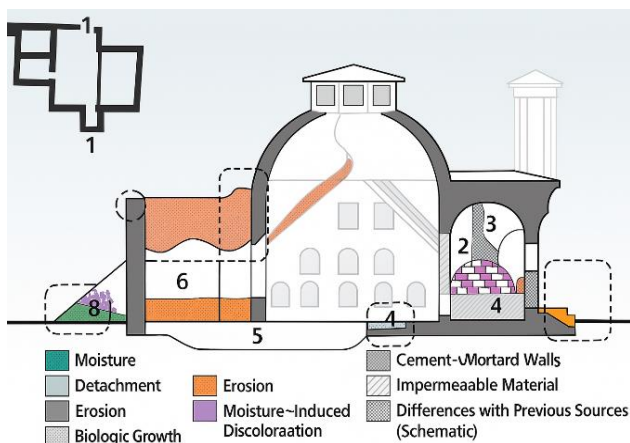
Figure 10. Deterioration and potential sources of damage in the Ince Minareli Madrasa [49]. Capillary water movement within porous stone material, salt crystallization, surface discoloration, material loss, and deterioration concentrated around the portal, minaret base, and lower wall zones

One of the most critical deterioration mechanisms observed in the structure is capillary rise. Moisture originating from the ground ascends through the porous stone fabric, particularly affecting the lower sections of the portal (*taçkapi*) and the base of the minaret, and progressively advancing upward over time. Capillary water carries dissolved salts into the pore structure of the material, and these salts crystallize during evaporation, generating internal mechanical stresses that lead to cracking, surface detachment, and material loss [61]. These processes are directly reflected in observable deterioration patterns such as efflorescence, discoloration, surface scaling, and material fragmentation, especially in transitional and circulation spaces within the building (Figure 10).

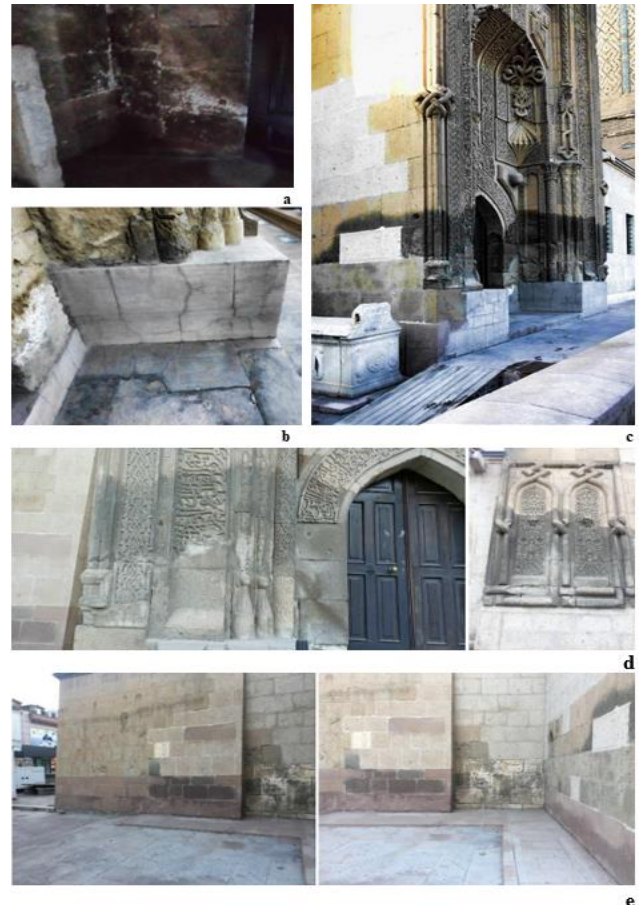
Figure 11. Visibly observed deterioration in the Ince Minareli Madrasa. a- Salt efflorescence on the corridor walls, b- Hairline cracks and surface delamination at the entrance base, c- Rising damp effects on the portal/*taçkapi* (author, 2023), d- Surface detachment, and losses in stone carvings observed at the entrance of the portal and at the base of the minaret, e- Discoloration on the exterior walls of the madrasa [61]

Due to moisture and water-related problems originating from the ground, excavations were carried out in 2001 in the *eyvan* flooring of the Ince Minareli Madrasa, which led to the discovery of a channel that had historically supplied water to the central pool [29]. At the time of its exposure, the channel was found to be dry and structurally damaged and therefore considered non-functional. As a result, the *eyvan* floor was elevated, and the channel was preserved and displayed as part of the building's presentation. This finding clearly indicates that the original water management system has lost its functional continuity, leading to uncontrolled moisture accumulation within the structure (Figure 11).

In the vaulted transitional area of the Ince Minareli Madrasa, efflorescence and discoloration are clearly observable indicators of such moisture-related effects

These indicators correspond to salt crystallization processes, where moisture transported to the surface evaporates and leaves crystalline deposits behind, weakening the material and causing surface detachment. However, changing environmental conditions may have caused intermittent or continuous water flow to resume within the channel. This possibility should be considered during efforts to identify the current source of the madrasa's persistent moisture issues [49].
