*International Journal of Engineering and Geosciences (IJEG),
Vol: 3; , Issue; 3, pp. 080-086, October, 2018, ISSN 2548-0960, Turkey,
DOI: 10.26833/ijeg.412348*

DETERMINING OF DIFFERENT INUNDATED LAND USE IN SALYAN PLAIN DURING 2010 THE KURA RIVER FLOOD THROUGH GIS AND REMOTE SENSING TOOLS

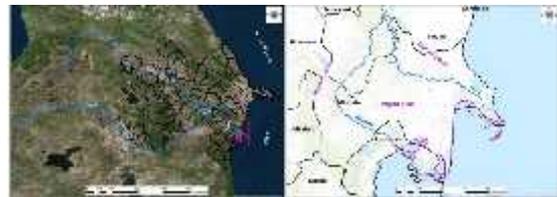
Figure.1 Study area

The Salyan plain, west of the Caspian Sea and situated downstream the Kura river, was selected as a study area (Fig. 1). The primary reason to select this area for the study is a regular occurrence of floods.

The Salyan plain embraces the area from the right side of Kura river between the Kura and the Akusha rivers to the Caspian Sea (Aslanov, 2013). The plain is totally below the sea level (maximum -12.2 m and minimum -30.59 m). The Salyan plain is surrounded by the South-East Shirvan plain and the North Mughan plain from the north-west, the West Lankaran lowland from the south, and the Caspian Sea from the east.

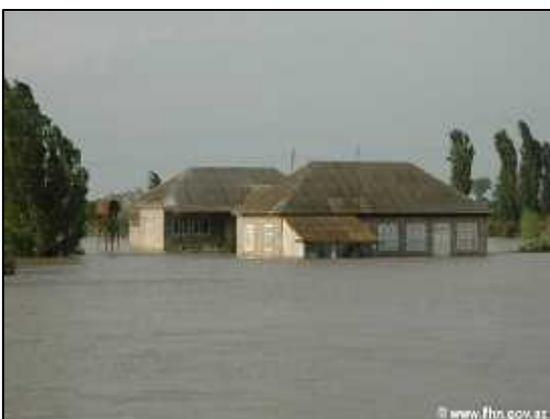
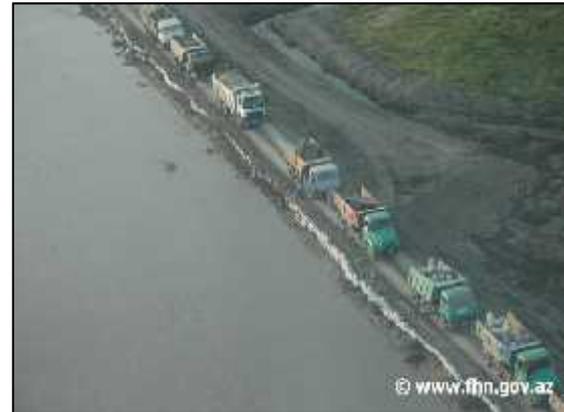
Figure.3 Images from the 2010 flood (<http://www.fhn.gov.az/index.php?aze/pages/33>)

The most recent flood event occurred in 2010 May and differed in extent from the previous flood events, significantly impacting the state budget. During the flood, 11 districts and approximately 150 settlements were damaged either completely or partly (Fig. 3).

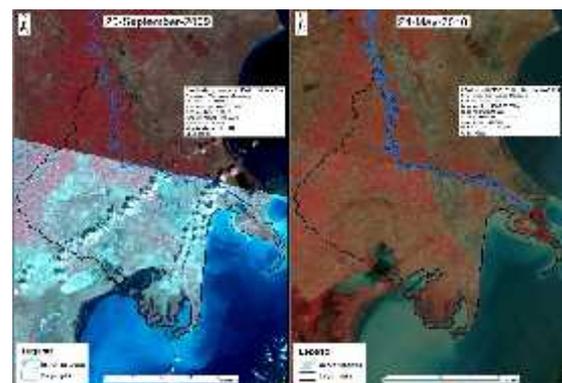
Figure 6. LANDSAT 5 satellite images before and after flood. Even in this scale inundated areas during 2010 flooding are clearly visible

Flooded areas obtained through the interpretation of satellite images, are clearly visible if two satellite maps are compared (Fig. 6). For the study area, the flooded area was estimated for 1336 ha.

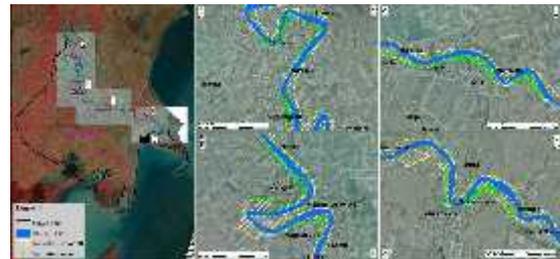
Figure 10. Houses under floodwaters

One of the mostly inundated land use types were settlements. For settlements, high resolution orthophotos allowed to identify buildings that were flooded in 2010 (Fig. 10, Table 4). In total, more than 800 buildings were identified as flooded in the settlements of Salyan and Neftchala districts within the boundary of the Salyan plain.
