## Corrosion Performance and Protection of Centrifuged Hot-Dip Galvanized Coatings (CHDG) on St37 Steel Hooks in GFRC Façade Systems: A Case Study

**Abstract:** St37 steel hooks are used to attach glass fiber-reinforced concrete (GFRC) panels to the surface of buildings. The corrosion products formed on the surface of the hooks cause tensile stresses in the surrounding concrete, resulting in cracking and potentially decreasing the load-carrying capacity of the hooks. It is, therefore, essential to protect these hooks from corrosion. Centrifugal hot-dip galvanizing (CHDG) is the preferred process, particularly for protecting small metal parts used in outdoor applications. This study is the first one aiming to investigate the protection effect of the CHDG coating on hooks used in the assembly of GFRC panels. GFRC panel hooks are often used in three different configurations during the assembly process. To evaluate this, the three most common hook assemblies were tested: unmounted (A), hooks embedded in GFRC (PD), and mounted with the hot-dip galvanized profile (KT). These were investigated for 96 hours at  $35 \pm 2$  °C in a continuous salt fog environment with 5 wt.% NaCl solution,

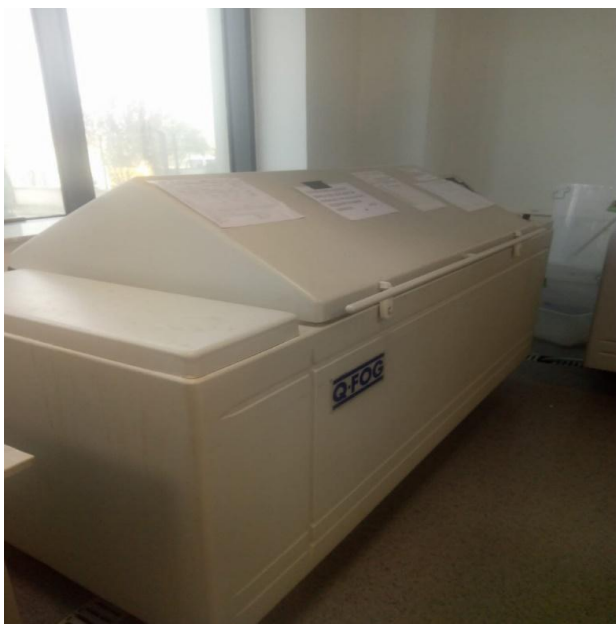
**Figure 2.** Salt spray test chamber

To replicate corrosive environmental conditions, the hook units were subjected to controlled conditions within a Salt Fog Test Chamber MT-SIS-087 (Q-LAB). The test chamber was maintained at a temperature of  $35 \pm 2^\circ\text{C}$  and a relative humidity of  $50 \pm 5\%$  in a 5% NaCl

environment, by ASTM B117 requirements (Figure 2). The 5% NaCl solution was prepared using deionized water and analytical grade sodium chloride. The specimens were exposed to the salt spray for 96 hours. Visual inspections were conducted at 48 and 72 hours.

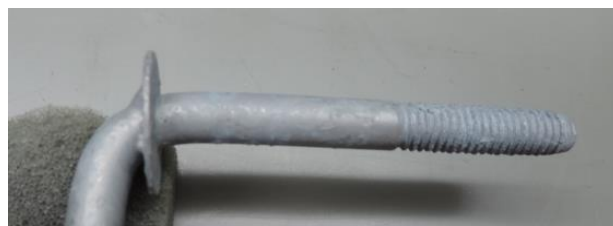
**Figure 3.** Appearance of unit-A before the salt spray test

Figure 3 shows the appearance of the St37 steel hook unit-A before the neutral salt spray test. For hook unit A, visual inspections revealed corrosion primarily affecting 40% to 50% of the total surface area. White rust formation and localized discoloration were observed. Notably, there was no evidence of red rust on the samples, indicating a significant level of corrosion resistance (Figures 4, 5 and 6).

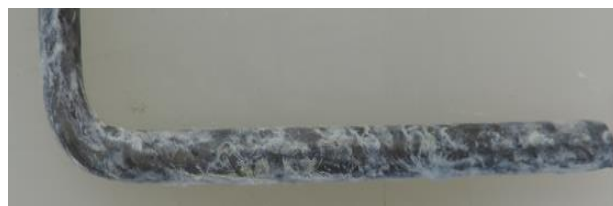
**Figure 4.** Appearance of unit-A after the 48<sup>th</sup> hour interim control

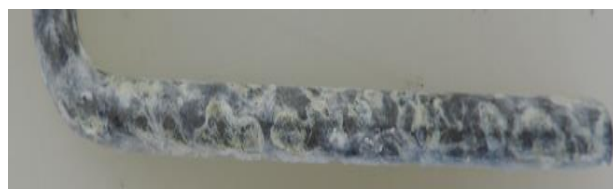
**Figure 5.** Appearance of unit-A at the 72<sup>nd</sup> hour interim control

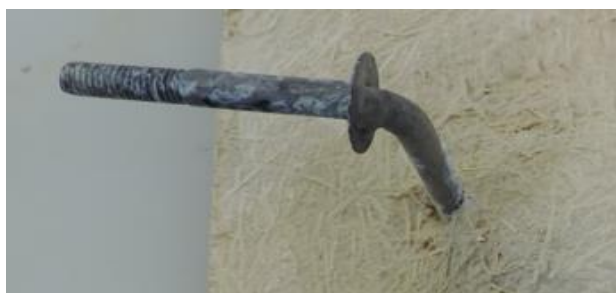
**Figure 8.** The appearance of unit-PD, after the 48<sup>th</sup> hour

The appearance of the St37 steel hook unit-PD before the neutral salt spray test is shown in Figure 7. In contrast to unit-A, the embedded hooks, PD, exhibited corrosion effects covering approximately 20% to 30% of their respective surfaces. The rust amount increased as the salt spray exposure time extended. Before and after the salt spray test results are shown in Figures 8, 9, and 10.

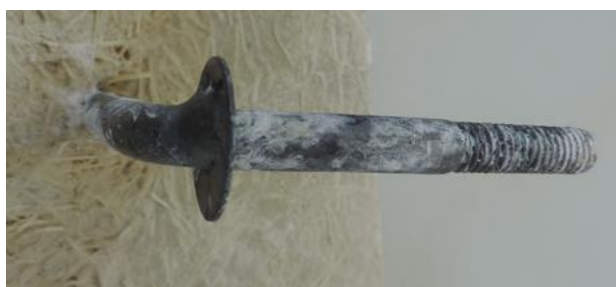
**Figure 9.** The appearance of unit-PD, after the 72<sup>nd</sup> hour

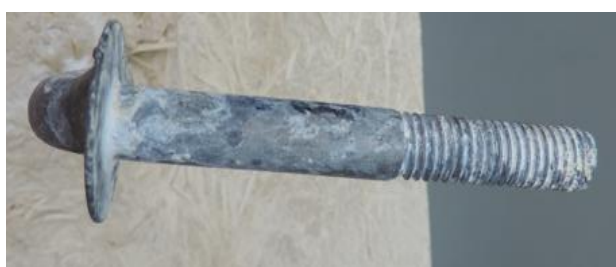
**Figure 10.** The appearance of unit-PD, after the 96<sup>th</sup> hour

White rust formation and localized discoloration were again noted, while the absence of red rust suggested moderate corrosion resistance. The metal parts

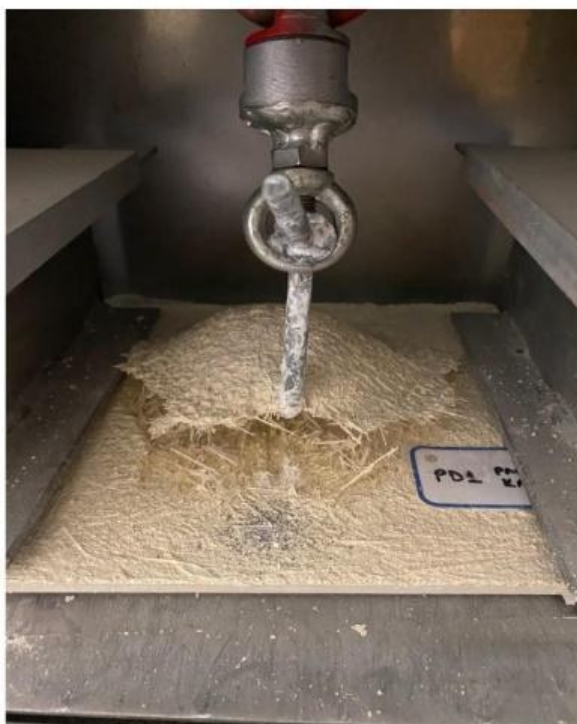
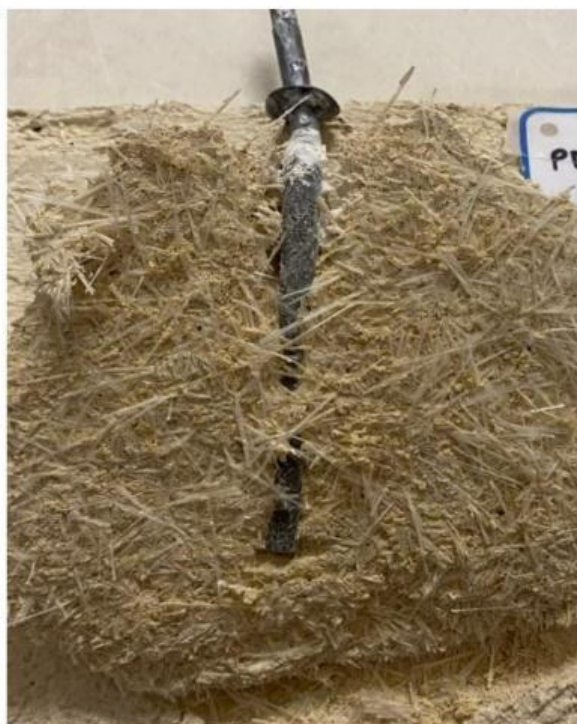
**Figure 11.** No rust was observed on embedded parts after severe corrosion

embedded in the concrete panel were tested for corrosion due to water-salt penetration using 'bonding pad test' device. It was observed that the parts separated under a force of 350 kN. No discoloration due to corrosion was detected on the removed metal anchor element (Figure 11).

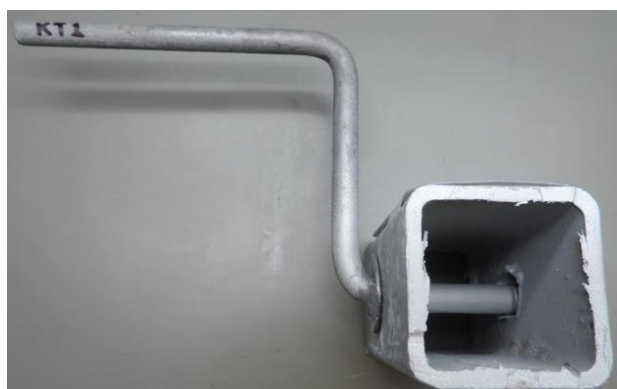
**Figure 12.** The appearance of the hook sets, before the salt spray test

Figure 12 shows the appearance of the St37 steel hook sets before the neutral salt spray test. The hook sets exhibited similar corrosion patterns to the hook units, with approximately 40% to 50% of the surface area affected. White rust and localized discoloration were observed, but red rust was not evident (Figures 13, 14, and 15).

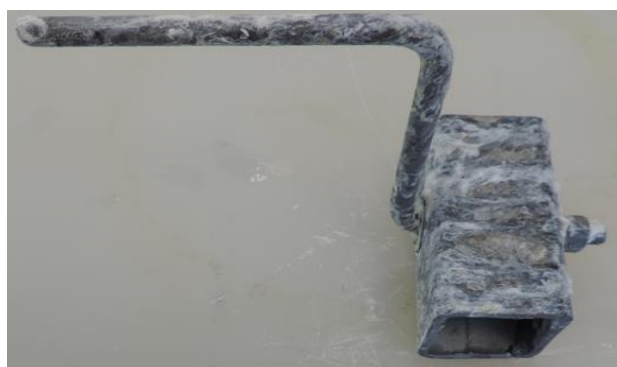
**Figure 13.** The appearance of the hook sets, after the 48<sup>th</sup> hour interim control

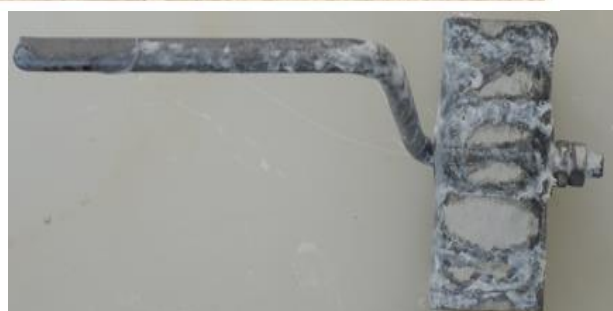
**Figure 14.** The appearance of the hook sets after the 72<sup>nd</sup> hour interim control

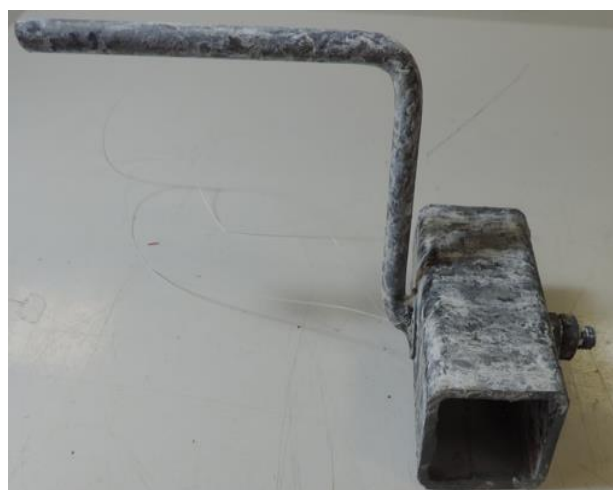
**Figure 15.** The appearance of the hook sets after the 96<sup>th</sup> hour interim control
