## TREATMENT APPROACHES FOR TRAUMATIZED ANTERIOR TEETH WITH EXCESSIVE TISSUE LOSS: THREE CASE REPORTS

### Travma Sonucu Ön Dişlerde Meydana Gelen Geniş Doku Kayıplarının Farklı Restoratif Yaklaşımlarla Tedavi Edilmesi: Üç Olgu Bildirisi

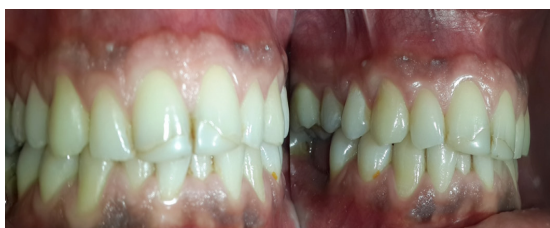
A 29-year-old male patient attended to our clinic for the removal of old composite restorations on central incisors because of their unesthetic appearance (Figure 1). Clinical and radiological evaluations revealed that the teeth were vital and the surrounding tissues were healthy. Vitality of the teeth was confirmed via vitality tests. According to the patient's anamnesis, the teeth had been fractured during a bicycle fall. Direct composite restorations with dentin pin reinforcement had been placed 12 months after the trauma. The patient had no complaint, except for the unesthetic appearance. Radiographic images showed healthy periapical tissues and structures. The lamina dura was normal, and there was no sign of secondary caries. Overbite and anterior guidance were identified on occlusal examination. Based on all evaluations, indirect ceromer laminate veneers of central incisors were indicated. Periodontal problems were treated during the first session. At the following session, local infiltrative anesthesia was applied and the old composite restorations were removed via water cooling using a high-speed handpiece. A thick-grained diamond round drill (Acurata GmbH & Co. KG, Thurmansbang, Germany) was used (Figure 2). Dentin pins were then unscrewed with hand tools. After color matching with a shade scale (Vita Zahnfabrik H. Rauter GmbH & Co., Bäd Sackingen, Germany), the color of the teeth was double checked using a spectrophotometer (Vita Zahnfabrik H. Rauter GmbH & Co.); this was followed by tooth preparation. The preparation process began with a round-edged, thick-grained laminate veneer drill (Acurata GmbH & Co. KG). The drill was placed on the enamel tissue, and one-third of the enamel was removed. Thin, rough drills were used to cut the labial surface, and the preparation was supragingivally completed in a chamfer shape. Considering the presence of a deep bite as well as the excessive loss of dentin tissue, 2 mm of the incisal edge was removed and a step was established on the palatal surface for a porcelain overlap to prevent probable problems in protrusive movements. Finally, all sharp margins were rounded (Figure 3). To eliminate gingival involvement, the retraction cord was placed in the gingival sulcus, and

Figure 1. Frontal and lateral views of old restorations.

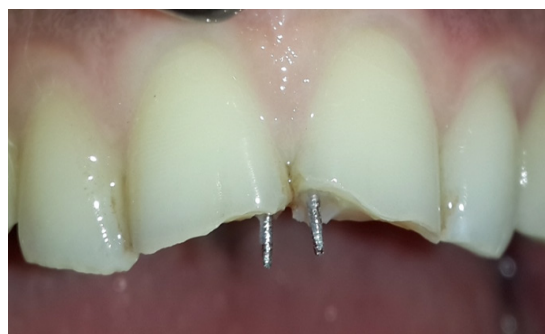
Figure 2. Dentin pins found on incisal edges of old restorations.

In Case 1, dentin pins and composite restorations were removed. By evaluating the patient's occlusal relationships and esthetic expectations, indirect ceromer laminate veneers with a palatal overlap were planned because of the presence of an open bite. Recently, this type of laminate veneer preparation has been commonly recommended (13). Calamia (14) reported that including the incisal edge increases the fracture resistance of laminate restorations. Castelnovo and Tjan (15) have reported that restorations without cutting-edge preparations have lower durability than those with 2 mm incisal edge reduction. In a similar approach, Smales and Etemadi (16) reported that after 7 years of clinical evaluation, laminates with incisal edge preparations have a higher clinical success. Ceramic laminate veneer restorations are more esthetic because they have translucent features that are similar to those of the enamel. At the same time, ceramic veneers have advantages in terms of colorization, stiffness, marginal compatibility and microleakage (17). On the other hand, technical sensitivity, timing, reparability and the patient's economic status must be considered while choosing ceramic laminate veneers (18). In Case 2, because of the probable orthodontic treatment, direct composite restorations were preferred. A silicone guide was obtained for layering composites and gaining the desired shape and texture of the restoration. It is generally not possible to reflect the texture of the enamel and to create the anatomic form precisely in the direct application of composite materials.

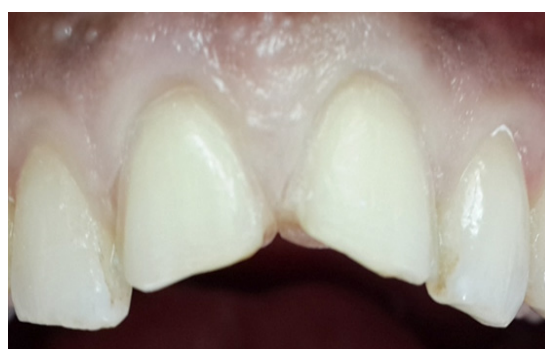
Figure 3. Laminate veneer preparations of central incisors.

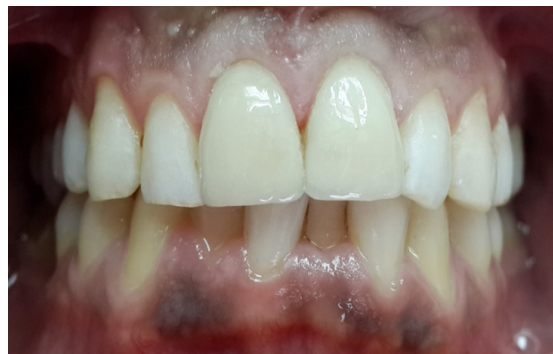
Figure 4. Ceromer laminate veneers.

impressions were taken in two steps using additional types of polyvinyl siloxane. Provisional restorations were then placed with direct composite resin (Filtek Supreme, 3M ESPE, Dental Products, St. Paul, MN, USA) in the same session. Laminate veneers were produced with ceromer material (GC GRADIA, GC Corporation, Tokyo, Japan) in the laboratory. Roughening of the porcelain inner surface was achieved with  $Al_2O_3$  followed by the application of silane (Monobond-S, Ivoclar Vivadent, Schaan, Liechtenstein) to the inner surfaces of laminate veneers. After 60 s, a bonding agent (Syntac Adhesive, Ivoclar Vivadent) was placed following silane manipulation. At the same time, enamel and dentin surfaces were etched with 37% orthophosphoric acid (Total-Etch 3M Scotchbond Universal Etchant, 3M ESPE GmbH Dental Products, Neuss, Germany) for 30 and 15 s, respectively. After removing the acid with water and drying the tooth surfaces gently, a primer (Syntac Primer, Ivoclar Vivadent, Schaan, Liechtenstein) was applied. It was then thinned with air spray, and an adhesive (Syntac Adhesive, Ivoclar Vivadent, Schaan, Liechtenstein) and a bonding agent (Heliobond, Ivoclar Vivadent, Schaan, Liechtenstein) were applied according to the manufacturer's instructions. Using proper colored resin cement (Variolink II, Ivoclar Vivadent, Schaan, Liechtenstein) for the surfaces of restorations, laminate veneers were adapted to the teeth. After light activation of labial surfaces for 2 s, excess gingival and proximal cement was removed with an explorer and dental floss. Light activation was performed for 40 s on the facial, mesial, distal, and palatal aspects of both teeth. The restorations were then evaluated for occlusal interferences. The marginal areas were polished with a silicone rubber polisher and polishing disks (Sof-Lex, 3M ESPE, GmbH Dental Products, Neuss, Germany) (Figure 4). The patient was recalled for the control sessions at 6-month intervals. During the 6-, 12- and 18-month evaluations, the restorations showed no discoloration at the margins and maintained their integrity. No secondary caries was noted in radiographic controls.

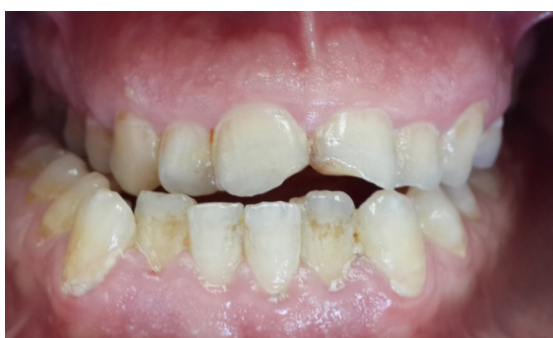
A 27-year-old male patient attended to our clinic for the treatment of fractured central incisors. According to the anamnesis, he had fractured his teeth during a fall 7 years ago and had not undergone any treatment since then. Upon clinical evaluation, no other symptoms that could affect the treatment plan were observed. A periapical radiograph revealed no pulpal involvement, roots and surrounding tissues were found to be sound, and the lamina dura was found to be solid. According to vitality tests, both teeth were vital. Evaluation of the occlusion of the patient revealed asymmetry along

with class III malocclusion (Figure 5). The patient had limited vertical and lateral jaw movements. After consultation with the Department of Orthodontics, the patient was convinced to have orthognathic surgery and orthodontic treatment. Anterior composite restorations were planned for the fractured teeth. Following periodontal treatments, a model was created to allow the fractured teeth to be reconstructed by a wax up. Following this, another mold with a heavy silicone base was constructed to reproduce the shape and contours of the restorations. During the next session, the mold of the reconstructed teeth was cut into two halves (Figure 6). The palatal portion of the mold fit precisely into the anterior teeth and served as a reference guide. The restorative material and color were selected with a shade scale (Vita Zahnfabrik H. Rauter GmbH & Co.). Caries was removed using a thick-grained diamond and high-speed carbide bur. After designing the cavity, a wide bevel was created on the enamel surface. Celluloid bands were adapted on both surfaces, followed by etching the enamel for 30 s and the dentin for 15 s with 37% orthophosphoric acid (Total-Etch 3M Scotchbond Universal Etchant, 3M ESPE, GmbH Dental Products, Neuss, Germany). A bonding agent was then applied. A three-colored enamel composite (Clearfil Majesty ES-2, Kuraray, Okayama, Japan) was placed on the palatal portion of the reference guide in a thin layer (0.5 mm), and dentin restorative material (Clearfil Majesty ES-2, Kuraray, Okayama, Japan) was applied to this layer. The reference guide was then attached to the palatal surface of the teeth, and photopolymerization was performed for 20 s. An incisal restorative material (Clearfil Majesty ES-2, Kuraray) was used for restoring the vestibular surface. Finishing, polishing and adjustments were performed with multilaminated drills, abrasive straps and polishing paper disks (Opti- Disc, Kerr, Orange, CA, USA) (Figure 7).

**Figure 5.** View of fractured incisors and Class III malocclusion.

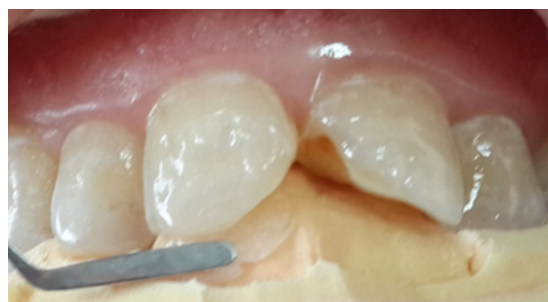
**Figure 6.** Layering of composite resins with silicone guide.

It was therefore noted that obtaining the restoration by layering the composite creates a precise, anatomic form and results in a more natural tooth appearance (19, 20). dos Santos and Maia (21) reported that in their placement of anterior teeth restorations, the use of a silicone index was an effective method to create the anatomic form and to increase clinical success.

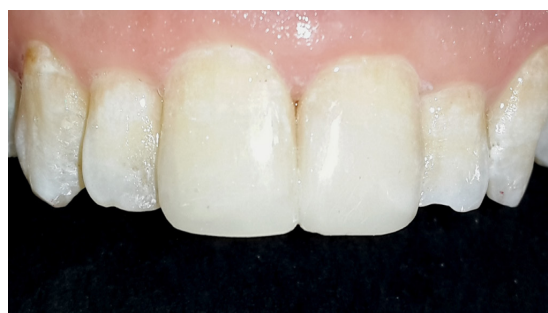
**Figure 7.** Restorations after treatment.

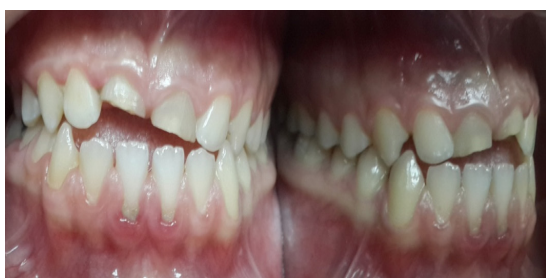
A 16-year-old female patient attended to our clinic for esthetic treatment of fractured central incisors (Figure 8). Upon clinical evaluation, it was determined that the teeth were non-vital. During anamnesis, the patient revealed that she had had a car accident 6 years ago, which was the cause of the fractures. The occlusion evaluation revealed that asymmetry and malocclusion existed between the upper and lower jaws. However, the patient did not accept orthodontic treatment. Therefore, following endodontic treatment, fiber post-reinforced composite restorations were planned.

**Figure 8.** Frontal and lateral views of central incisors.

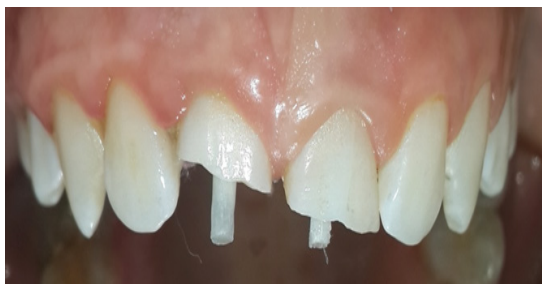
**Figure 9.** Views of cemented fiber posts.

Products) and a suitable fiber post (RelyX Fiber Post, 3M ESPE, GmbH Dental Products) were applied to the cavity. Photopolymerization was achieved with a LED source (Hilux Ledmax 550, Benlioğlu, Ankara, Turkey) (Figure 9). The excessive part of the fiber post was removed, and composite restorations (Filtek Ultimate dentin, body, and enamel, 3M ESPE, St. Paul, MN, ABD) were manipulated to achieve a precise fit. Finishing and polishing were performed with thin-grained burs and disks (Sof-Lex, 3M ESPE, GmbH Dental Products) (Figure 10).

In Case 3, considering the age of the patient and the rejection of the orthodontic treatment option, fiber posts and direct composite restorations were applied. It was reported that (22-24) the use of materials that have similar elasticity modulus to dentin for the restorations of endodontically treated teeth with excessive tissue loss minimizes problems that may occur in the teeth and surrounding tissues (22-24). Therefore, fiber post application was considered suitable for this patient.

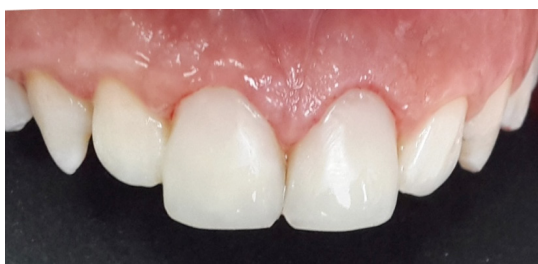
**Figure 10.** Restorations after treatment.
