6 Şubat 2023 Türkiye Depremleri Sonrası Hasar Görmüş Yollardan Elde Edilen Asfalt Bağlayıcılarının Fiziksel ve Reolojik Özelliklerindeki Bölgesel Farklılıklar

Regional Variations in the Physical and Rheological Properties of Asphalt Binders Recovered from Earthquake-Damaged Roads Following the February 6, 2023 Türkiye Earthquakes

doi: <https://doi.org/10.62520/fujece.1766725>
Research Article

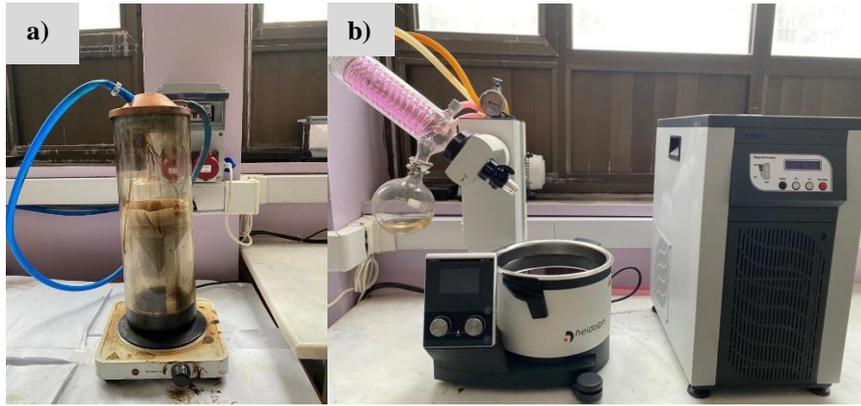
Figure 1. a) Extraction device b) rotary evaporator

Reclaimed asphalt pavement (RAP) materials were sampled in accordance with the EN 932-1 standard (TS EN 932-1, 1997). To assess the aggregate gradation of the RAP, an extraction procedure was conducted (Figure 1a). The aged binder obtained from the RAP through this extraction process was recovered using a rotary evaporator, following the TS EN 12697-3+A1 standard (2019) (Figure 1b). The bitumen content was quantified by conducting a total of 50 extraction tests. Throughout the experimental program, the recovered aged binder served as the primary binder material [20-22].

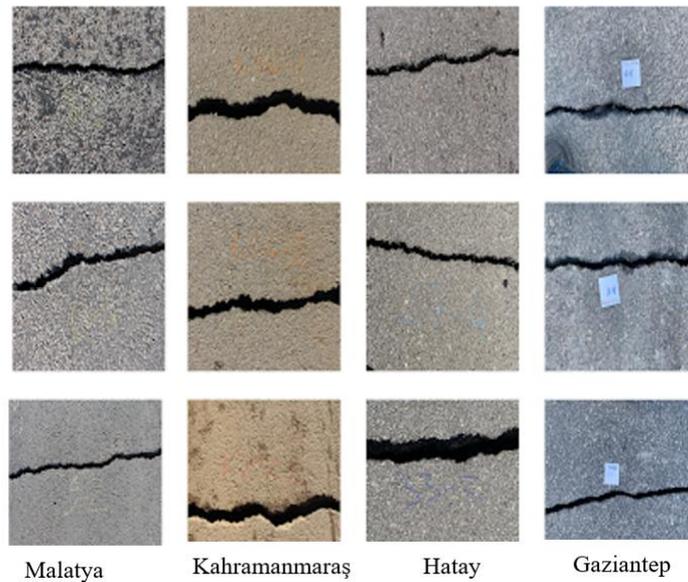
Figure 2. Sample images of asphalt deformations by province

Samples were taken from the provinces of Hatay, Kahramanmaras, Gaziantep, and Malatya. The samples from Hatay, Kahramanmaras, Gaziantep, and Malatya were labeled with the letters H, K, G, and M, respectively. The numbers next to these names in the article indicate that they were taken from different regions. Examples of asphalt deformations by province are given in Figure 2.

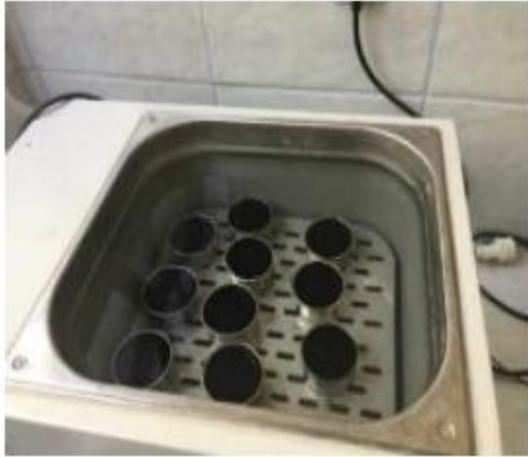
Figure 3. Water bath

The sample to be subjected to the penetration test is first placed in an oven until it becomes fluid and, after being mixed to achieve homogeneity, is poured into the penetration container. The material in the container is then left to cool at 25 °C for 60–90 minutes. Subsequently, the sample is kept in a water bath at 25 °C (Figure 3) for another 60–90 minutes before being placed on the table of the penetration apparatus (Figure 4). A 100 g weighted needle is positioned so that it just touches the surface of the sample and is then released to penetrate for 5 seconds. The procedure is repeated three times, and the average of these values is recorded as the penetration value.

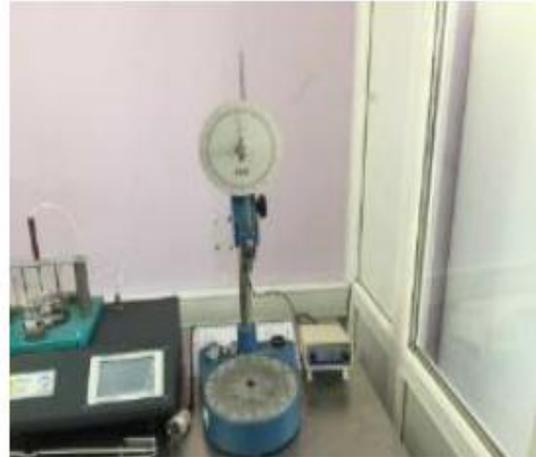
Figure 4. Penetration testing device

It is a test method used to determine the hardness, i.e., the consistency, of a bituminous binder. It is expressed as the depth (in tenths of a millimeter) to which a standard needle penetrates a bitumen sample under a 100 g load at 25 °C for 5 seconds. The unit of the penetration value is 10^{-1} mm. There is an inverse relationship between the penetration values and the consistency of bituminous binders. An increase in the penetration value of a bitumen sample indicates a decrease in its consistency, meaning it has begun to soften. Conversely, a decrease in the penetration value indicates an increase in consistency, meaning the bitumen has hardened. A penetration test was carried out according to the TS EN 1426 standard.

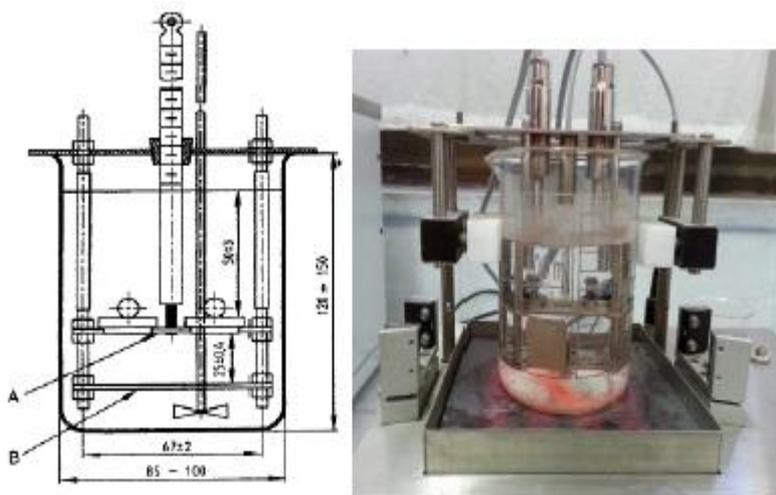
Figure 5. Softening point test setup

This test is conducted to determine the softening temperature of bitumen. In the procedure, a standard ring apparatus is filled with bitumen, and a ball is placed on top from a height of 2.5 cm. The test begins at 5 °C, and the temperature is increased at a rate of 5 °C per minute. The softening point is defined as the temperature indicated on the thermometer at the moment the bitumen sample makes contact with the base. The softening point test was performed according to the TS EN 1427 standard.

If the measured softening temperature exceeds 80 °C, glycerin should be used instead of water as the test medium, and the initial temperature should be set to 32 °C. The softening point is particularly important for limiting rutting in asphalt mixtures with high binder content. There is a strong correlation between this parameter and deformation susceptibility; a decrease of 5–6 °C in the softening temperature has been reported to result in approximately 20% more rutting. The automatic softening point apparatus used in the test is shown in Figure 5.

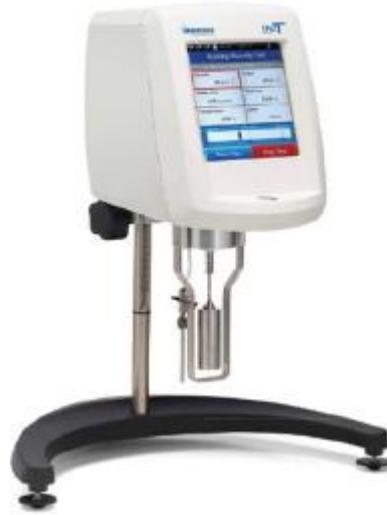
Figure 6. Viscometer test device

The Rotational Viscometer (RV) test is performed to evaluate the flow behavior of bituminous binders at high temperatures. In this test, a Brookfield-type viscometer, in compliance with the AASHTO T316 standard, is used (Figure 6). The viscosity values obtained are analyzed to determine whether the binder

provides sufficient fluidity during mixing and pumping processes. In the procedure, the spindle is rotated at a constant speed of 20 revolutions per minute by a motor, and the viscosity readings are recorded. The RV test, typically conducted on unaged binders, generally assumes that the viscosity at 135 °C should not exceed 3 Pa·s.

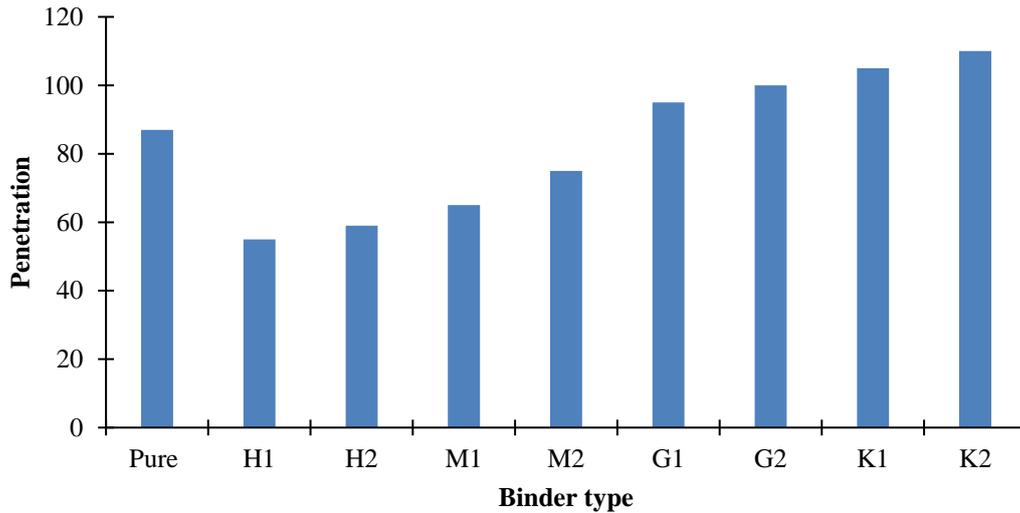
Penetration test results are given in Figure 7. The penetration test results indicate clear regional variations in binder hardness among the asphalt samples collected from earthquake-affected areas. The lowest penetration values were observed in H1 and H2 (Hatay), reflecting significant binder hardening and aging, likely caused by severe mechanical stresses, substantial temperature fluctuations, and intense ground movements following the earthquake. M2 and M1 (Malatya) exhibited moderate penetration values, suggesting less hardening compared to Hatay. G1 and G2 (Gaziantep) showed higher penetration values, indicating softer binders with lower levels of aging. The highest values were recorded for K1 and K2 (Kahramanmaras), suggesting that the binder retained much of its flexibility with minimal hardening. These differences can be attributed to variations in local ground motion intensity, traffic loading conditions, climatic influences, and the pre-existing structural state of the pavement layers. Overall, the findings highlight the necessity for post-earthquake maintenance and rehabilitation strategies to be tailored to the specific material performance characteristics of each region, rather than relying on a uniform repair approach.

Figure 7. Penetration test results

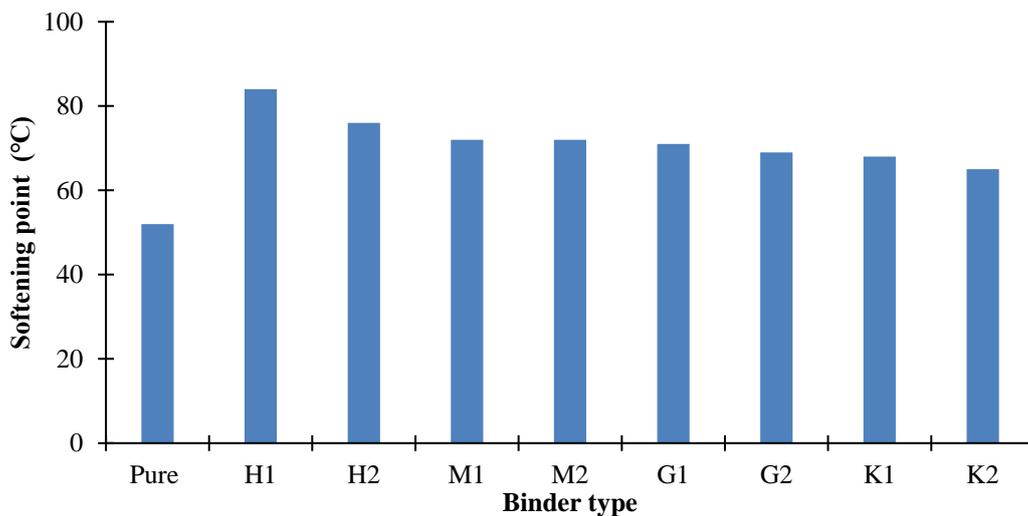
The softening point test results are given in Figure 8. The softening point test results reveal notable variations in high-temperature performance among asphalt binders collected from different earthquake-affected regions. The highest softening point was observed in H1 (Hatay), indicating significant hardening of the binder and enhanced resistance to deformation at elevated temperatures. H2, M2, and M1 samples exhibited moderate softening points, reflecting partial hardening effects. In contrast, G1 and G2 (Gaziantep) and K1 and K2 (Kahramanmaras) showed lower softening point values, suggesting that these binders tend to flow more easily at high temperatures and have retained a degree of elasticity. These differences can be attributed to regional variations in temperature fluctuations, traffic loading conditions, and the intensity of mechanical stresses induced by the earthquake. Overall, the findings highlight that high-temperature performance varies by region, and such differences should be taken into account when planning maintenance and rehabilitation strategies.

Figure 8. Softening point test results

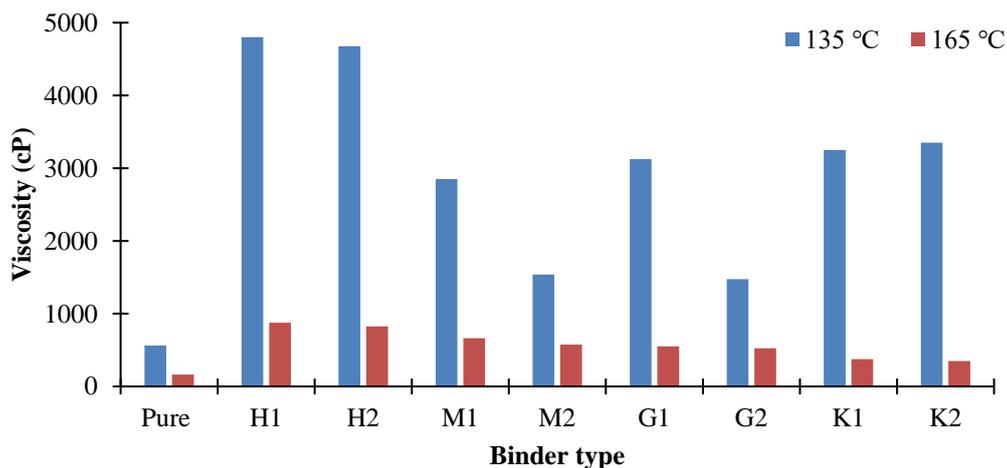
Viscosity test results are given in Figure 9. The viscosity test results reveal significant regional variations in the high-temperature performance of asphalt binders collected from earthquake-affected areas. At 135

°C, the highest viscosity values were recorded for H1 (4800 cP) and H2 (4675 cP), indicating substantial hardening of the binder and markedly low fluidity even at elevated mixing temperatures. Such high-viscosity binders can lead to increased energy consumption during production, workability challenges during mixing and paving, and potential compaction issues if not adequately heated. M2 (2850 cP), G1 (3125 cP), K1 (3250 cP), and K2 (3350 cP) exhibited moderate viscosity values, while M1 (1538 cP) and G2 (1475 cP) showed the lowest readings, suggesting that these binders have undergone less aging and retain greater flowability.

At 165 °C, viscosity values decreased significantly for all samples. H1 and H2 dropped to 875 cP and 825 cP, respectively; M2 to 662.5 cP, M1 to 575 cP, G1 to 550 cP, G2 to 525 cP, K1 to 375 cP, and K2 to 350 cP. This reduction highlights the pronounced influence of temperature on binder workability. While higher temperatures improve flow and facilitate mixing and compaction, binders with high viscosity at lower temperatures may raise production costs and pose application challenges, particularly in colder climates where adequate spreading and compaction may be hindered.

Figure 9. Viscosity test results

These findings demonstrate that the rheological properties of asphalt binders vary considerably across regions following the earthquake, likely due to differences in local seismic intensity, traffic loads, climatic conditions, and pre-existing pavement characteristics. Consequently, post-earthquake maintenance and rehabilitation strategies should account for the temperature-dependent viscosity behavior of binders, with mixing and paving temperatures optimized to match regional conditions for improved performance and cost efficiency.

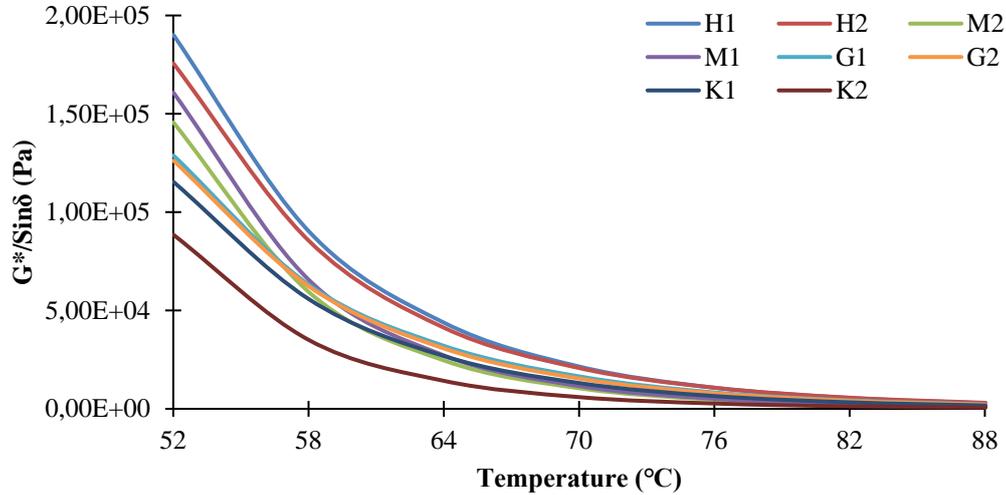
Figure 10 illustrates how the rutting parameter values of the binders vary with increasing temperature. The $G^*/\sin\delta$ results obtained from the DSR test provide a measure of the binders' resistance to permanent deformation at high service temperatures. In general, all samples exhibited a clear decrease in $G^*/\sin\delta$ values as the temperature increased, reflecting reduced stiffness and rutting resistance at higher service temperatures. At 52 °C, the highest value was recorded for H1 (1.90×10^5 Pa), followed by H2 (1.76×10^5 Pa) and M1 (1.61×10^5 Pa). These results suggest that certain binders from Hatay and Malatya maintained high rigidity even at relatively high temperatures, indicating strong rutting resistance. Conversely, the lowest initial value was observed for K2 (8.85×10^4 Pa), indicating a softer binder more prone to deformation at elevated temperatures. As the temperature increased to 58 °C, 64 °C, and 70 °C, all binders showed declining values, though H1 and H2 consistently remained higher than the others. At 76 °C, H1 and H2 still led with 1.08×10^4 Pa, while M2 (4669 Pa) and K2 (2735 Pa) dropped considerably. At 88 °C, all samples fell below 3000 Pa, with the lowest value again in K2 (638 Pa). This trend highlights that while stiffness decreases significantly at high temperatures for all binders, those with higher initial values maintain relatively better performance.

Overall, there are pronounced differences in high-temperature rutting resistance among the asphalt binders collected from different regions after the earthquake. Hatay samples (H1, H2) exhibit the highest stiffness and rutting resistance potential, while the K2 binder from Kahramanmaras has the lowest values. This underscores the influence of regional conditions, seismic severity, traffic loads, and aging levels on binder performance.

Figure 10. Variation of $G^*/\sin\delta$ values with temperature

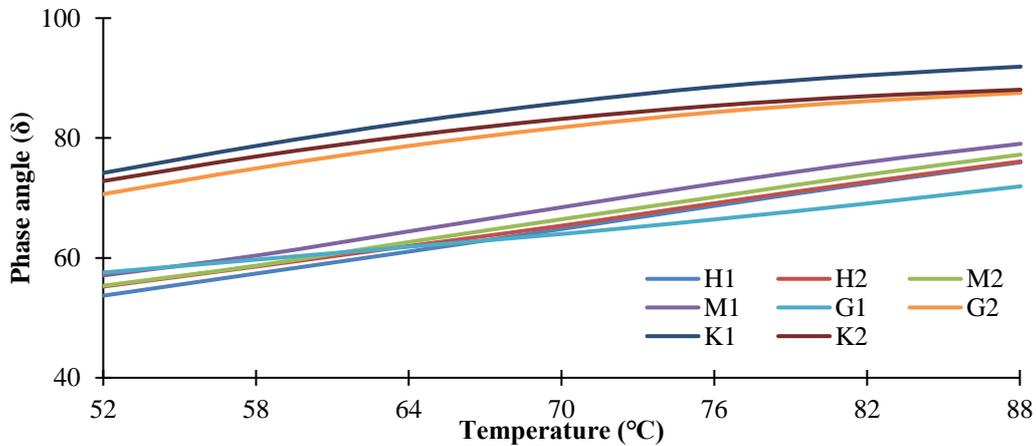
Figure 11 shows the change in the phase angles of the binders with temperature. The phase angle (δ) values reflect the viscoelastic behavior of binders, indicating the balance between their elastic and viscous components. Overall, phase angle increased with temperature for all samples, suggesting a shift from predominantly elastic to more viscous behavior at higher service temperatures. At 52 °C, the lowest phase angles were observed for H1 (53.7°) and H2 (55.23°), indicating a higher elastic component and potentially greater resistance to deformation. The highest initial values were found for K1 (74.18°) and K2 (72.83°), showing that these binders displayed a more viscous character even at lower temperatures. At 64 °C and 70 °C, all samples continued to show increasing phase angles, with K1, K2, and G2 reaching the highest values, confirming their viscous-dominated behavior. In contrast, H1, H2, and M1 retained relatively lower phase angles, maintaining a greater degree of elasticity. At 88 °C, K1 (91.91°) and K2 (88.06°) recorded the highest phase angles, while H1 (75.94°) and H2 (76.09°) had the lowest, suggesting that Hatay binders preserved more elasticity under high temperatures, whereas Kahramanmaras binders became highly viscous. These results highlight clear regional differences in the elastic–viscous balance of asphalt binders collected after the earthquake, which are directly influenced by both temperature and the degree of material aging.

Figure 11. Variation of the phase angles of the binders with temperature
