Kahramanmaraş Sutcu Imam University

Journal of Engineering Sciences

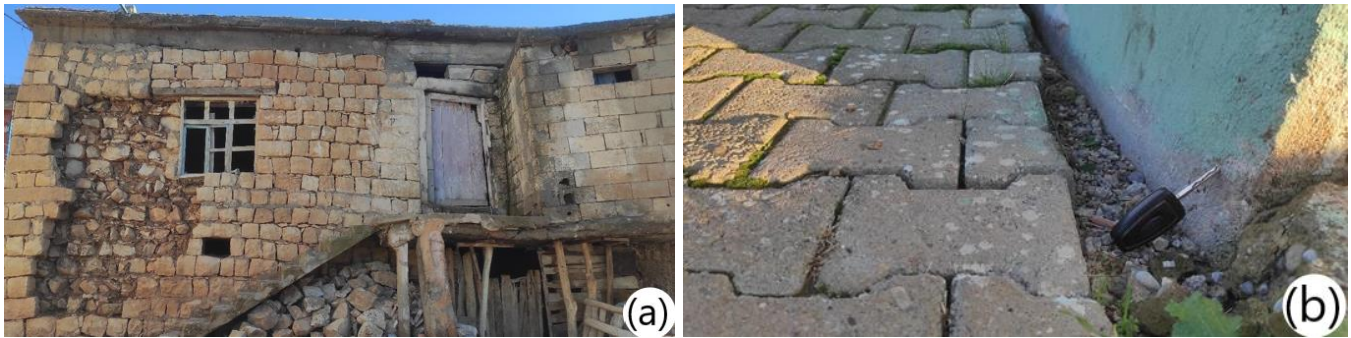
Figure 5. Structural Damage **a.** Final State of the Structure **b.** Different Surface Settlement

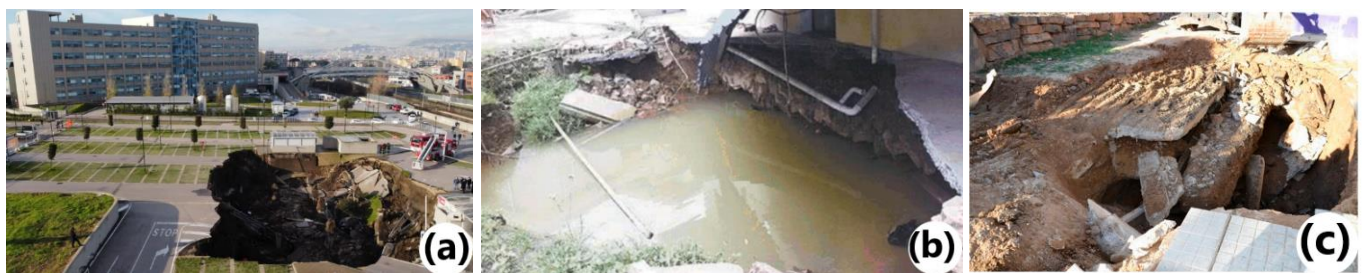
Figure 9. Sudden Collapses and Surface Settlements Caused by Changes in the Groundwater Level and Heavy Rainfall **a.** Italy **b.** China **c.** Spain

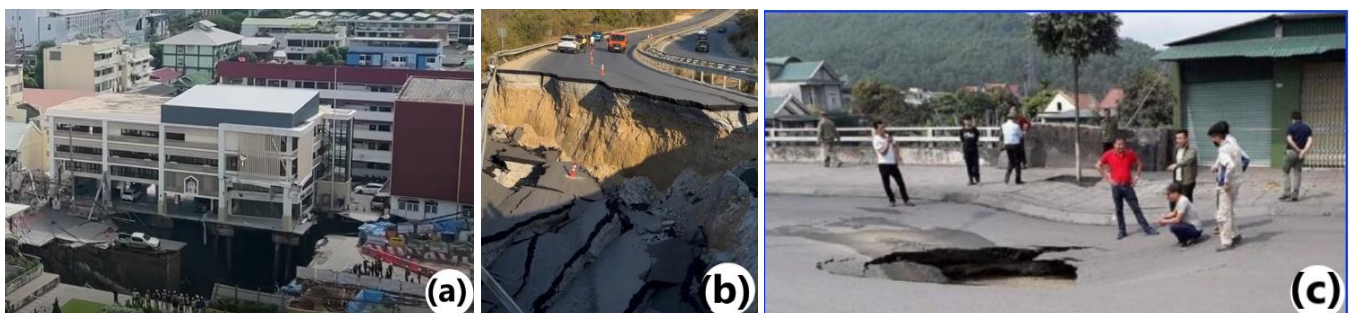
Figure 12. Stability Issues in Road Structures in Karst Formations **a.** Bangkok **b.** Türkiye **c.** Vietnam

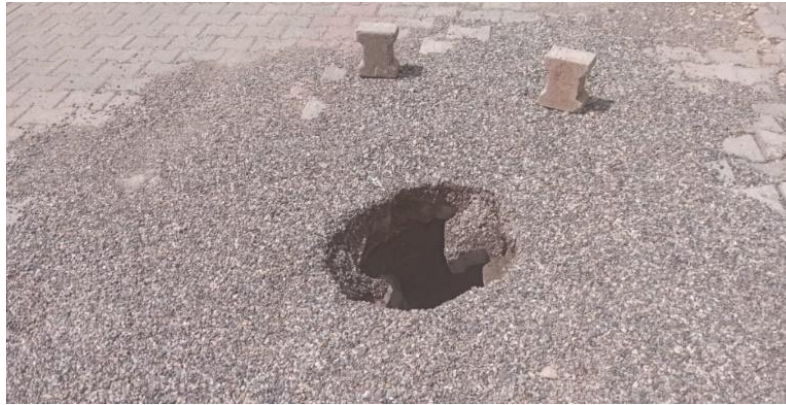
Figure 13. Surface Collapse Observed on a Road Section Caused by Subsurface Void Development
