# SUITDER

## A Methodological Study on the Conservation of Traditional Isparta Houses\*

Yasin TEKİN\*\* - Hasan Ş. HAŞTEMOĞLU\*\*\*

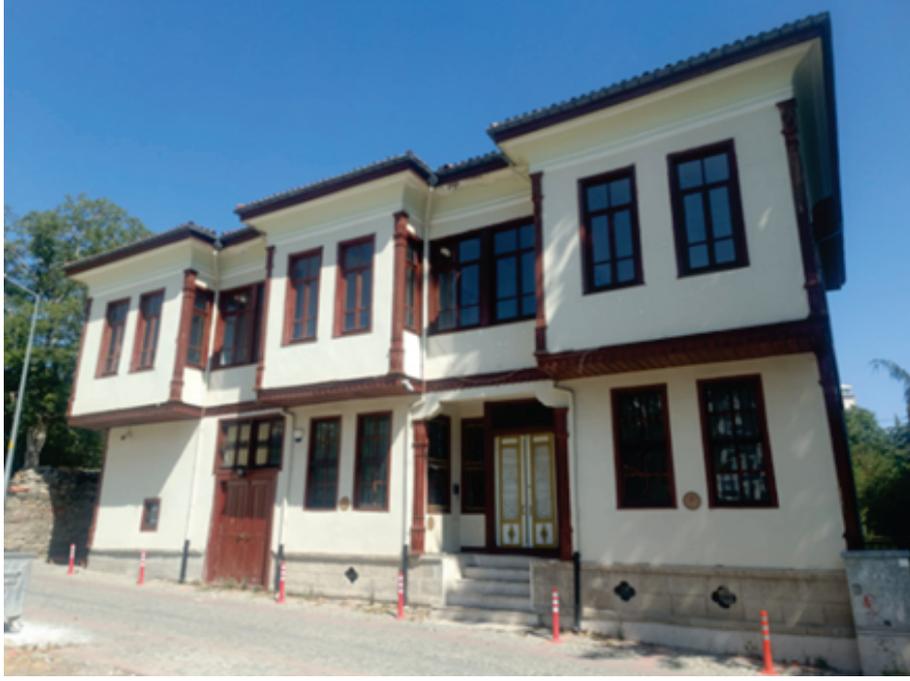
Figure 1. Isparta Center, 405-131 parcel, restored traditional house

- Restored traditional houses have been restored with qualified applications by public institutions, local governments, and property owners (Figure 2).

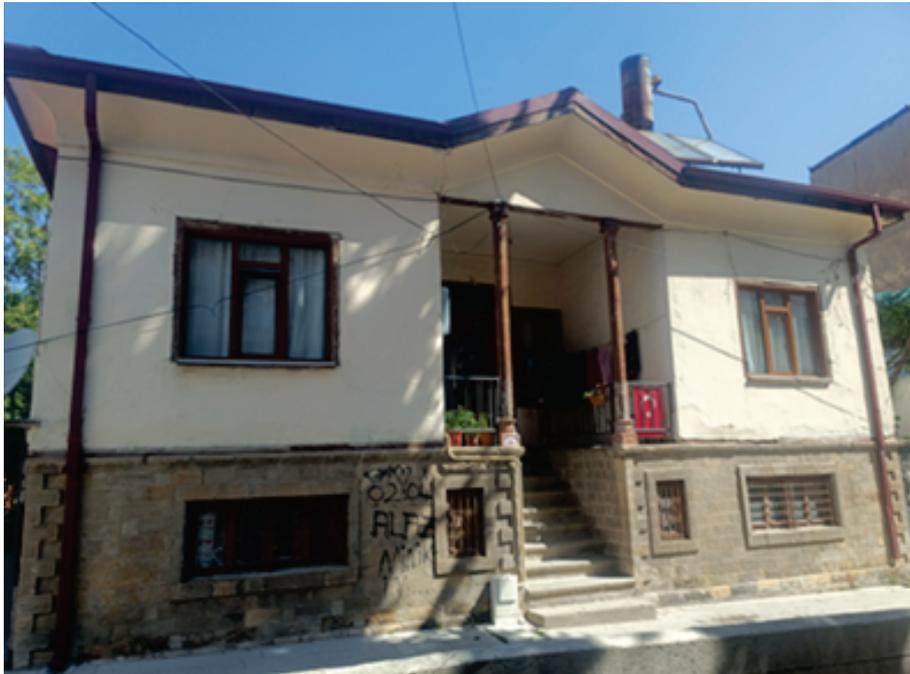
**Figure 2.** Isparta Center, 408- 24 parcel, simply repaired traditional house

- Traditional houses that have undergone simple repairs are traditional houses that the owners have tried to protect with repairs that can be defined as simple repairs (painting, changing the joinery, repairing the roof, etc.) (Figure 3).

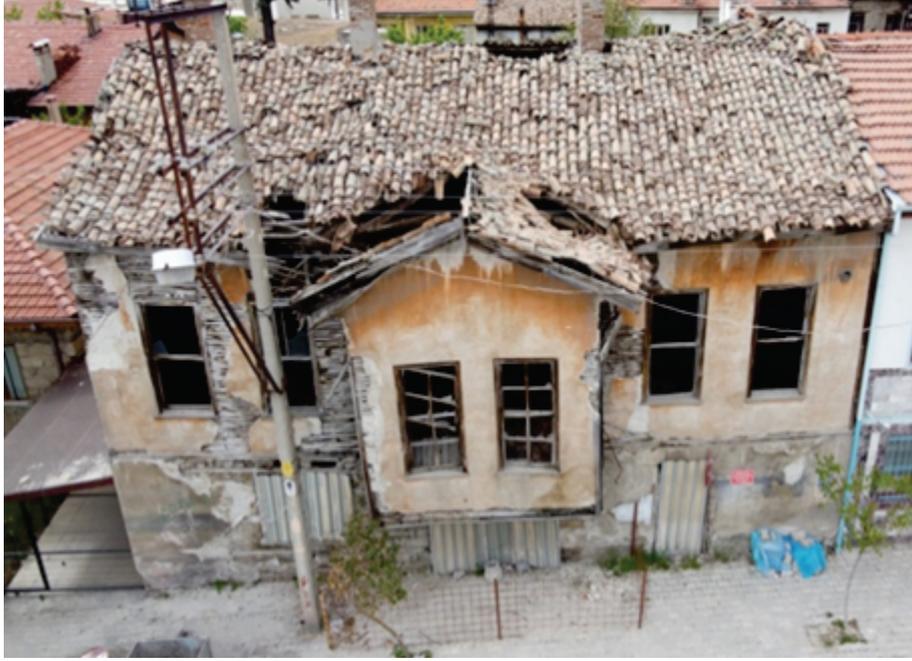
**Figure 3.** Isparta Center, 189-8 parcel, damaged traditional house

- Damaged traditional houses have been abandoned by the owners and are structurally unusable (Figure 4). Demolished traditional houses have been completely lost due to structural damage and fires (Figure 5).

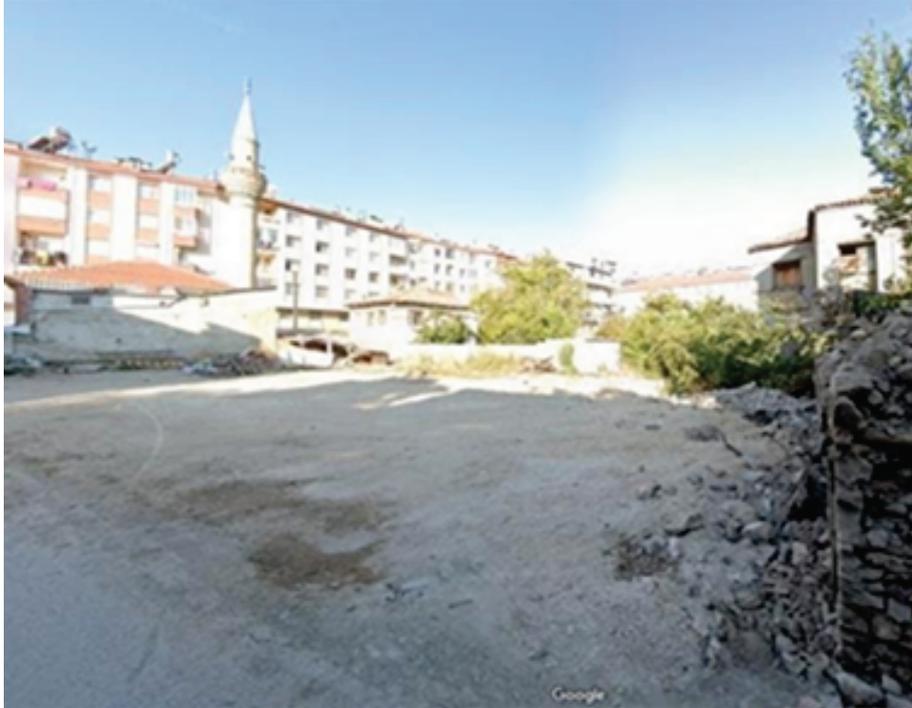
**Figure 4.** Isparta Center, 8013-3 parcel, land of the completely demolished house

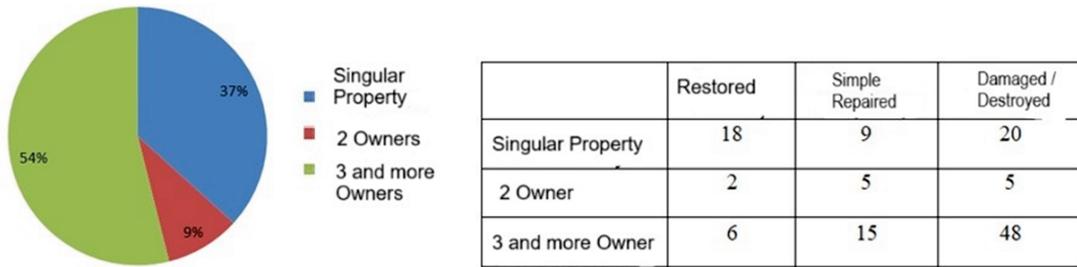
Of the traditional housing stock, 47 out of 128 houses have single ownership, whereas 81 have a fragmented ownership structure. While only 12 of the traditional houses with a fragmented ownership structure have two owners, 69 have three or more owners (Figure 6).

**Table 2.** Ownership status analysis

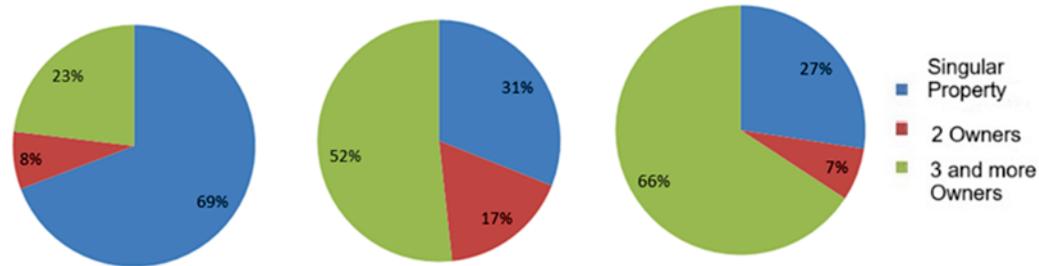
When the property status of traditional houses under protection was examined in terms of their structural condition, specifically in terms of their classification into restored, simply repaired, and damaged/demolished, the following results were obtained (Figure 7).

**Table 3.** Ownership status specific to the classification into restored, simply repaired, and damaged/demolished

The analysis results, as presented in the graphs in Figure 7, clearly reveal the relationship between ownership status and structural status. In restored traditional houses, sole ownership is prominent at a rate of 69%. Of the 18 restored houses with single ownership, six belong to the Municipality and the Provincial Special Administration. Of the damaged/demolished traditional houses, 66% have intense fragmentation of ownership and have three or more owners. While this situation affects decision-making processes, on the one hand, it also causes owners to avoid assuming responsibility for traditional houses, on the other hand.

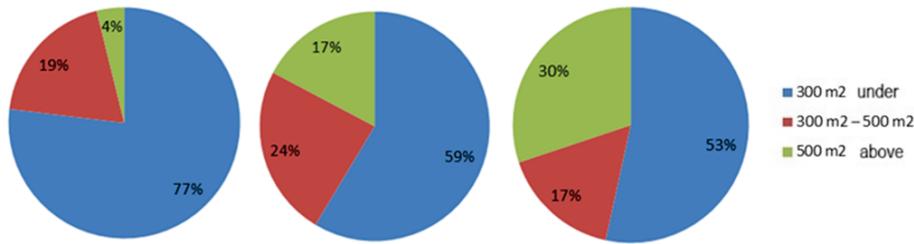
When the effect of parcel sizes is analyzed in terms of the protected traditional housing stock classified as restored, simply repaired, and damaged/demolished, the following analysis results (Figure 9) are reached.

**Table 5.** Analysis of traditional houses classified as restored, simply repaired, and damaged/demolished, based on plot size

The most striking relationship between parcel sizes and structural condition is that 77% of restored traditional houses have a parcel size under 300 m<sup>2</sup>. However, 22 of the 28 large-scale parcels, with an area of over 500 m<sup>2</sup>, are in a damaged/demolished structural condition, accounting for 78% of the total.

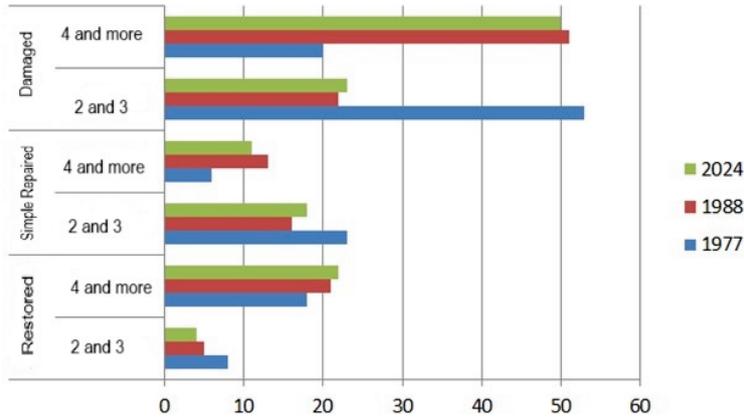
Number of floors and changes in the zoning block where traditional housing is located (Figure 10).

**Table 6.** Changes in the number of floors of traditional houses classified as restored, simply repaired, and damaged/demolished over the years

In this respect, changes in the zoning block where traditional housing is located were classified. While the number of floors was categorized into two groups: 2-3 floors and 4 floors and above, two different construction densities were observed, specifically 40% and free. The usage decisions within the block were determined as residential and residential/commercial. The primary purpose of these analyses is to evaluate the impact of rent increases resulting from the number of floors, construction area, and commercial use on traditional houses under protection. On the other hand, when these analyses were examined in terms of the structural conditions of traditional houses under protection, specifically in terms of restored, simply repaired, and damaged/demolished classifications, the following results were obtained.

In general, when the zoning status around traditional houses is examined in terms of the criteria above, the following results are reached. As the number of floors and apartment buildings around traditional houses increases, the process of abandoning these houses also increases. The process of abandoning traditional houses increases with the decrease in construction density around these houses. As commercial use around traditional houses increases, the likelihood of restoring these traditional houses also increases.

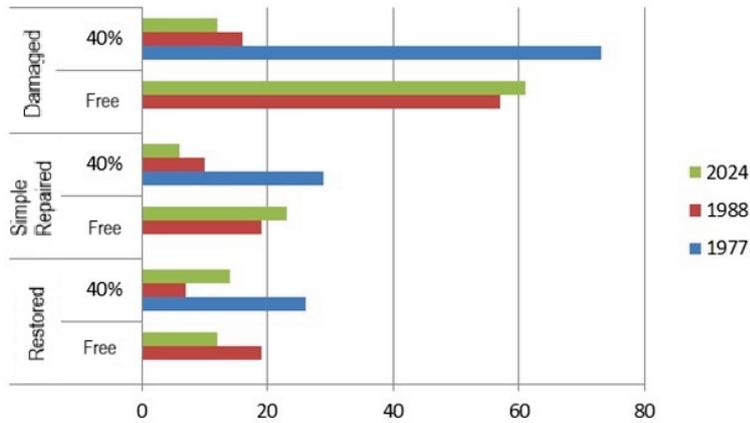
Building density and changes in the zoning block where traditional housing is located (Figure 11).

**Table 7.** Change in the density of traditional houses classified as restored, simply repaired, and damaged/demolished over the years

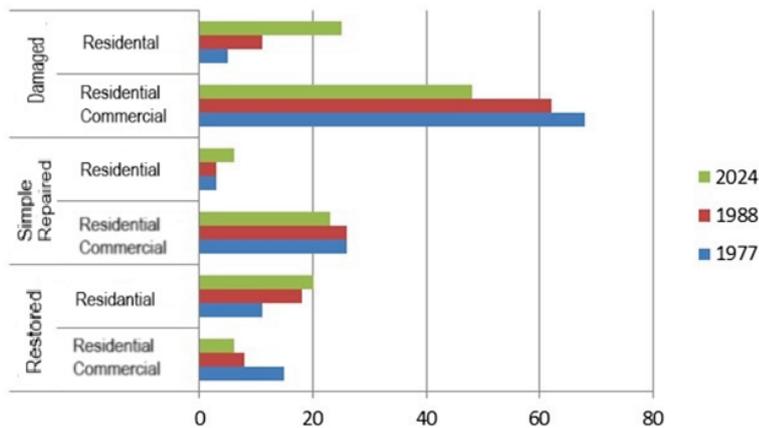
Usage decisions and changes in the zoning block where traditional housing is located (Figure 12).

**Table 8.** Change in the usage decision of traditional houses classified as restored, simply repaired, and damaged/demolished over the years

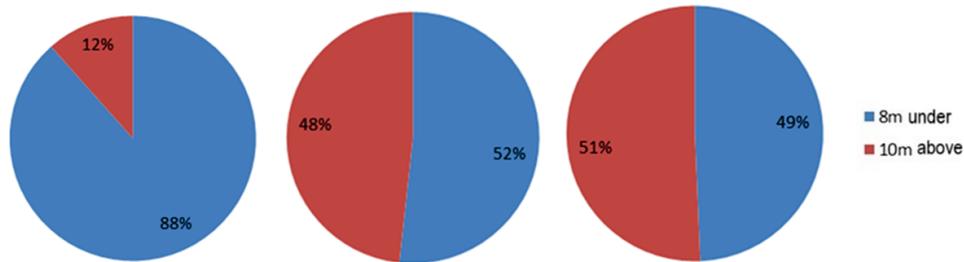
**Table 9.** Road width of the parcel where traditional houses classified as restored, simply repaired, and damaged/demolished are located

Regarding the parcels where restored traditional houses are located, 23 out of 26 traditional houses face roads with a width of less than 8 m, and three face roads with a width of more than 10 m. Contrary to expectations, the fact that the parcel has a road-facing width below the standard has no negative effect on the restoration processes. On the other hand, in terms of the parcels where simple restoration has been done, 15 out of 29 traditional houses face roads with a width of less than 8 m, and 14 face roads with a width of more than 10 m. The fact that the parcel has a road-facing width below the standards does not have a significant effect on traditional houses that have undergone simple restoration. However, in terms of the parcels where damaged and demolished traditional houses are located, a similar situation is observed for traditional houses that have undergone simple restoration. Thirty-six out of 73 traditional houses face roads with a width of less than 8 m, whereas 37 face roads with a width of more than 10 m. Therefore, the width of the road facing the parcel is below the standards and does not have a significant impact on damaged and demolished traditional houses.

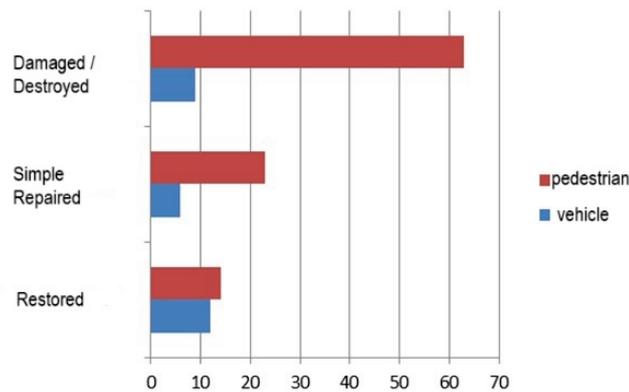
**Table 10.** Types of roads facing the parcels where traditional houses classified as restored, simply repaired, and damaged/demolished are located

Concerning the type of road that the parcel on which the traditional house is located faces, except for the street rehabilitation/urban design works carried out by the municipality in the city center of Isparta and the pedestrian paths located in a small number of dead-end streets, traditional houses usually face vehicle roads. When examined in this context, the most significant effect of the road type criterion is evident in the restored traditional houses group, due to the street rehabilitation/urban design works carried out by the municipality. Twelve out of 26 restored traditional houses face pedestrian paths, which corresponds to approximately 46%. Whereas this ratio in traditional houses that have undergone simple repairs is 6/29, i.e. approximately 20%, it is 9/64, i.e. approximately 12% , in damaged and collapsed structures. Although the analysis of these proportional changes reveals that pedestrian paths positively affect restoration processes, since pedestrianization occurs after restoration, it cannot provide meaningful data (Figure 14).

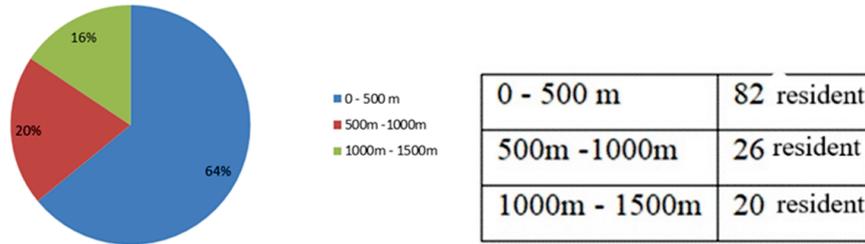
**Table 11.** Distance of traditional houses to the city center

Thus, the study accepted 500 m as the appropriate walking distance, and the study area was divided into three regions with diameters of 1000 m and 1500 m, with Kaymakkapı Square (junction) as the center, which is considered the city center of Isparta. In fact, the farthest traditional houses from the city center are located 1,440 m away in the Doğançı Neighborhood, specifically in block 1687. These houses are located on parcels 11 and 12. Most of the 128 traditional houses located in the city center of Isparta (Figure 15) are within walking distance to the city center.

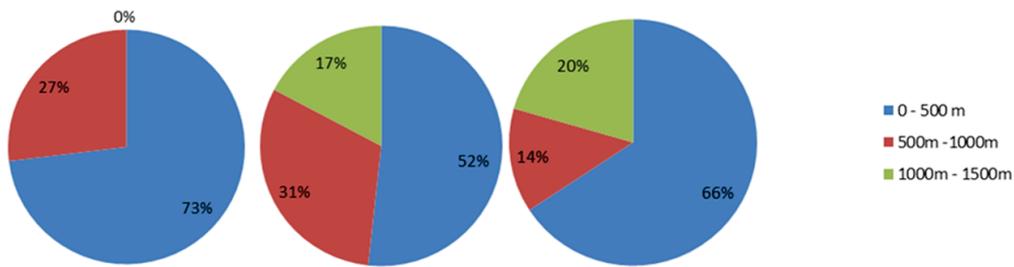
**Table 12.** Distance of traditional houses classified as restored, simply repaired, and damaged/demolished from the city center

While classifying traditional houses in terms of their distance from the city center, the study aimed to investigate the impact of the distance from the city center on restoration, simple repair, and damage. The investigation of the restored traditional houses revealed that 19 of the 26 restored traditional houses were within walking distance to the city center. While seven houses were within a range of 500 m to 1000 m, none of the 20 traditional houses located more than 1000 m from the city center were restored. This indicates that the distance from the city center is a crucial criterion in restoration processes (Figure 16).

However, it is impossible to make clear judgments about the distance of the traditional houses that have undergone simple restoration and have been reclaimed/demolished from the city center. The most striking point here is that none of the 20 houses located at the farthest distance from the city center have been restored and 15 have been reclaimed/demolished. This supports the notion that distance from the city center is a crucial criterion in restoration processes.

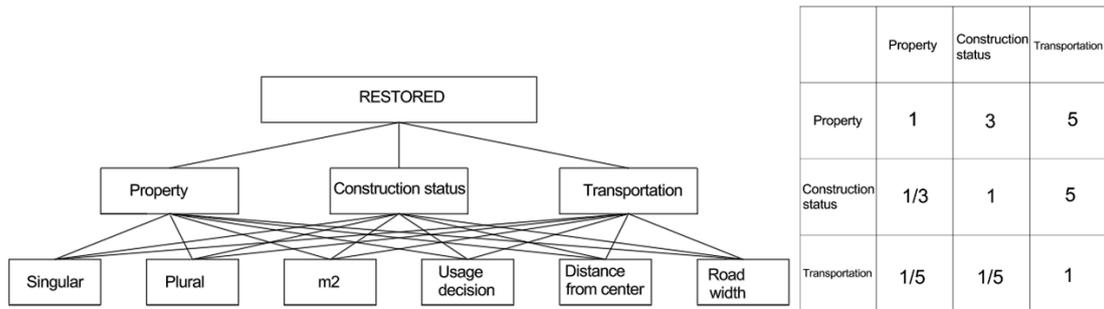
**Table 18.** An AHP relationship diagram and comparison matrix for restored traditional houses

Standard preference table values are derived from expert opinions in applications. In this context, the data and relations obtained from the analyses were used as expert opinions in the study. Therefore, calculations were made by preparing standard preference tables and a criteria matrix in terms of ownership, zoning, and transportation criteria for traditional houses that have been restored, simply repaired, and damaged (Figures 22, 23, and 24). However, the road type variable was not taken into consideration because it established a relationship in terms of result, not cause. On the other hand, the number of floors and the density of construction included in the zoning criteria were considered together and evaluated as the construction area (m<sup>2</sup>).

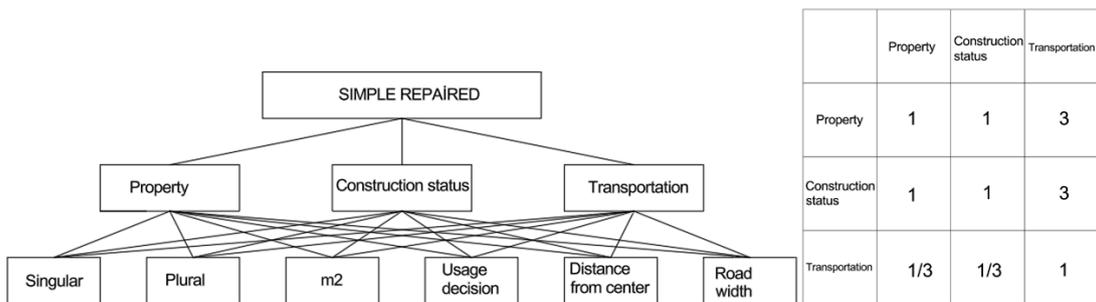
**Table 19.** An AHP relationship diagram and comparison matrix for traditional houses with simple repairs

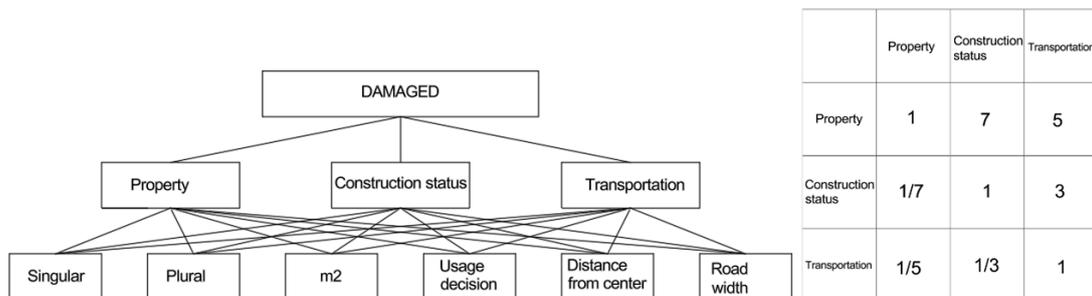
**Table 20.** An AHP relationship diagram and comparison matrix for damaged/demolished traditional houses

When we proceed to the calculation part, the values in each column of the comparison matrices are collected one below the other and added to the bottom of the table. The values in the same table are divided by the totals found. Here, the sum of the values in the newly formed column should be 1. These calculations were performed in the same manner for all comparison matrices, and the row averages were determined. After the row averages for all criteria were found, the matrices in Figure 25 below were reached.
