Determination of Vertical Deformations on Dams: Obruk Dam Sample

Keywords: Vertical deformation, Precise Leveling, Obruk Dam

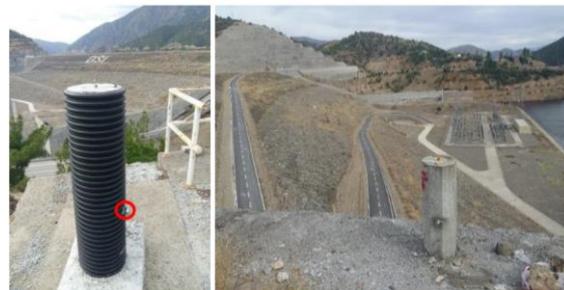
Figure 2. The new reference point N1 (left) and existing observation point N5 (right). Apparatus is shown inside the red circles for precise leveling.

Two of the existing pillars (N5 and N6) used in the construction of the dam that were installed by Turkey General Directorate of State Hydraulic Works (DSİ) were selected as reference points and added to the network. In addition, 6 new reference points (N1-N4, N7, N8) which are expected to have zero movement around the dam like N5 and N6 were established (Fig. 2). Bronze leveling apparatus and facilities attached to pillars for precision leveling and preliminary evaluation were completed in

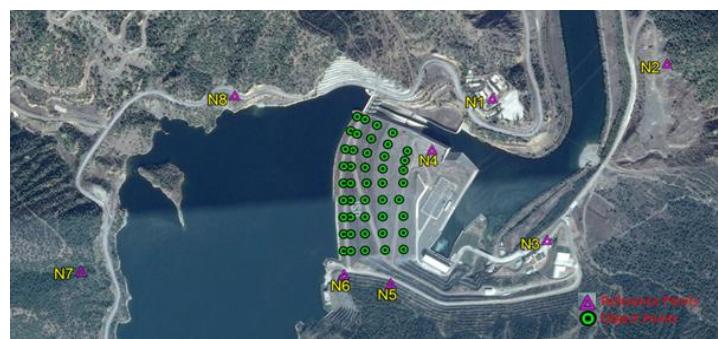
Figure 3. Locations of 8 references and 44 object points around the study area (Alkan et al., 2016)
Şekil 3. Çalışma alanı çevresindeki 8 referans ve 44 nesne noktasının konumları (Alkan vd., 2016)

November 2015. A total of 44 object points were established, 9 points on the upstream side and 35 points on the downstream side of the dam embankment, with 4 rows of points, the first three include 9 and the last 8 points starting from the upper body (Fig. 3). Force centering equipment was used on those points to conduct GNSS and distance measurements, and a new apparatus was installed on the edges of the object points for precise leveling (Fig. 4).

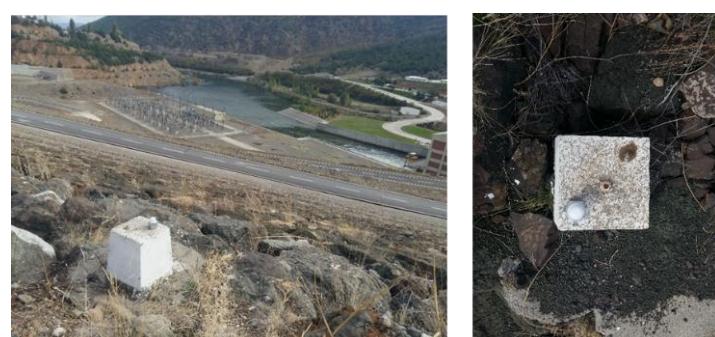
Figure 4. One of the object's points the downstream (left). The white apparatus was used for GNSS and distance observations, while the other add-on (upper right corner) was used for precise leveling.
