The effect of forming process on the corrosion characteristics of DX51D galvanized steel sheets

Research Article/Araştırma Makalesi

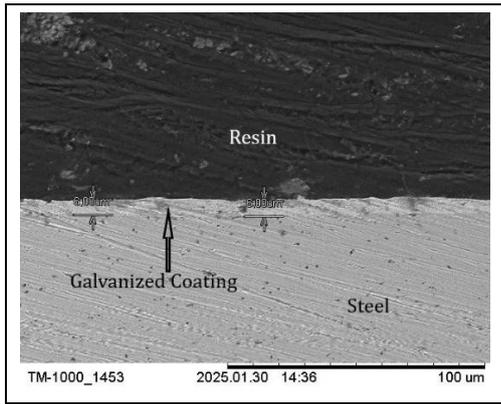
The cross-sectional view of the galvanized coating obtained by SEM is given in Figure 1. The zinc coating is measured at 6 μm in this figure, corresponding well with the X-ray measurement (6.64 μm).

Figure 1. The cross-section of the galvanized coating.

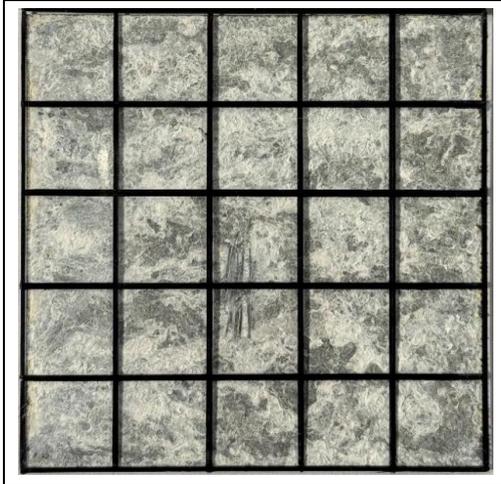
Figure 2 illustrates the identification of white and red rust rates by the template method for the frame-cut (FC) sample with no forming process tested in the salt spray. Due to the flexibility of acetate paper, this measurement technique was easily applied to all formed samples, even those with complex forms.

Figure 2. White and red rust rate identification for the FC sample via the template method.

The red and white rust percentages on the samples were determined via the template method. In this method, a square of size 70 x 70 mm² is drawn on an acetate paper. Twenty-five equal squares are drawn inside the drawn square. Each small square corresponds to 4%. The template is placed on the samples, and the red and white rust falling inside the squares is evaluated in terms of % rust. Since the formation of red rust will occur after the formation of white rust, the occurrence of red and white rust in the same frame is counted as two ratios. Under these conditions, the red rust rate in galvanized parts cannot be higher than the white rust.

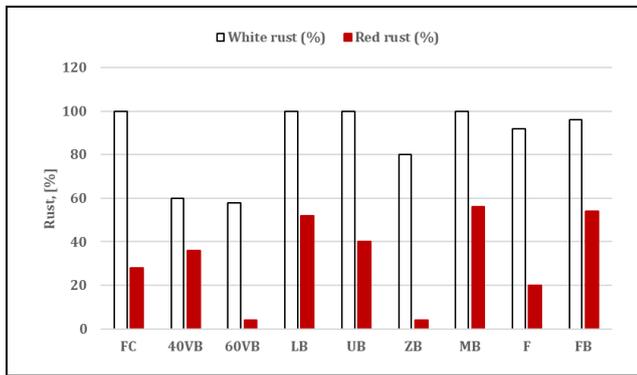
The percentages of white and red rusts of all salt spray tested samples are given in Figure 3. White rust is a prevalent type of corrosion that initially occurs on galvanized steel when it encounters moisture and oxygen. Corrosion frequently occurs during the initial phases of exposure to a corrosive atmosphere, such as in a salt spray test.

Figure 3. White and red rust percentages after salt spray tests.

The white, chalky deposit is visible on the surface of the galvanized coating. Although white rust may impact the visual aspect of galvanized steel, it often does not substantially diminish the zinc coating's protective qualities. Red rust forms as the steel beneath the coating erodes by depletion of the zinc coating. This suggests the zinc coating has been compromised or fully corroded in specific regions [13]. The reddish-brown rust observed is characteristic of iron oxide, indicating the oxidation of the steel substrate. Red rust occurs when the integrity of the zinc coating is damaged, enabling moisture and oxygen to penetrate the steel and start the corrosion process. Red rust is a more severe issue than white rust since it signifies

The white rust percentages are higher for all samples, as expected. The minimum red rust percentage is obtained in 60° V (60VB) and Z-bent (ZB) samples as 4% Figure 4(a). The highest red rust percentage is in the multiple-bent (MB) sample at 56% Figure 4(b). The 60VB sample showed minimum percentages of both white and red rust. The red rust percentages of the three samples (L-bent, multiple-bent, and folded+bent) are higher than 50%. Generally, the white rust is recognized in all shaped samples by the duration of 72 h in the salty environment. This result is consistent with literature. Haiducu et al. observed white rust formation on steel galvanized at various batch temperatures and durations within 48 h of exposure in salt spray testing [15].

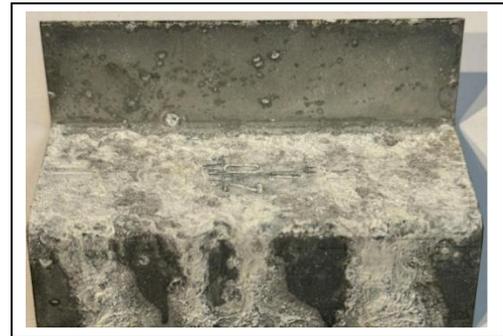
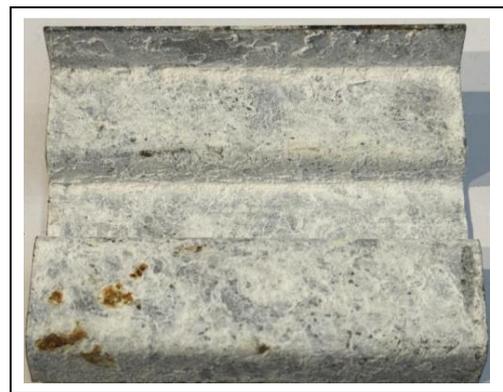
Figure 4. After the salt spray test. (a): ZB sample with minimum red rust. (b): MB sample with maximum red rust.

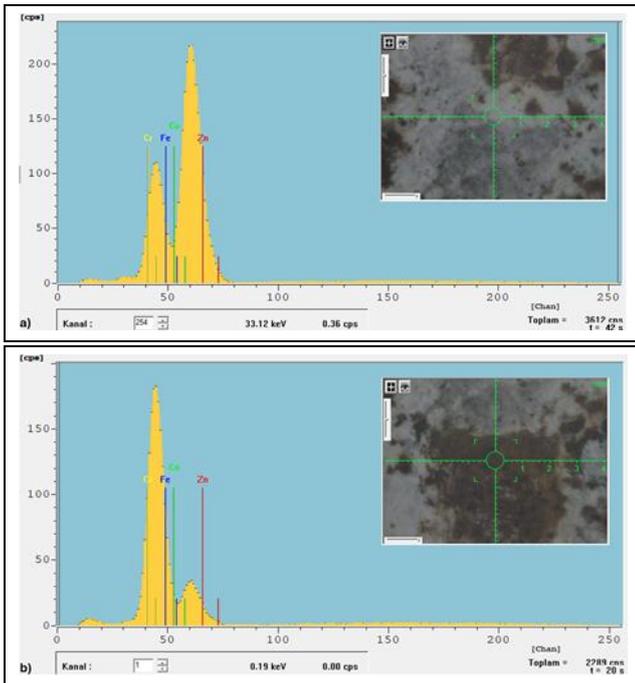
The X-ray of the MB sample, showing the highest red rust after the salt spray test, is given in Figure 5, depicting the elemental analysis of the white and red rust in this sample. By examining the white rust, the galvanized coating thickness is averaged by three measurements as 4.20 μm , an acceptable coating thickness for corrosion resistance (Figure 5(a)). On the other

hand, the zinc coating thickness in the red rust region was 1.4 μm by averaging five measurements (Figure 5(b)). There were coating thickness values below 1 μm , indicating destroyed coating and vulnerable to corrosion. This result is confirmed by the Zn amounts, where red rust has rather less Zn than white rust. Inversely, the Fe amount is higher in red rust, meaning that the zinc coating disappeared and the red rust containing iron oxides formed. The chromium (Cr) element was also identified in the galvanized coatings. According to the literature, the Cr element comes from the passivation treatment, applied after galvanizing to form a dense protective film for extending the service life of the galvanized coating [16]. The film produced by the passivation prevents the formation of white rust or delays the onset of white rust, maintaining the appearance of the coating.

Figure 5. X-ray analysis of (a): White rust, and (b): Red rust in salt spray tested MB sample.

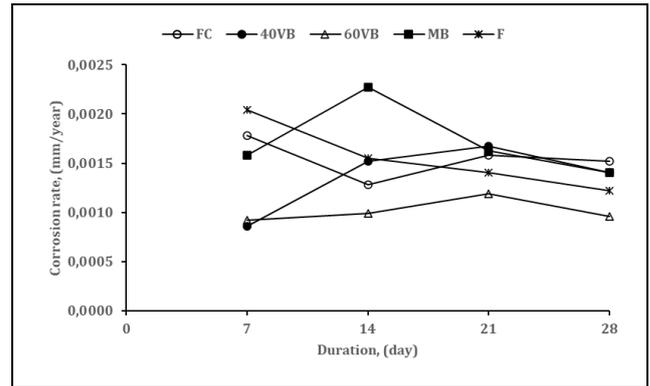
Figure 6 illustrates the corrosion rates of some samples (FC, 40VB, 60VB, MB, and F) over 28 days in the atmosphere, measuring mass losses at the end of every 7 days. After the seventh day, while the F sample showed a maximum corrosion rate of 0.00204 mm/year, the 40VB one had a minimum value of 0.00086 mm/year. The F sample's corrosion rates decreased gradually towards day 28. Inversely, the 40VB sample's corrosion rate increased with duration. After the end of the 28th day, the F sample's corrosion rate was lower than that of 40VB. These two samples showed nearly the same corrosion rates at the end of the 14th day.

Figure 6. Corrosion rates of some samples in the atmosphere.

The corrosion rates of the 60VB sample on the 7th and 28th days are close to each other. This sample showed a relatively stable corrosion rate throughout the period, with a slight peak around the 21st day. When the corrosion rates of a material are stable, it means that the material has established a consistent state in its association with the corrosive environment. Based on the findings of the present study, it can be inferred that the 60VB sample is more trustworthy for extended periods of use in atmospheric situations.

In the FC sample, the second highest corrosion rate is inferred on the 7th day, showing a decrease in the next seven days, then increasing for the remaining duration. At the end of the 28th day, the frame cut sample had the highest corrosion rate of 0.00152 mm/year.

The MB sample's corrosion rate showed a maximum peak value of 0.00227 mm/year on the 14th day, then decreased relatively rapidly at the end of the next seven days (the 21st day), continuing to decline but more slightly. After 28 days, its corrosion rate is below the frame-cut sample's.

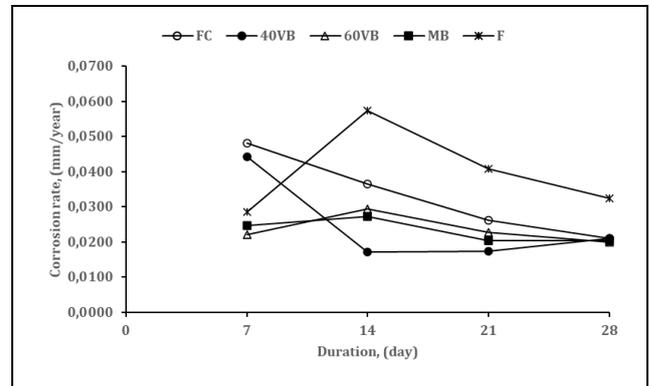
The corrosion rates of the samples held in the atmosphere are given in Figure 7 for the poultry manure environment. In this environment, after the 7 days of corrosion, while the frame-cut sample showed a maximum corrosion rate of 0.04810 mm/year, the 60VB sample had a minimum value of 0.02208 mm/year, below nearly half of the FC sample value.

Figure 7. Corrosion rates of some formed samples in a poultry manure environment.

The corrosion rates of the 60VB and MB samples show relatively stable behavior, suggesting better corrosion resistance in poultry manure after 28 days. The FC and 40VB samples' corrosion rates are decreased gradually with the duration time. The folded (F) sample has a peak value of corrosion rate (0.05730 mm/year) on the 14th day, then decreases after that. Despite this decrease, the highest corrosion rate is determined for the F sample as 0.03234 mm/year at the end of 28 days. All samples, except for the F, showed nearly similar corrosion rates after 28 days in the poultry manure environment. The decrease in corrosion rates over time is in line with the development of protective layers and the stabilization of corrosion rates. Decreases in corrosion rates with elapsed time were explained by Hernandez-Alvarado et al. with the formation and growth of

Comparing the corrosion rates of the same formed samples in two environments (atmosphere and poultry manure), the 60VB sample showed the most stable behavior by showing little corrosion rate differences between the 7th and 28th days. In addition, the corrosion rates of all samples are very high in poultry manure. The corrosion rates for FC, 40VB, 60VB, MB, and F samples are, respectively, 14, 15, 21, 17, and 23 times higher in poultry manure after 28 days of corrosion. This result suggests that poultry manure is a more corrosive medium than the atmosphere due to many chemicals (Table 2). When used in natural atmospheric conditions, galvanized sheets have a thin passive zinc carbonate layer that begins to form immediately after production and continues to slow down. This layer, which is the product, partially protects the sheet from severe corrosion that may occur later, but this natural barrier is insufficient for many strong corrosive environmental conditions. The mechanism of formation of this corrosion layer is as follows [18]:

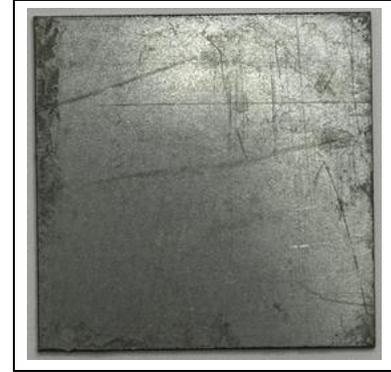
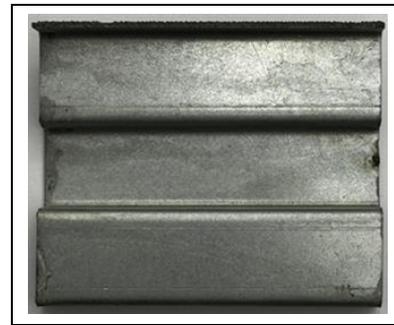
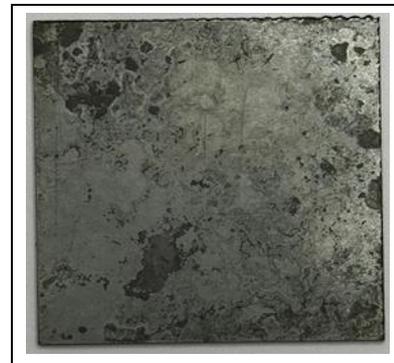
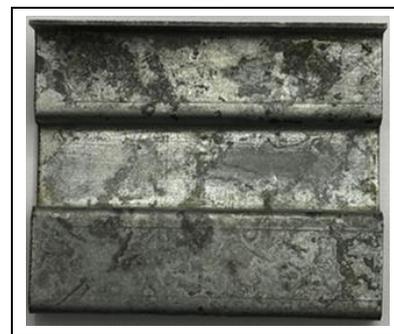
Figure 8 illustrates the corroded surfaces of FC and MB samples after 28 days of corrosion in the atmosphere and poultry manure. It is inferred from the figure that poultry manure showed a more severe corrosive effect, showing clear surface degradations on both sample surfaces Figure 8(c) and (d). In the atmospheric condition, Figure 8(a) and (b), in parallel with the low corrosion rates, generally smooth and unaffected surfaces are seen, showing the protective layer effect of the zinc coating. Few local degradations can be seen, especially near the cut edges, showing that laser cutting has a detrimental effect on corrosion resistance. This result can be attributed to the generated high temperatures, above the melting point of zinc, and burning galvanized coating in and near the cut sections by laser cutting. Therefore, the galvanized layer's protective effect may have been compromised in these specific places, leading to its accelerated deterioration due to increased reactivity with the corrosive environment. No visible reddish-brown rust formation is recognized in the FC, MB, and other sample surfaces (40VB, 60VB, and F) in the poultry manure after 28 days. However, the coating thicknesses were measured below 1 μm , as 0.634 μm and 0.427 μm , respectively, too low for corrosion resistance at dark-colored corroded surfaces of MB and F samples. This suggests that the red rust formation may begin, even if not visible to the naked eye, due to the low coating thickness in these places.

Figure 8. Corroded surfaces of (a): FC, (b): MB samples in the atmosphere, and (c): FC, (d): MB samples in poultry manure.

compounds, decreasing the corrosion resistance and forming red rust on the surface [19]. The absence of aggressive ions in the atmosphere, according to salty and poultry manure environments, smooth and non-corroded surfaces are seen in atmospheric conditions by comparing Figures 4 and 8.

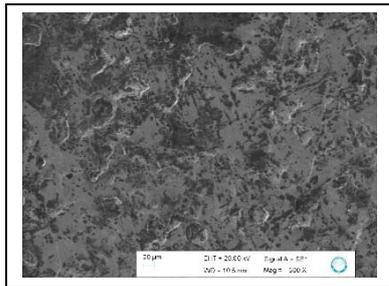
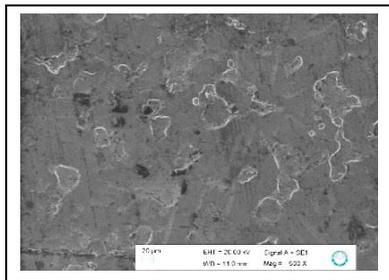
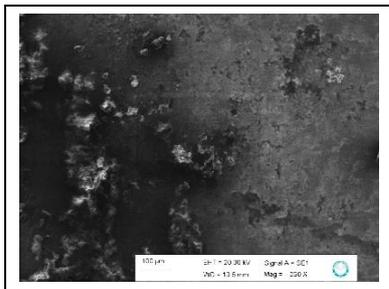
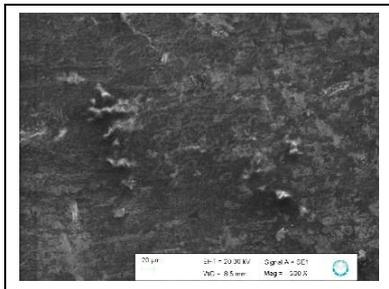
Figures 9(a) and (b) show the corroded surface morphologies in the atmosphere for the 60VB and FC samples, respectively. A relatively uniform corrosion with evidence of small pittings is seen in both figures. These pittings are more on the 60VB's surface. Figures 9(c) and (d) illustrate the corroded surfaces of the 60VB and F samples in the poultry manure. Contrary to Figures 9(a) and (b), these surfaces depict severe localized corrosion with clear irregular corrosion products. The aggressive constituents of the poultry manure, such as ammonia and organic acids, could have caused these products. The surfaces appear rougher with deeper pittings due to higher corrosion rates in the poultry manure, as verified by Figure 7.

Figure 9. Corroded surfaces of (a): 60VB, (b): FC samples in the atmosphere, and (c): 60VB, (d): F in the poultry manure.
