Endangered Mosque Heritage in Nakhchivan: Architectural Documentation and Conservation Priorities

Mahammad Bayramov¹

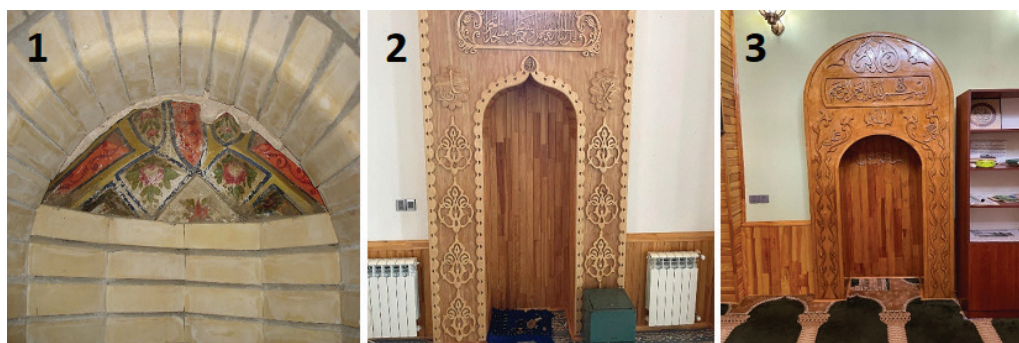
The preservation of mosques and shrines, and their proper execution, is one of the important issues. In this regard, it can be said that these cultural objects are often repaired or restored through personal initiatives. Although such restoration work, conducted outside of professional expertise, aims to improve the monuments, it often leads to both the loss of their historical value and a reduction in their lifespan. This, in turn, accelerates the deterioration of the monuments. During such restoration and repair work, the architectural features of mosques and shrines are often neglected, and their appearance is almost entirely altered. Random and unprofessional interventions, coupled with insufficient knowledge about the monument, can significantly change its historical and architectural characteristics. Of course, alongside the incorrect practice of restoring mosques and shrines through individual initiative, although the restoration of many architectural monuments is carried out at the state level, the self-directed actions of unskilled specialists have caused considerable harm to these monuments. The elements that suffer the most damage during the restoration of mosques and shrines are their mihrabs. Recently, mihrabs distinguished by specific architectural styles have been dismantled and replaced with mihrabs made of furniture materials, or, as in the case of the Ordubad Juma Mosque, covered with tiles. Mihrabs made of furniture materials can be found in the Dəstə Juma Mosque, the Vənənd Juma Mosque, and the Burcunu Mosque in Vənənd (Figure 1). Mihrabs, one of the most important architectural elements of mosques, were originally constructed with great delicacy and thoughtfulness, featuring intricate patterns, motifs, and inscriptions. In this regard, the Ordubad Juma Mosque in the Ordubad region, dating back to the 17th century, which is considered one of the architectural jewels of the region, can be cited as a significant example.

Figure 1. Mihrabs; 1- Vənənd Mosque (former); 2- Vənənd Mosque (current); 3- Burcunu Mosque (author's archive).

The lack of supervision by specialists over the restoration and repair work of Azerbaijan architectural monuments, including mosques and shrines, as well as the absence of a unified concept regarding restoration and repair activities, creates certain problems in the preservation of these monuments. This situation leads to the restoration of architectural monuments through personal initiatives and by non-professional specialists, which can result in their distortion or even destruction, an outcome that must be strictly prevented.

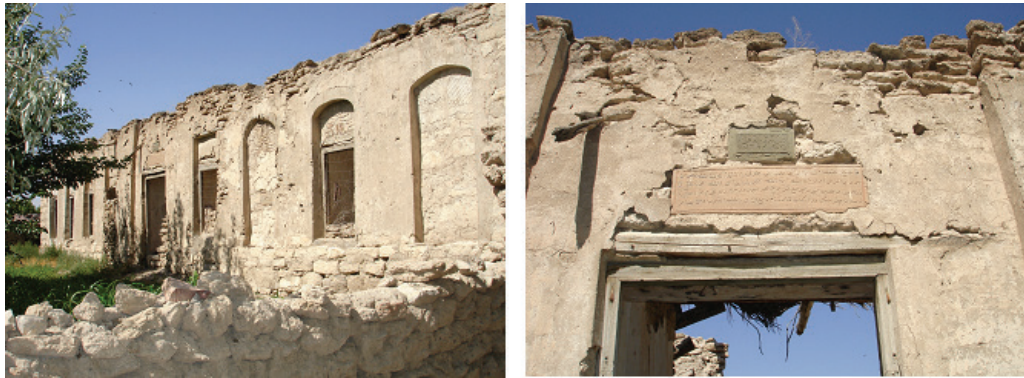
The ancient mosque located in the northern part of Xok village in the Kangarli district stands out as one of the historical-religious buildings dating back to the 18th century (Figure 2). Although the mosque is currently in an unusable condition, it is possible to imagine its original appearance based on its architectural features and remaining elements. The building is rectangular in plan and constructed in an elongated form. The entrance of the mosque is located on the south side. The roof has completely collapsed. Based on the remaining construction elements, it can be said that the roof was supported by wooden beams, and the ceiling was held up by wooden columns. The courtyard of the mosque is surrounded by a stone wall. The walls are mainly built of stone, while some parts, particularly

certain sections of the walls and window headers, are constructed with baked bricks. The window headers are completed with semicircular arches. Above the entrance door, there are two inscriptions written in Arabic script. One of these inscriptions relates to the construction of the mosque, and the other to restoration work carried out at a later period. Based on the content of the inscriptions, it is determined that the mosque was built in the 18th century. Unfortunately, this historical site has not been preserved to the present day. Currently, only the ruins of the structure remain. Such monuments are part of our national heritage, and their loss would mean the erasure of our history. Therefore, it is essential to take ownership of the mosque and implement preservation measures before it is completely destroyed.

Figure 2. Ruined state of the Old Xok Mosque (author's archive).

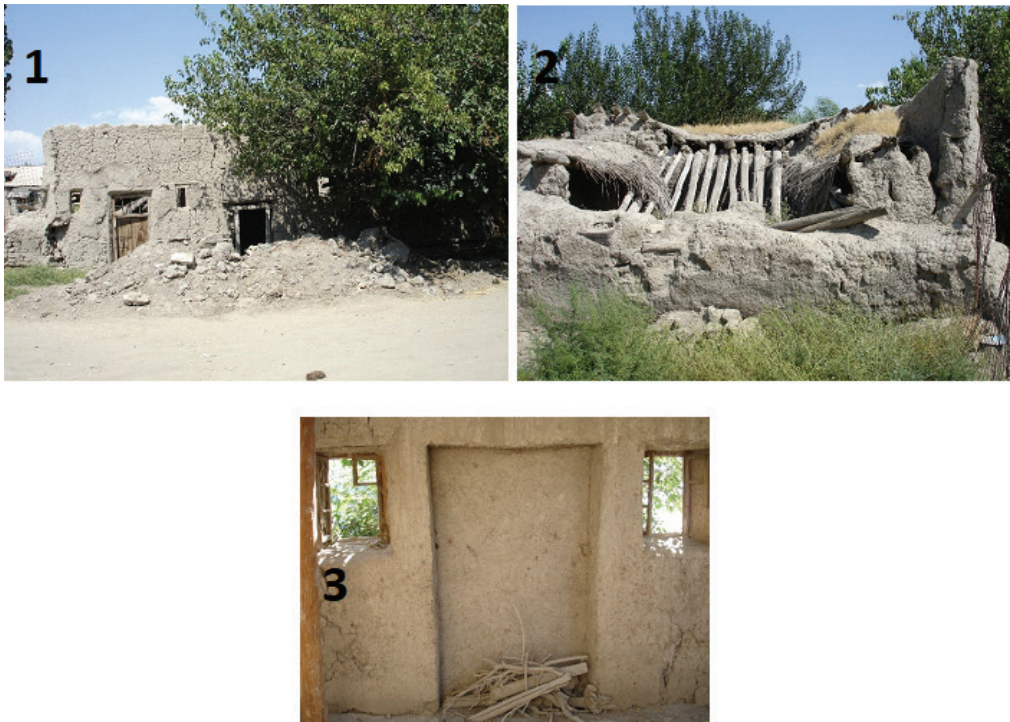
The historical mosque located in Kurchulu village of the Sharur district was built in the central part of the village (Figure 3). The main part of the mosque has a rectangular form and is constructed from stone materials. In later periods, an additional auxiliary building with a rectangular plan, built from bricks, was added to the structure. Two entrance doors are located on the south wall of the main building. One of these doors was intended for male visitors, and the other for female visitors. The mihrab, positioned at the centre of the qibla wall, is designed as a rectangular niche and was used to indicate the direction of prayer. A part of the mosque's partition has survived relatively well to the present day. Based on the remaining elements of the mosque in its ruined state, it can be determined that the ceiling structure was supported by wooden columns. The capitals of these columns were also made of wood, with inscriptions carved on them. Inscriptions written in Arabic script can be observed on the capitals. Based on the obtained information and architectural features, it is possible to date the initial construction of the Kurchulu Mosque to the 18th century, while later modifications and additions belong to the 20th century. This indicates that the mosque was in use for a long period and underwent functional changes over time. The internal columns of the Kurchulu Mosque have a stepped structure, similar to those in the Qıxmırlı, Qurbanlı, Xanaga, Burcunu, and Yurdcu mosques. Overall, such wooden column constructions were commonly used in many mosques built between the 17th and 18th centuries (Bayramov, 2025).

Figure 3. Ruined state of the Kurchulu Mosque; 1-Entrance, 2-Auxiliary building, 3-Mihrab (author's archive).

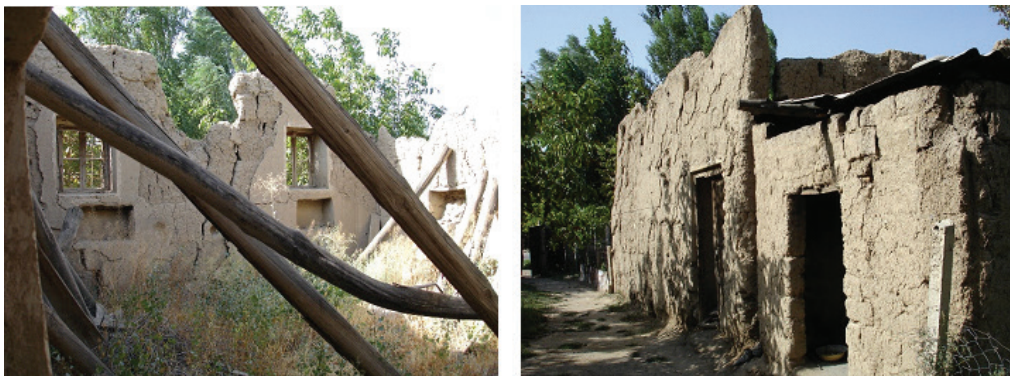
The mosque is located in Aşağı Aralıq village of the Sharur district. The historic mosque has a rectangular plan and is constructed from stone materials. The entrance is situated on the eastern side. To the left of the entrance, a later-added auxiliary building made of bricks was constructed to serve additional needs. The structure has not survived intact to the present day. The mosque's roof has completely collapsed and fallen inward. The remains of the ruined roof

structure, particularly the wooden beam fragments, indicate that the roof was flat (Figure 4). The doors and windows of the building are rectangular in shape. Beneath each window, there are elongated rectangular niches. The mihrab, located on the south wall, is completely destroyed, and its original location can only be determined based on its contours. There are various oral traditions among the local population regarding the construction of the mosque. These traditions can be considered an important source that reflects the role of the architectural monument in society and the way it has been valued. Based on the architectural features and construction techniques, it is estimated that the mosque was built between the 18th and 19th centuries. Currently, only the ruins of this building remain. It is among the historical-religious monuments in need of preservation and is noteworthy as part of the national cultural heritage.

Figure 4. Ruined state of the Aşaqı Aralıq Mosque (author's archive).

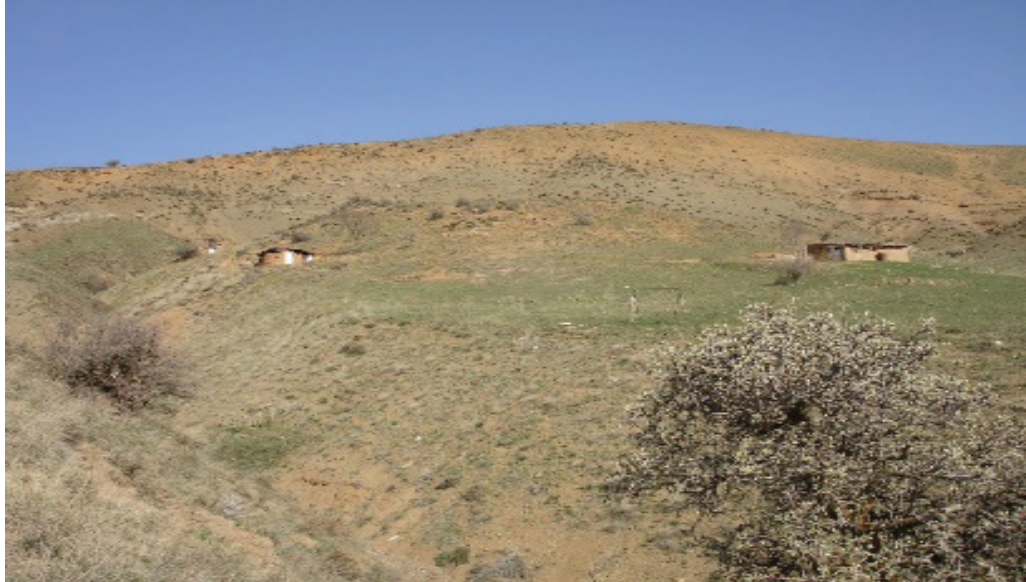
The Seyid Pir is a pilgrimage complex consisting of three structures built in close proximity to one another, located on a mountain slope to the north of Göynük village (Figure 5). The entrances of these structures face south, and their internal layout is organized in accordance with Islamic religious principles, featuring numerous burial sites. The interior wall surfaces are decorated with religious inscriptions, depictions associated with Islamic sacred figures, and

various illustrative elements with different narrative themes. The complex is not only a religious-functional space but also a sacred centre where significant rituals are performed within the belief system of the local population. Residents of surrounding villages visit this pir, offer sacrifices, and make vows there in the hope that their prayers will be fulfilled. Pilgrims customarily tie pieces of cloth and scarves of various colours to trees around the pir and to areas near the structures, symbolically expressing their wishes. In the northwestern part of the complex, there is also a small shrine with a rectangular plan, constructed by stacking natural rock fragments.

Figure 5. View of the three structures within the Seyids Pir Complex (author's archive).

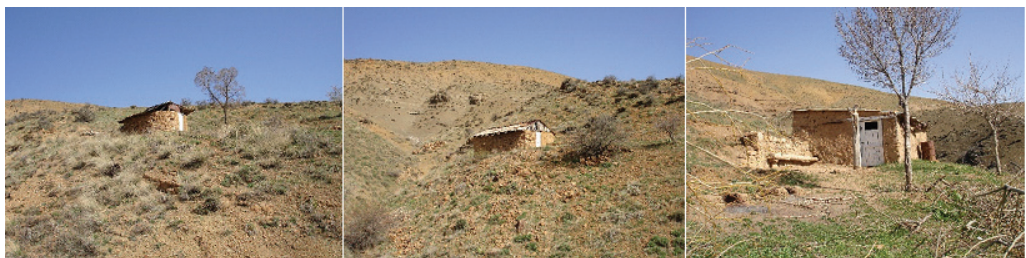
This site, like the other structures, is associated with the tradition of pilgrimage. Existing ethnographic and architectural studies indicate that the structures forming the Seyids Pir Complex were built over the graves of sacred individuals and, in this respect, correspond to the classical concept of a pir. As the pir buildings have undergone multiple restorations, their exterior and interior appearances have been completely altered. The remains of an ancient Muslim cemetery located near the complex have survived to the present day, further reinforcing the religious and historical significance of the area. Based on its general architectural characteristics and historical context, the Seyids Pir may be dated to the 17th–18th centuries. The buildings within the pir have currently been reconstructed (Figure 6). During the renovation of the Seyids Pir in Göynük village of Babek District, restoration and repair works were carried out in a new style, without taking into account the original architectural style and construction materials of the shrines previously located there.

Figure 6. View of the three structures within the Seyids Pir Complex (author's archive).

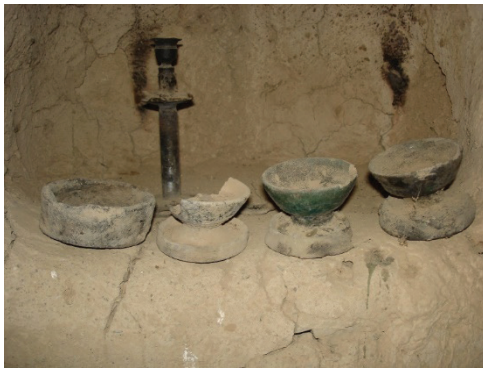
The Kilit Pir is located in a hilly area to the south of Kilid village, which is part of the Ordubad District of the Nakhchivan Autonomous Republic. The entrance of the monument is situated on the eastern side. The principal structure of the pir is a small building with a rectangular plan. Small rectangular niches set into the wall surfaces emphasize both the functional and decorative qualities of the space. The placement of lamps, presumed to date to the medieval period, within these niches indicates that religious ceremonies and pilgrimage rituals were conducted at the site. The grave located at the centre of the structure most likely belongs to an individual regarded as sacred and venerated by the local population. Archaeological observations carried out in the area revealed ceramic specimens of various forms and techniques around the pir (Figure 7). On the basis of these ceramic materials, the initial construction of the Kilit Pir is dated to the 16th–17th centuries. The uncovered materials provide valuable information about both the chronological framework of the monument and the religious-architectural traditions that existed in the region. In terms of both its architectural characteristics and functional purpose, the Kilit Pir is considered one of the typical representatives of medieval pilgrimage shrines in the Nakhchivan region (Figure 8). The hilly geographical setting in which it is located further enhances the shrine's spiritual and symbolic significance.

Figure 7. Interior of Kilit Pir (author's archive)
