## Accessibility Assessment of a Historic Mosque Through Universal Design Principles: The Case of Edirne Old Mosque

Research Article  
10.65520/erciyesfen.1914527

**Background/Aim:** This study examines the accessibility of the Edirne Old Mosque within the context of Universal Design Principles and assesses its relationship with contemporary access standards for historical buildings.

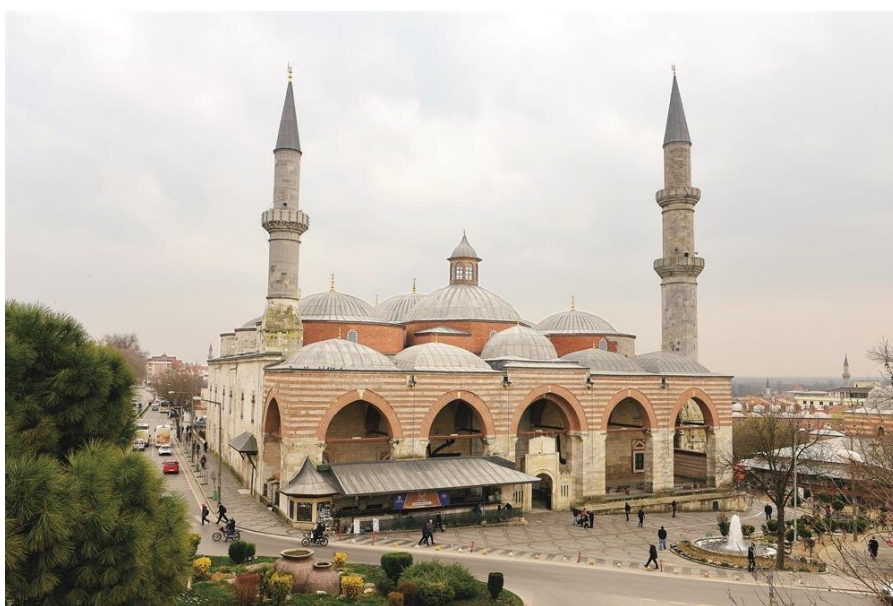
**Figure 3.** General view of the Edirne Old Mosque, field survey archive, 2025.

The Edirne Old Mosque, built in the early 15th century, is one of the best examples of the multi-domed mosque style of the early Ottoman period (Figure 3). The building lies in the middle of the city, at the intersection of Talat Paşa Boulevard and Saraçlar Street, an area with high pedestrian circulation. Approaches to the mosque are possible from the northern and eastern façades; however, the main entrance is accessed via several steps, which constitute a primary physical barrier, particularly for wheelchair users [11].

The mosque features a nine-domed plan layout, and the transitional space between the exterior and interior lacks contemporary accessibility elements such as ramps, thresholds suitable for wheelchair passage or elevators. Nonetheless, the surrounding open square and pedestrian axis present a potential to enhance physical access. Consequently, the study employs a comprehensive accessibility evaluation that considers both the mosque's structural-spatial attributes and its environmental-functional context.

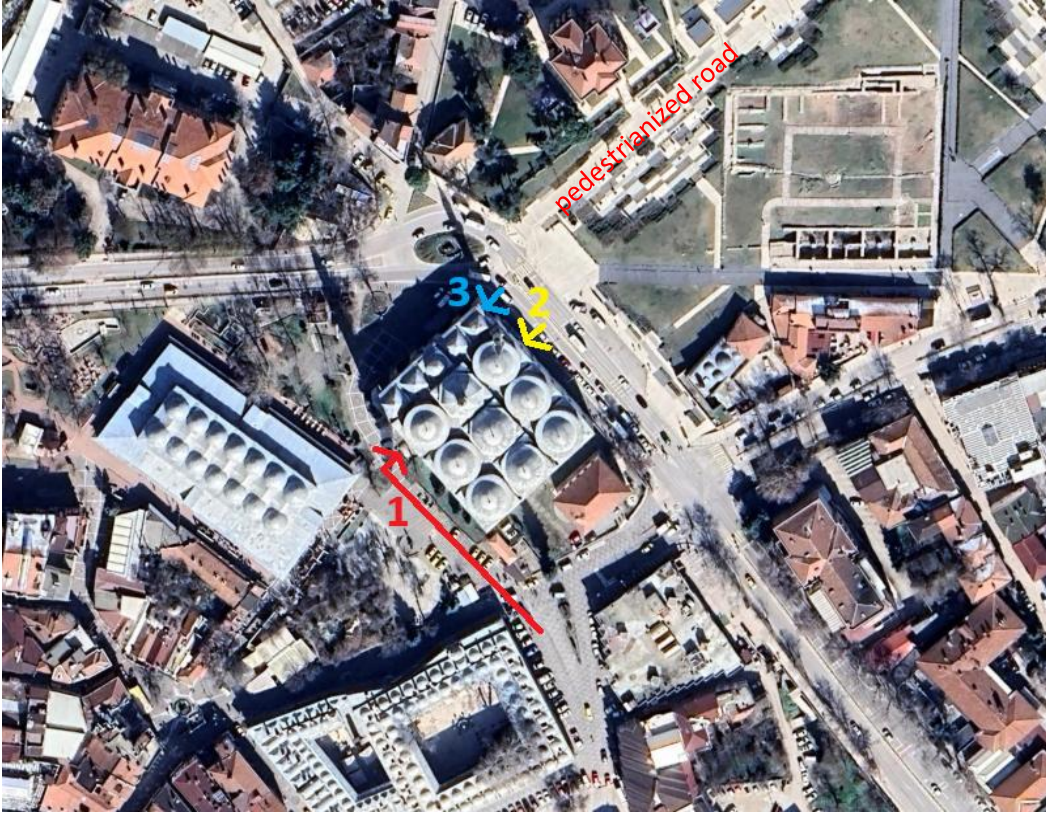
**Figure 5.** Access routes around the mosque: 1–Approach from parking, 2–Main prayer hall entrance, 3–Entrance to the portico (based on Google Earth view, 2025)

Parking areas along Talat Paşa Boulevard are elevated above the pavement level, restricting safe passage for wheelchair users. Surface irregularities, excessive slope gradients and a lack of tactile guidance further disrupt the pedestrian route. For visually impaired users, interruptions in tactile surfaces, obstacles such as lamp posts, tree pits, and signboards create navigational difficulties (Figure 5).

Field observations revealed that the access routes display unsuitable elevation variances, deteriorated surfaces, and a lack of ramps. Many of the existing slopes exceed the maximum 6.25% gradient recommended by ADAAG (2010), contradicting the “environmental continuity of access” principle emphasized in BS 7913 [8]. Nevertheless, the large open square surrounding the mosque presents an opportunity: with appropriately designed ramps and continuous tactile surfaces, the area could potentially be improved in terms of accessibility using low-impact adaptive measures in accordance with international conservation principles. Figure 6 shows the pedestrian access to the entrance of the mosque.

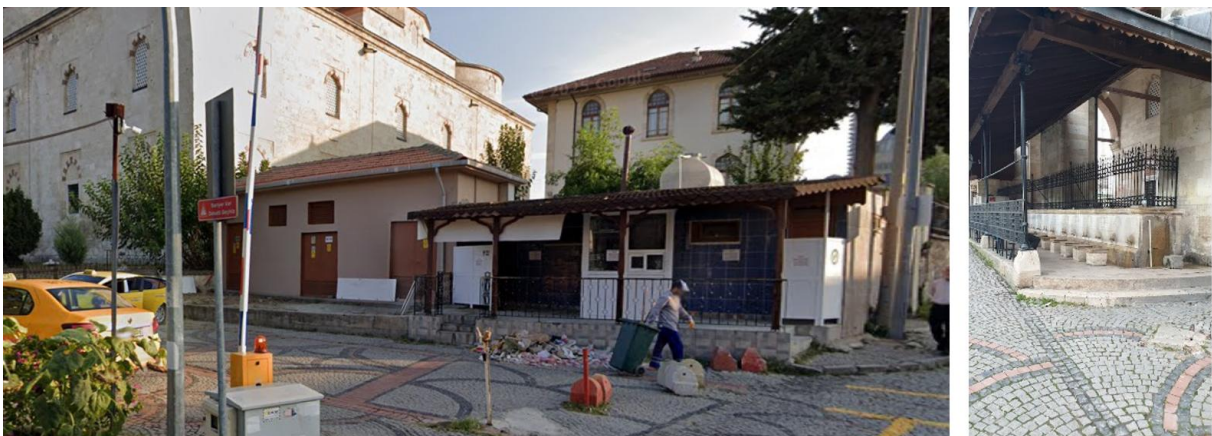
**Figure 9.** Nearby toilet and ablution facilities, field survey archive, 2025.

The ablution and toilet facilities located in the immediate vicinity of the mosque also present significant accessibility challenges (Figure 9).
