# Jeomorfolojik Arařtırmalar Dergisi

### Arařtırma Makalesi / Research Article

## URBAN EROSION IN THE CITY OF MATAMÉYE: VULNERABILITY, DAMAGES, AND CONTROL STRATEGIES

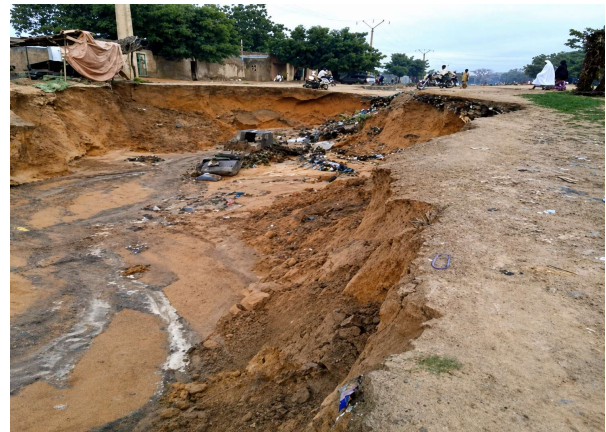
**Figure 9:** Gully erosion in the N'Wala neighborhood (right side of R3, depth 2.07 m). Figure by Abdou Sitou L. (2020).

development of gullies across several urban sectors, particularly during August, when rainfall intensity and frequency reached at their peak levels. The year 2019 thus represents a clear transition from limited linear erosion to more extensive and destructive gully formation, directly linked to rainfall intensity and temporal concentration. This trend is also clear from the intensity-duration=frequency curve of the rainrecords in the region (Figure 9). This shift resulted in the formation of four major gullies, with an estimated total soil loss of approximately 3540.7 m<sup>3</sup> during the 2019 rainy season (Figure 11). The figure 9 clearly shows a gully in the N'Wala neighborhood in 2019 after these ranin events.

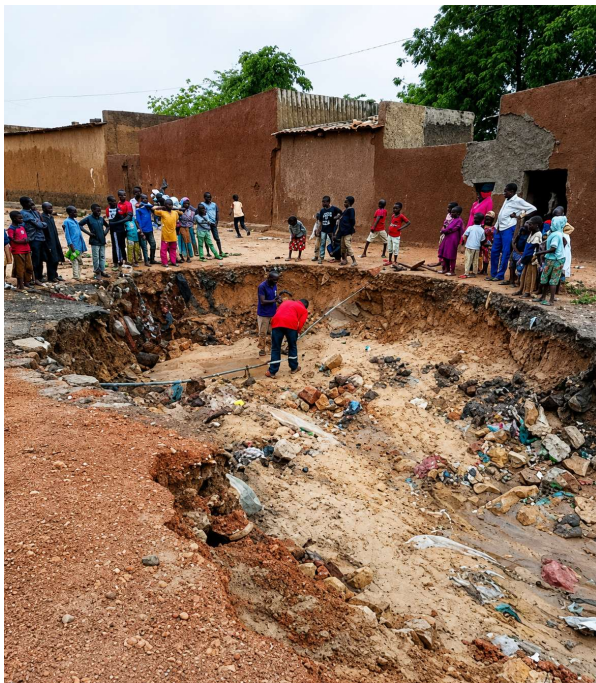
**Figure 12:** Headcut retreat after a 73 mm rainfall event (42 m<sup>3</sup> of soil removed) source: Abdou Sitou L., 07/09/2021.

September 6 and 7, totaling 108 mm, resulted in an estimated soil loss of approximately 42 m<sup>3</sup> due to headcut retreat in R4 gully located in the Sabon Gari neighborhood (Figure 12). Overall, these results demonstrate a strong relationship between rainfall intensity, frequency, and erosivity, and the observed dynamics of gully erosion in Mataméye. In the year 2021, three significant gully formed occurred, namely R5 gully (characterized by aggressive and intense erosion), the R6 channel (representing passive gully erosion), and the R7 gully (defined by aggressive vertical incision). The concentration of rainfall within short periods significantly enhances runoff generation and flow concentration, particularly in urban areas where surface conditions favor rapid hydrological response.

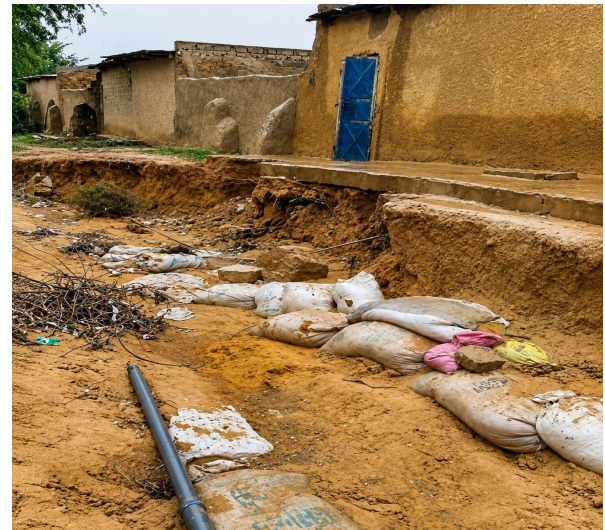
**Figure 15: Dynamics of Ravine R1 (2019)** source: Abdou Sitou L.

Spatial and morphometric analyses indicate that N'Wala (harboring the R5 and R6 ravens) is the most severely affected neighborhood, with more than four gullies totaling 183.2 m in length in 2021. In Sabon Gari, N'Wala, and Kanguiwa, gullies reach advanced dimensions, with widths exceeding 10 m, average depths of approximately 1.46 m, and lengths ranging from 80 to 120 m, reflecting an advanced stage of morphodynamic development. The heavy rainfall events recorded in 2019 caused substantial soil losses and rapid channel expansion. In response to this critical situation, municipal authorities implemented mechanical backfilling of a major gully (R1) in the Kanguiwa neighborhood. This gully was approximately 7.1 m wide and nearly 2 m deep and posed a direct threat to nearby residential areas (Figure 15).

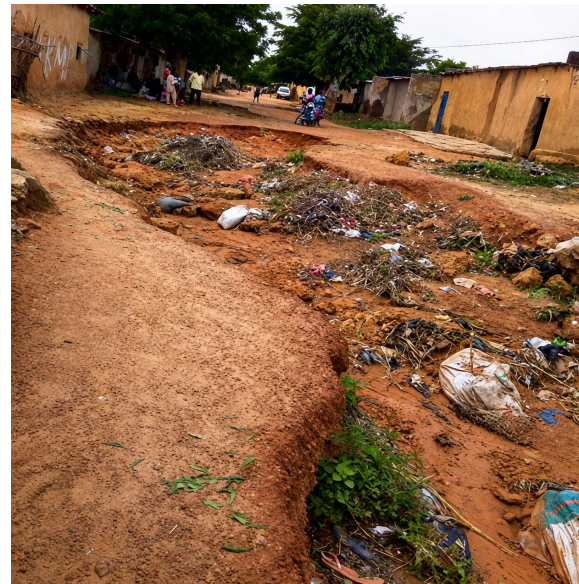
**Figure 16: Renewed Gully Erosion in Ravine R1 (2020)** source: Abdou Sitou L.

However, field observations and post-intervention imagery (Figure 16) reveal that this backfilling operation significantly altered the original gully morphology without ensuring long-term stabilization. Partial infilling resulted in the formation of an artificial and unstable cross-sectional profile, characterized by steep banks composed of loose, poorly compacted materials highly susceptible to concentrated runoff. Following the first intense rainfall events of 2020, these deposits were rapidly remobilized, leading to renewed channel incision, accelerated lateral widening, and reactivation of erosional processes. This evolution highlights the limited effectiveness of backfilling techniques when not combined with adequate drainage control and bank stabilization measures (e.g., riprap, vegetation cover, energy dissipation structures). It also illustrates the difficulty of controlling gully enlargement in urban environments when interventions remain local, short-term, and reactive, without consideration of the broader hydrological functioning of the watershed.

Consequently, the current gully morphology observed in Kanguiwa results from the combined effects of intense natural hydrological processes and inadequate anthropogenic interventions, which tend to enhance geomorphological instability and prolong land degradation dynamics.

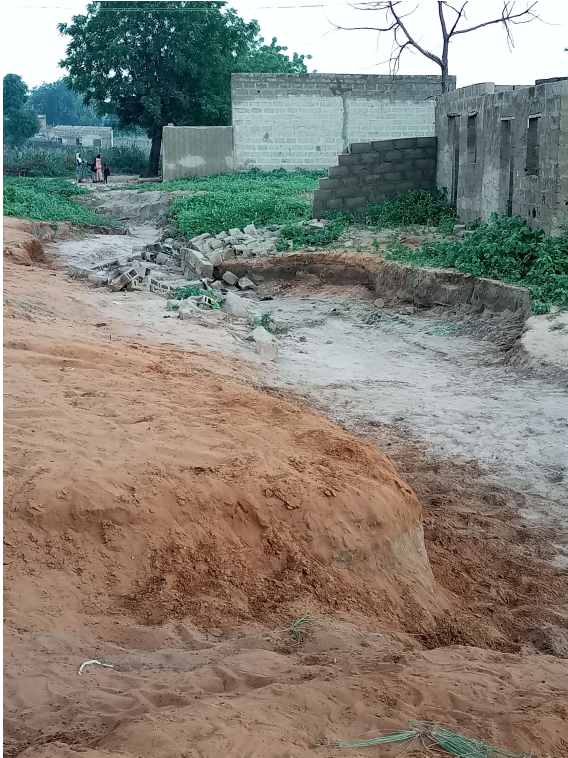
**Figure 17:** Housing Construction Triggering a Ravine (2021) source: Abdou Sitou L.

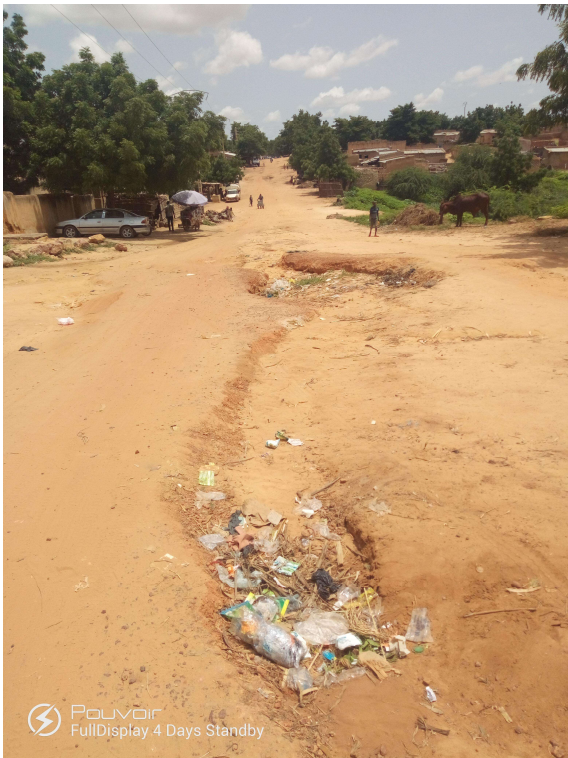
**Figure 18:** Road Degraded by Gully Erosion source: Abdou Sitou L. (2020).

Gully erosion in Mataméye has severely damaged unpaved and lateritic roads, causing frequent impassability and loss of accessibility.

This disrupts daily commuting, hinders the transport of goods, slows local economic activities, and forces residents to take long, unsafe detours. The ongoing road degradation also heightens social vulnerability by limiting access to markets, schools, health services, and emergency response (Figure 18).
